## **PRATT ROCK PARK**

Phase 1: Initial Needs Assessment  
Pratt Rock Park, Prattsville, New York

prepared for:  
Pratt Park Committee  
Prattsville, New York

April 18, 2022

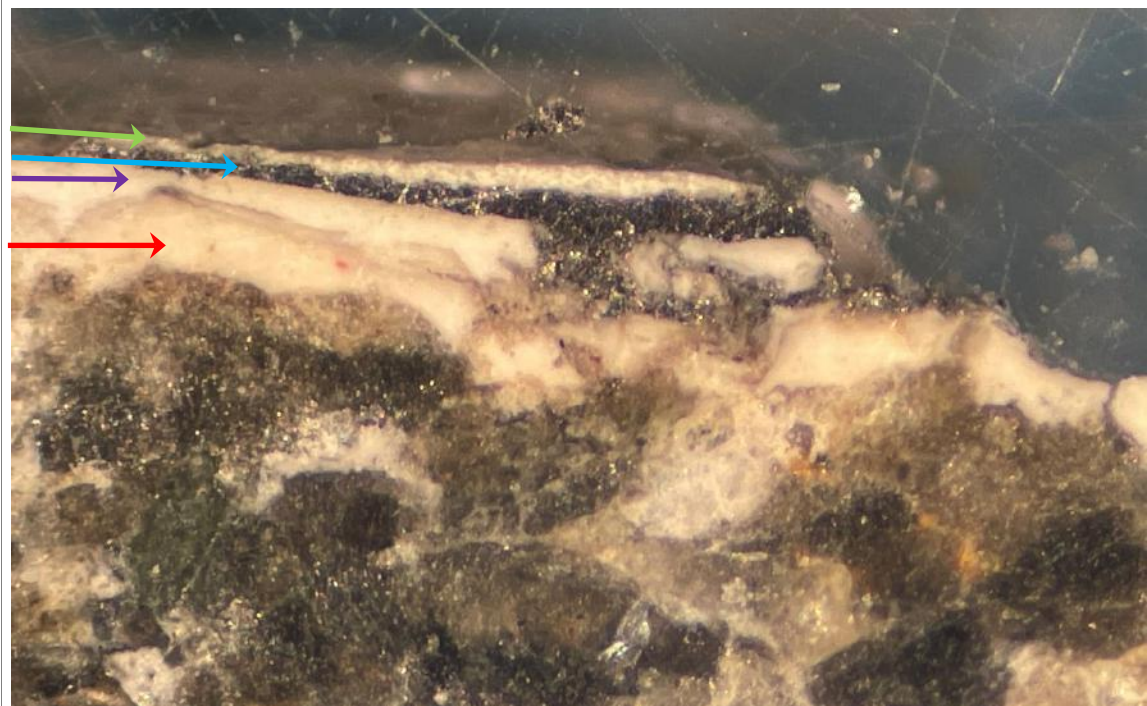
Analysis of the most intact and consistent samples shows that the earliest extant layer appears to be an off-white coating (Munsell Color® "White" N 9.5/), followed by a metallic gray coating, and the last white presentation layer. The most comprehensive stratigraphy observed was obtained from Sample 1, the mane of the "Horse" sculpture (see Figure 1 below). This sample shows an additional off-white layer in between the earliest coating and the metallic gray coating, with a soiling layer separating it from the previous layer. While this additional coating was not observed in the remaining samples, it is possible that the additional campaign was applied at the sculptures more easily accessed from the ground, or was selectively applied as needed, or had weathered away from the more exposed sculptures elsewhere.

**Figure 1: “Horse” Sculpture, Microscopic Image of Coating Sample 1 in Cross Section**  
*Earliest off-white coating indicated in red, a subsequent off-white coating indicated in purple, a gray metallic coating indicated in blue, and the final white presentation layer indicated in green.*

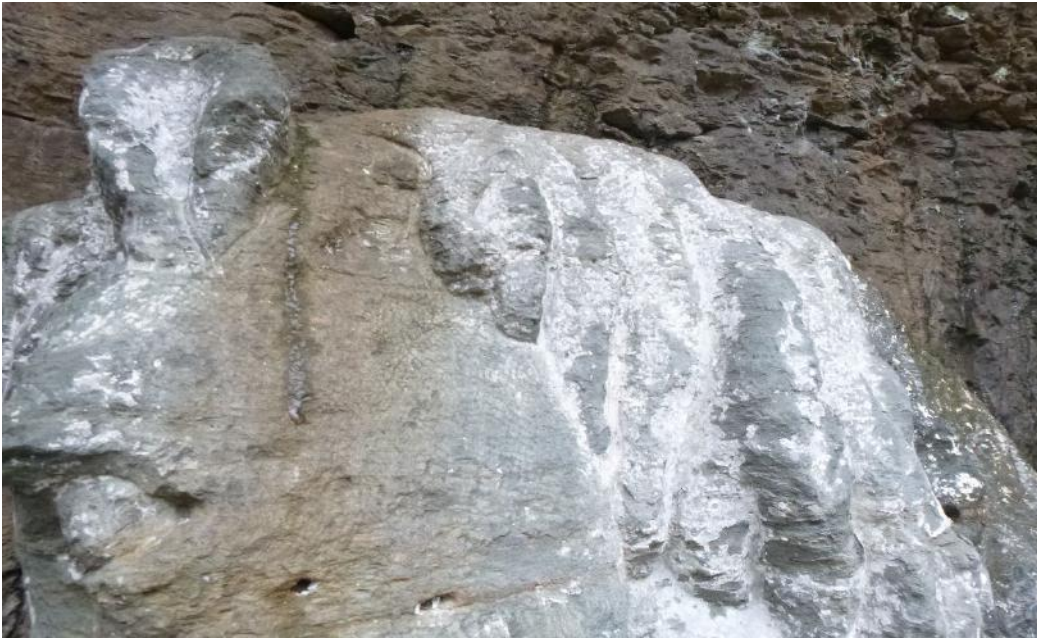
**Figure 1: "Horse" Sculpture, Coating Sample 1 Location**  
*Coating sample was obtained by ICR on 11/22/21 from the horse's mane.*

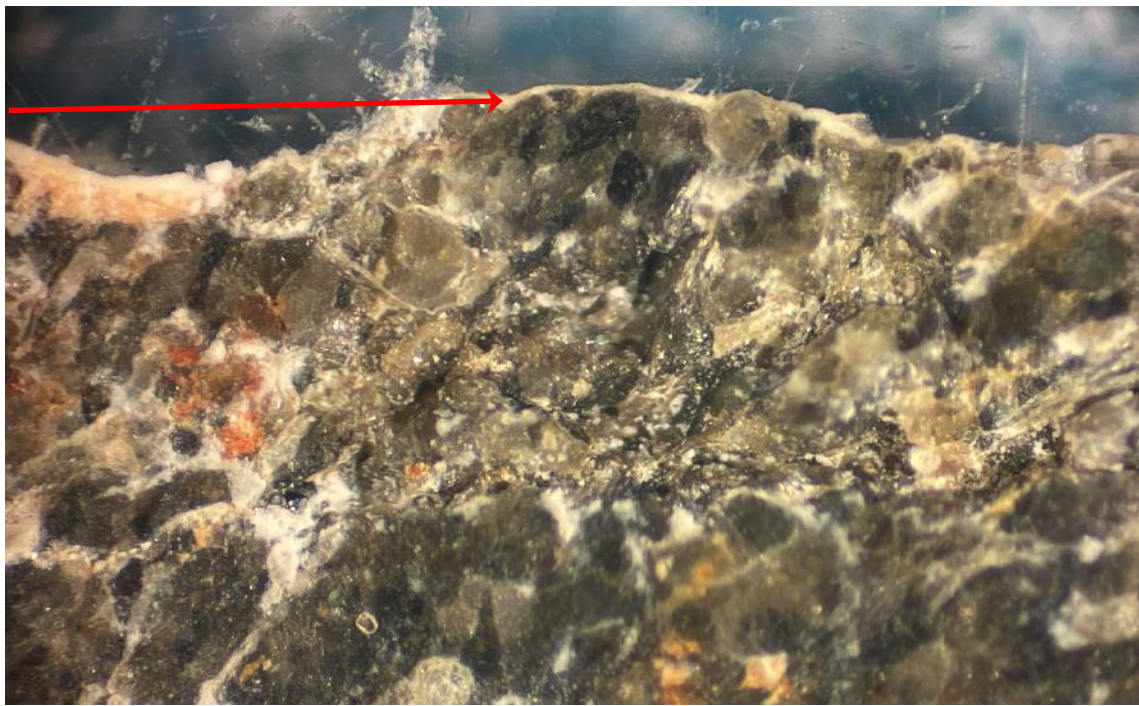
**Figure 11: “Hemlock Tree,” Top of Tree Location, Microscopic Image of Coating Sample 4 in Cross Section**  
*Minimal extant coatings observed with just a single white layer indicated in red. Sample was not very informative with incomplete stratigraphy.*

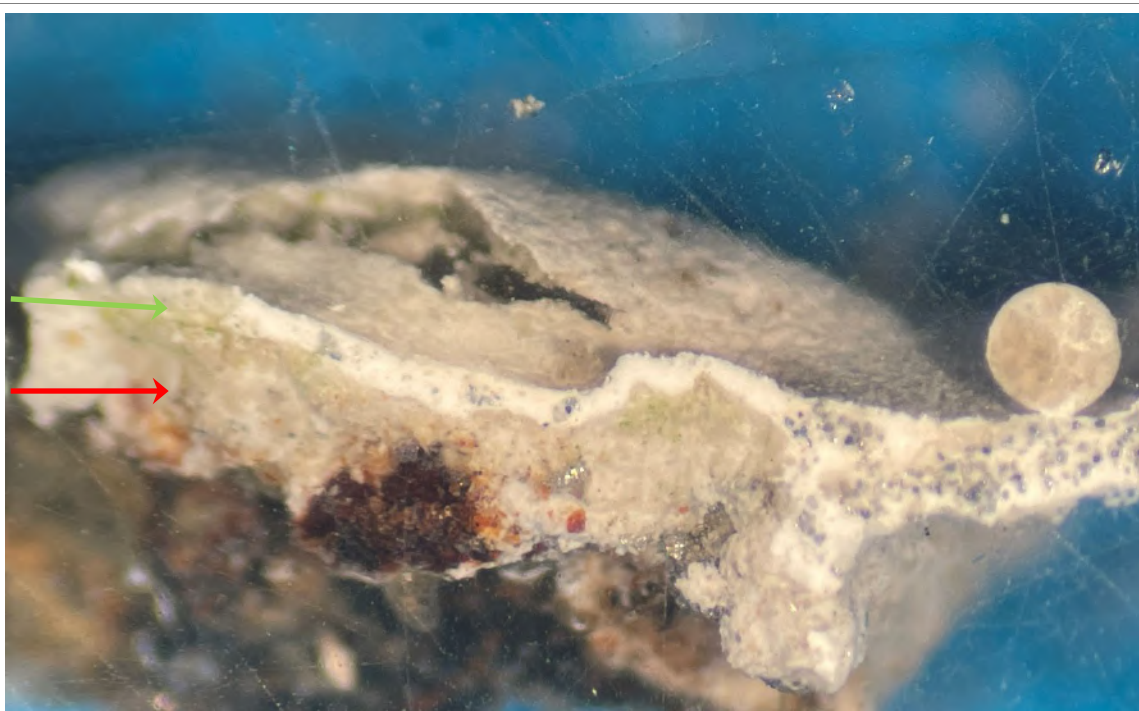
**Figure 12: “Bench C” Hemlock Sculpture, Microscopic Image of Coating Sample 5 in Cross Section**  
*Earliest off-white coating indicated in red, and the final white presentation layer indicated in green. There appear to be mobilized gray particles similar to the metallic gray layer observed in other samples, rendering inconclusive results.*

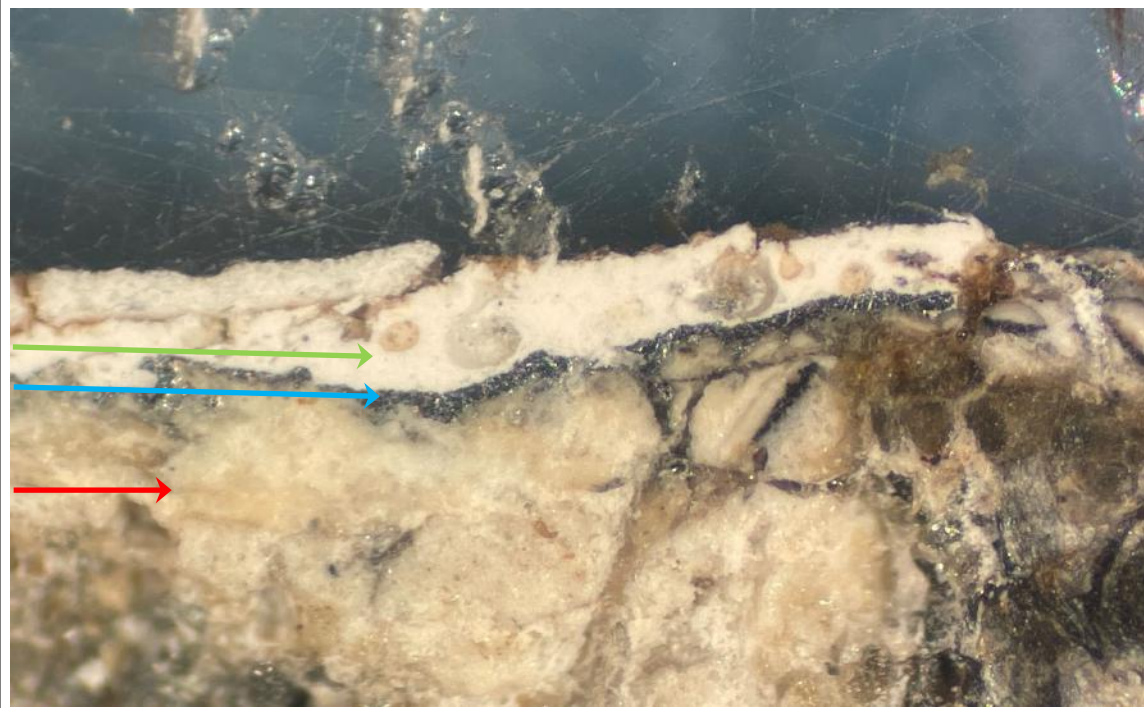
**Figure 13: "Portrait Bust of George W. Pratt," Microscopic Image of Coating Sample 6 in Cross Section**  
*Earliest off-white coating indicated in red, a gray metallic coating indicated in blue, and the final white presentation layer indicated in green.*

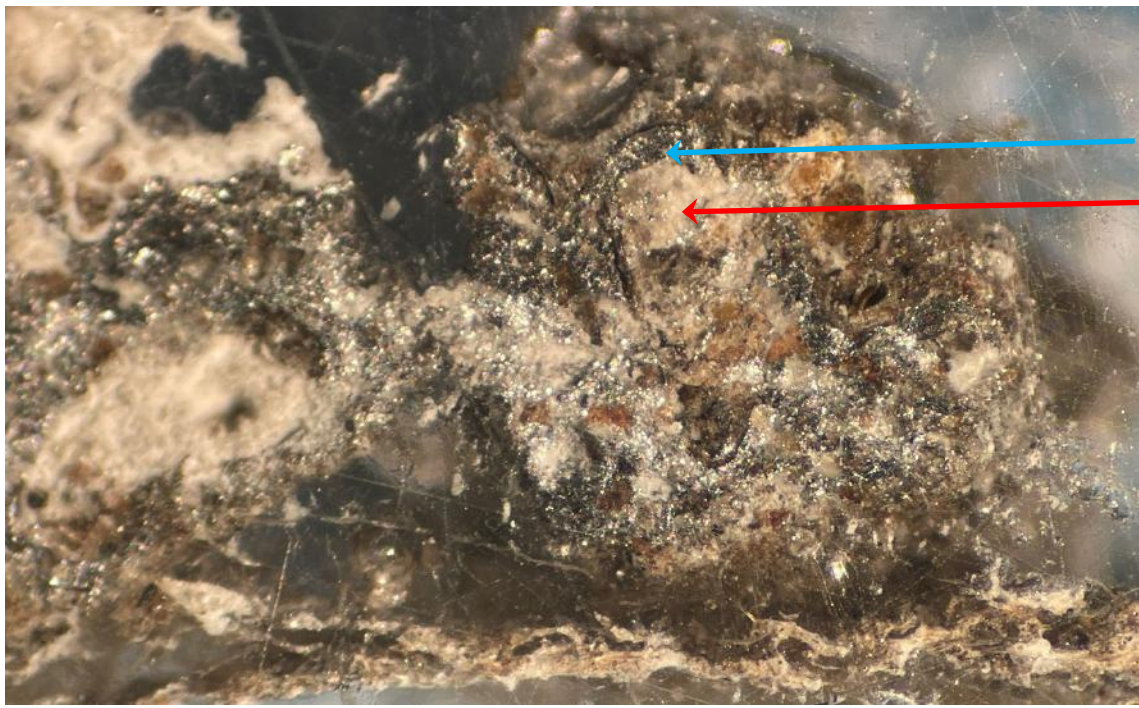
**Figure 15: “Plaque to George and Julia Pratt,” Microscopic Image of Coating Sample 8 in Cross Section**  
*Sample stratigraphy was irregular and could not be analyzed chronologically. Off-white coatings (red) and metallic gray coatings (blue) similar to layers in other samples were observed, but the findings are inconclusive.*

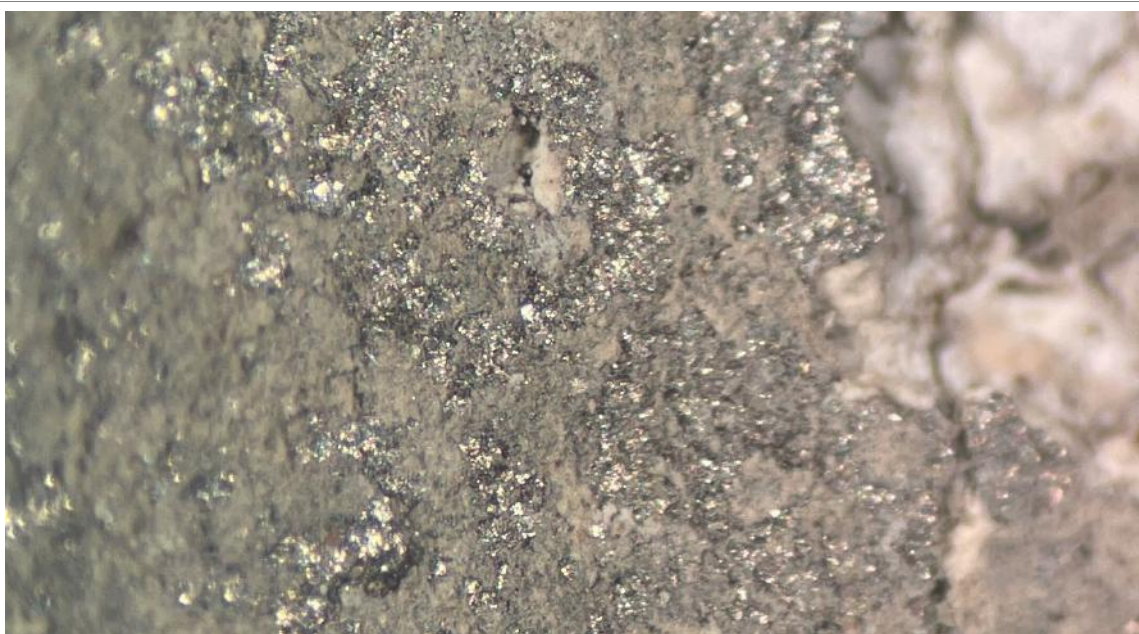
**Figure 16: “Horse” Sculpture, Microscopic Image of Hand Sample of Coating Sample 1**  
*Metallic gray layer exposed in hand sample, which could potentially be an aluminum paint, used as a protective layer beneath the final white presentation layer.*
