Pratt Rock Park

Initial Concept Plan

PRATT PARK COMMITTEE

TOWN OF PRATTSVILLE, NEW YORK

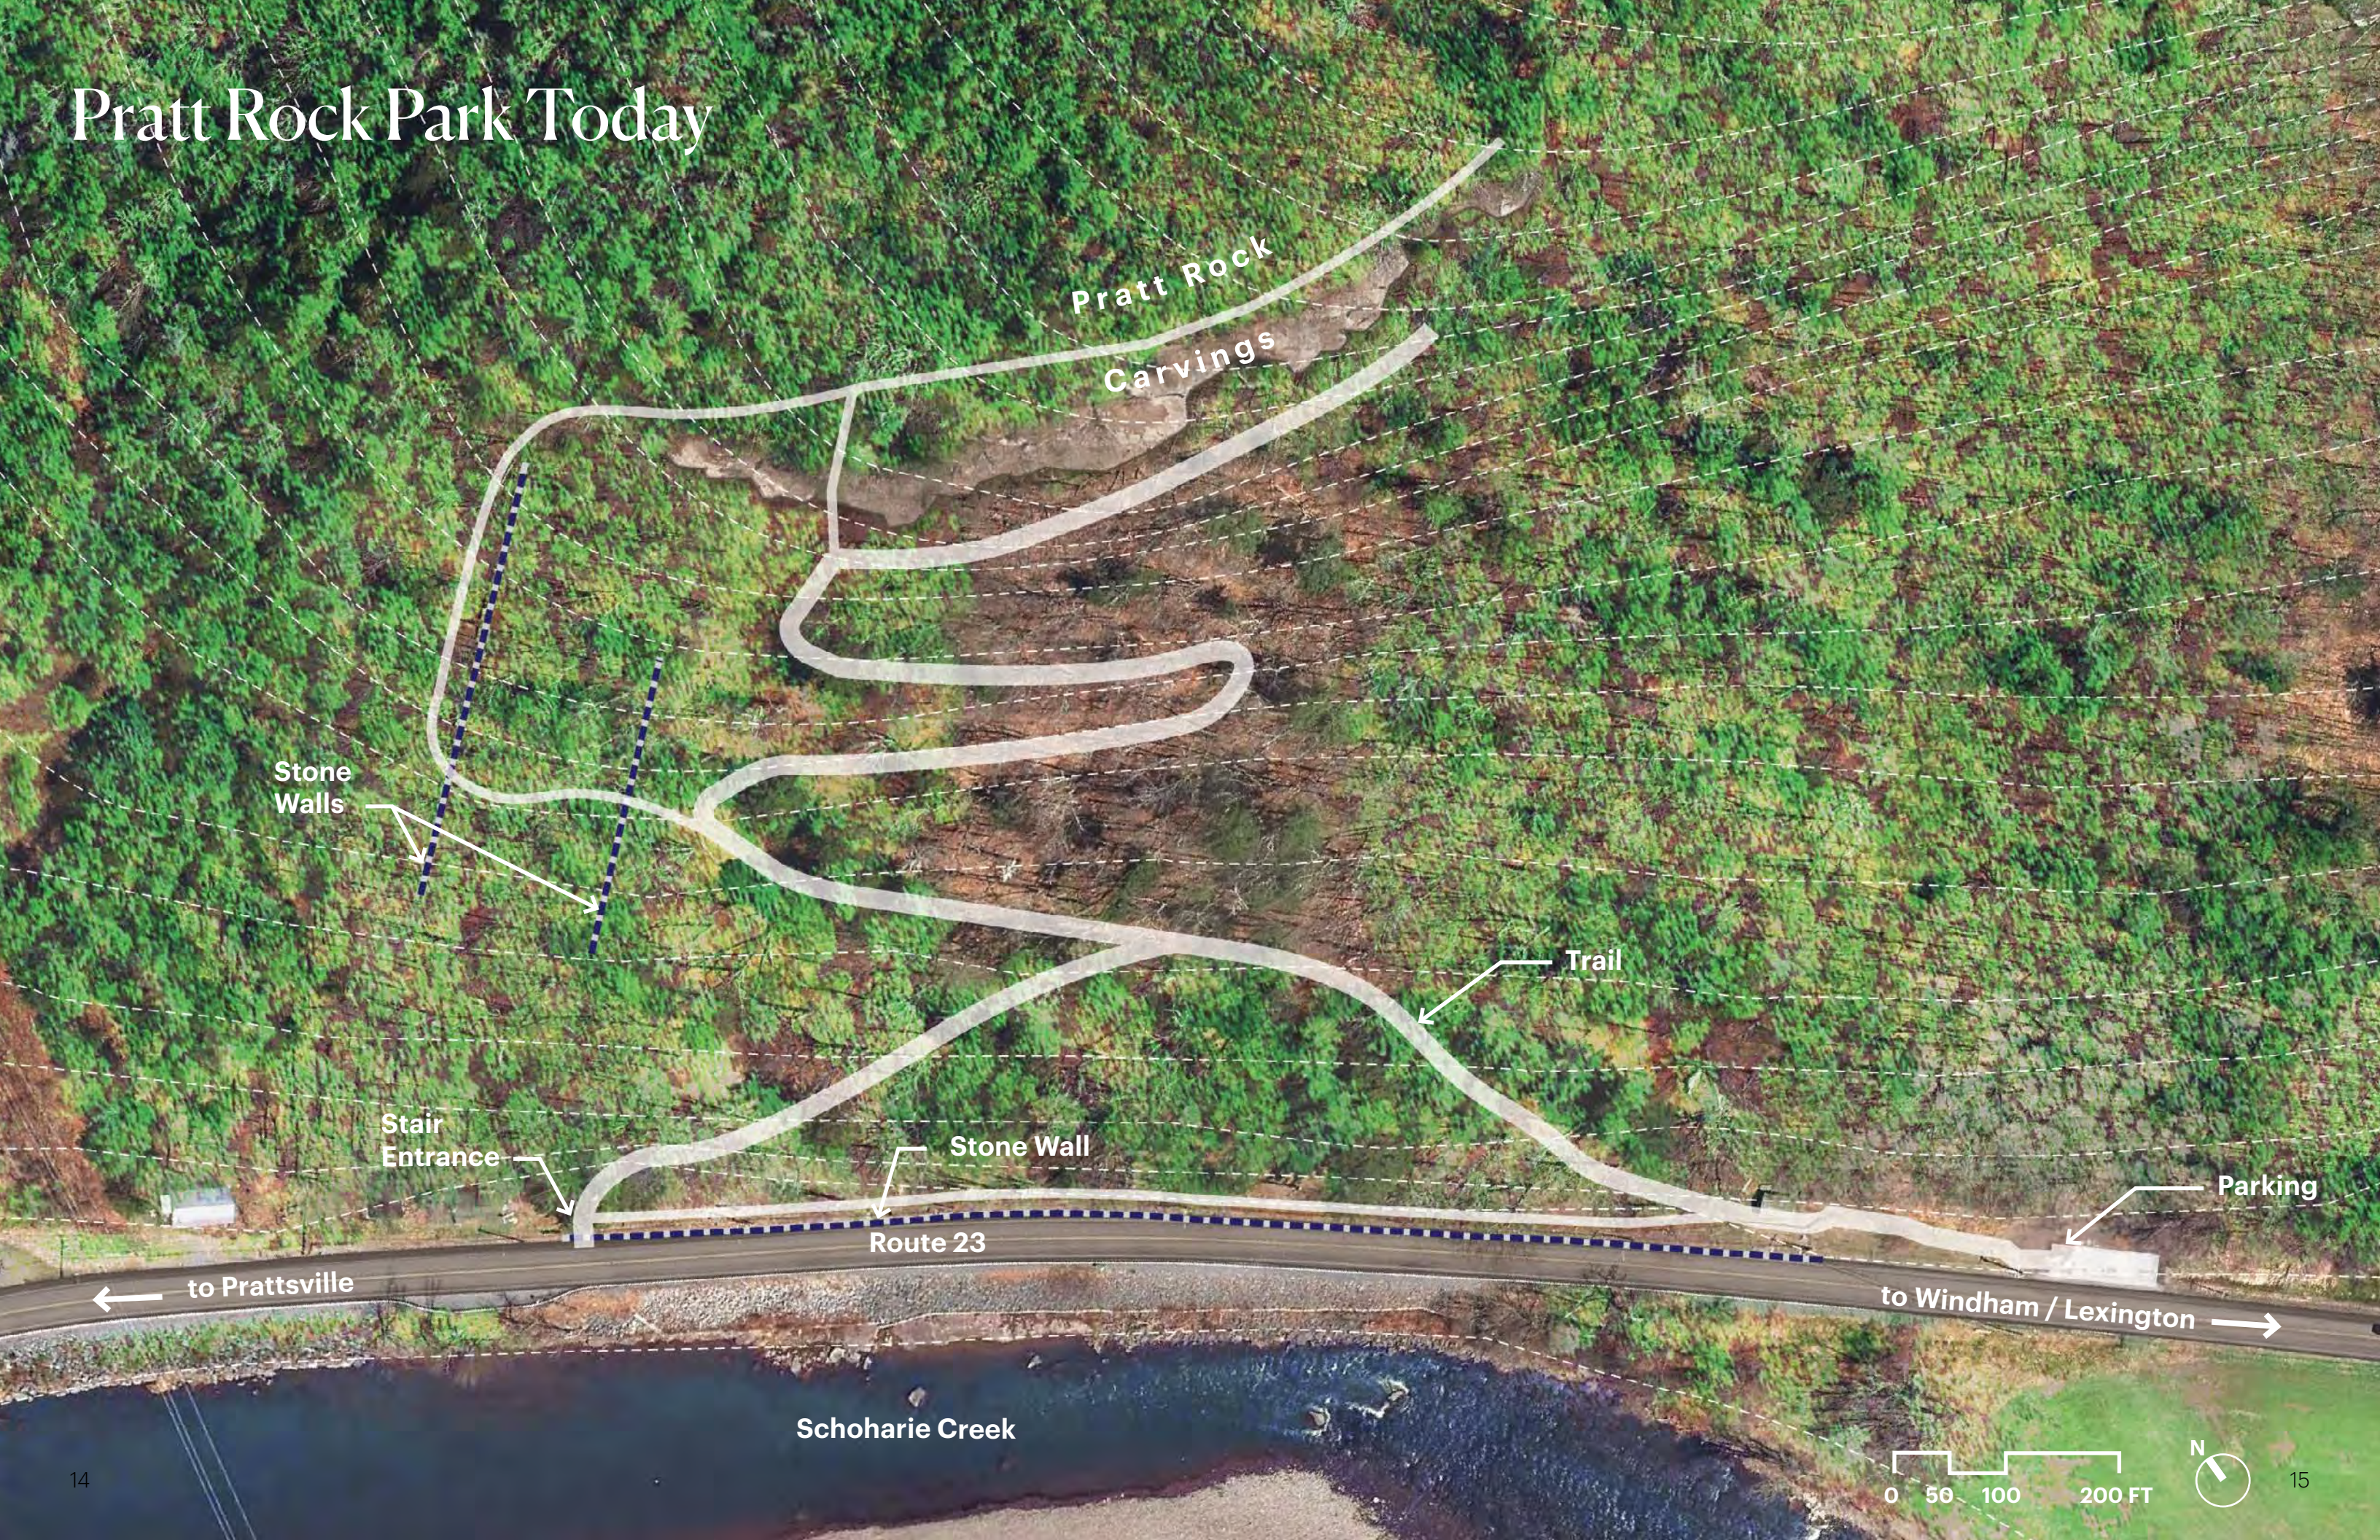
Pratt Rock
Carvings

Stone
Walls

Trail

Stair
Entrance

Stone Wall

Route 23

Parking

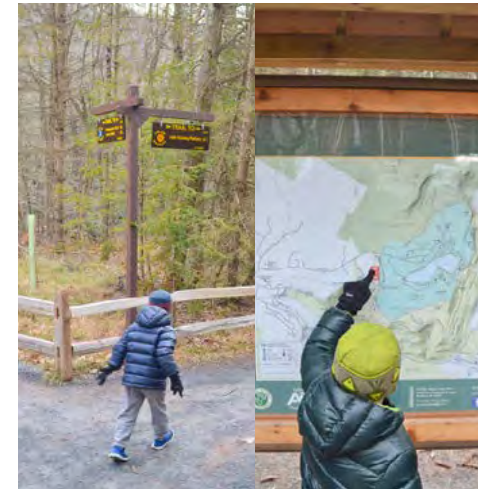
SIGNAGE

Signage provides trail users all necessary information regarding trails and facilities, in addition to the historical details of the park. Primary and secondary trailhead signs would give an overview of facilities and amenities around the larger site. Directional signs would help guide visitors at crossroads along the trail. To ensure safety while visiting Pratt Rock Park, warning signs would be placed around the site, cautioning hikers about any potential hazards.

- Trailhead signage
- ▲ Directional signage
- Interpretive signage

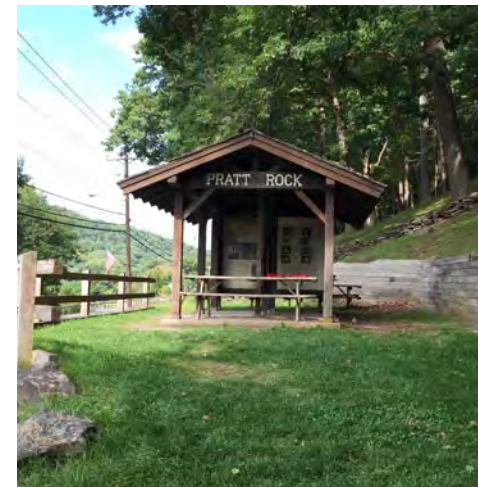
WOODEN PAVILION AND WALL REMOVAL

MVVA recommends removing the existing pavilion, which does not align with the original simplicity of Pratt Rock Park's path and approach, and moving the existing park's picnic tables into this area. These picnic tables would offer a resting place at the beginning or end of a visit, and no new furniture would need to be acquired. Also, removing the wooden retaining wall and reinforcing the slope above this area will help reestablish the park's original character.

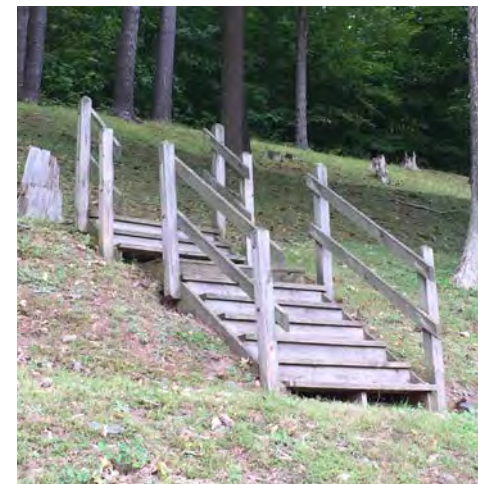
STAIR REMOVAL

The existing wooden stairs were a later addition to the park and interrupt the slow terraced rise to the carvings. Removing the stairs and reinforcing the trails along the terraces would reinstate the original means of traveling to the top of Pratt Rock.

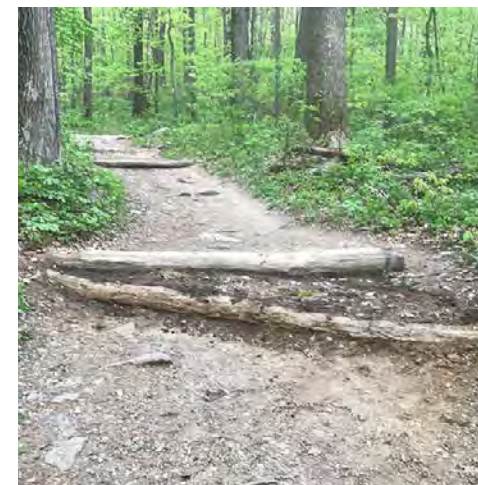
RUN-OFF MANAGEMENT

Effective drainage is essential to promoting trail safety and stability, and minimizing maintenance costs. The most effective drainage solutions are often the simplest to implement and maintain. These include: culverts, drainage depressions and dips, cross drains, drainage turnpikes, and switchback drainage. Waterbars could also be used to divert water off the trail treads.

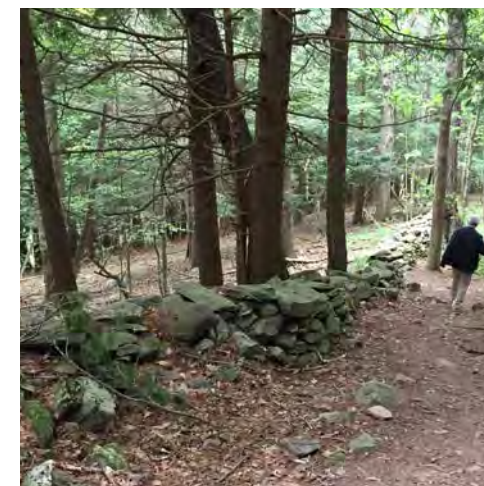
STONE WALL RESTORATION

The stone walls along the trail can be used for wayfinding purposes and are an integral part of the park's history. Restoring these walls would ensure their lasting impact in the park. These updates would require cutting vegetation growth, removing additional soil, and gathering loose stones that have fallen over time.

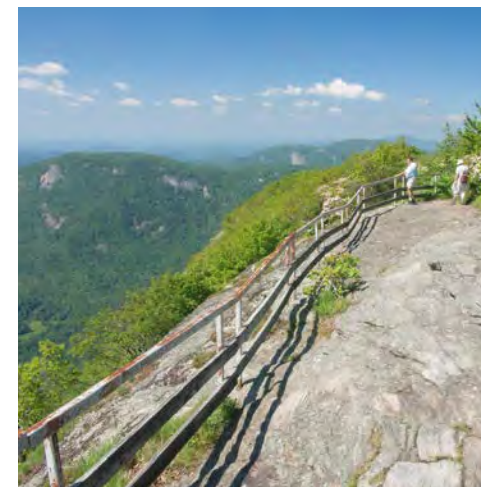
TRAIL AND PRATT ROCK LANDINGS

Adding an overlook would provide space for visitors to step back and look at the carvings from below. This could be accomplished by supplementing the trail below the rock carvings with a retaining wall and handrails. At the top of Pratt Rock, a handrail made of rot-resistant wood could be placed 3 to 4 feet from the edge, creating a landing area. It would be invisible from below and therefore preserve views of the carvings, but would ensure safety for visitors at the top.

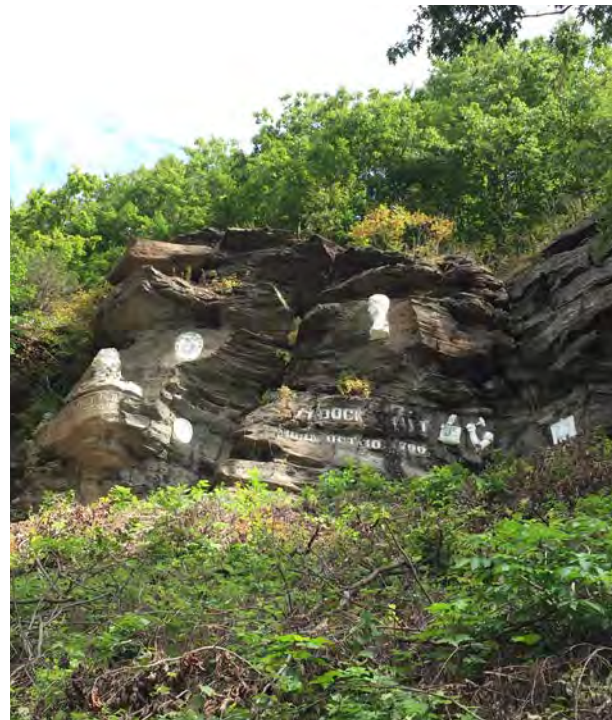
Midway along the trail, MVVA suggests creating an overlook area where the trail becomes wide enough to accommodate benches, signs, and handrails. This location would provide excellent views down to the valley and up to the carvings, with enough space to see both at the same time.

The landscape in this area would be cleared annually and planted with a woody shrub groundcover that would not grow above 2-3 feet (see p.24). A few hemlock trees would be added, providing a visual connection to the history of Prattville. This overlook would feature three benches and a sign explaining the history of Pratt Rock Carvings and the park.

View from the middle of the trail to Pratt Rock

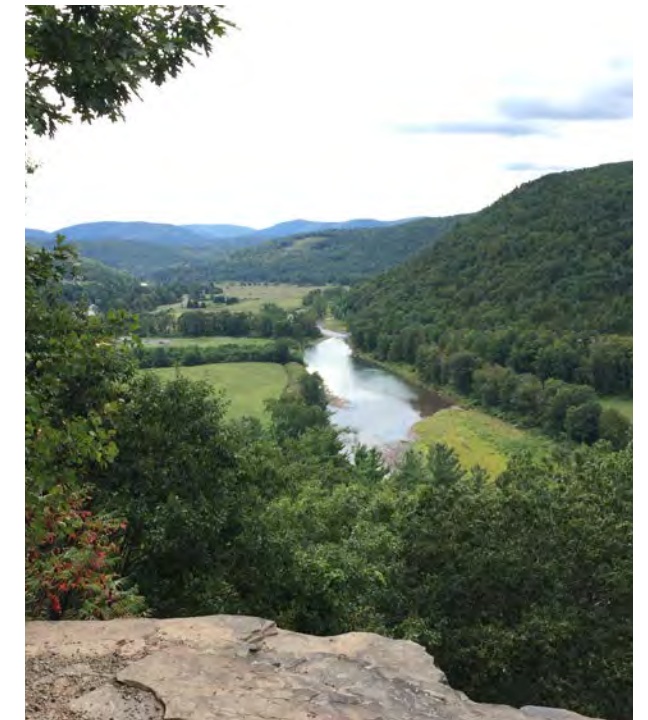
Finally, at the top of the trail near the Pratt Rock carvings, another overlook area will present a peaceful opportunity to contemplate the expansive views out over the valley. It will also provide three log benches and a sign describing the history of the Schoharie Valley and surrounding region. The landing area will be surrounded by a handrail made of reclaimed wood and will guarantee visitor safety.

A series of renovated steps carved into the rock will provide a safe route to the top of the trail. Handrails or a rope could be added to make the journey in the steeper part of the trail easier.

View from the top of Pratt Rock Park towards Schoharie Creek

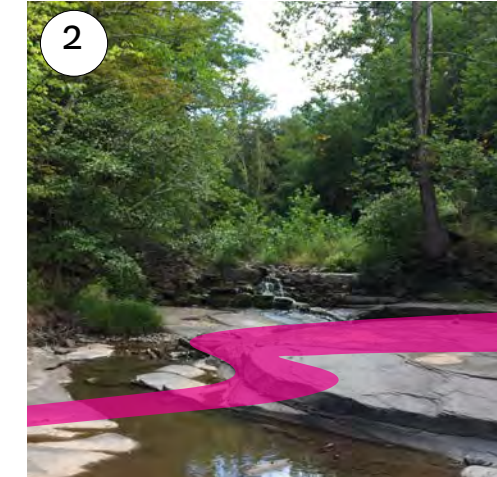
Path crosses Huntersfield Creek

The park network could be extended by lengthening DEP trails to cross Huntersfield Creek and connecting it to the water tower road. Also, incorporating additional signage would guide visitors through new areas.
