## **PRATT ROCK PARK**

Phase 1: Initial Needs Assessment  
Pratt Rock Park, Prattsville, New York

prepared for:  
Pratt Park Committee  
Prattsville, New York

April 18, 2022

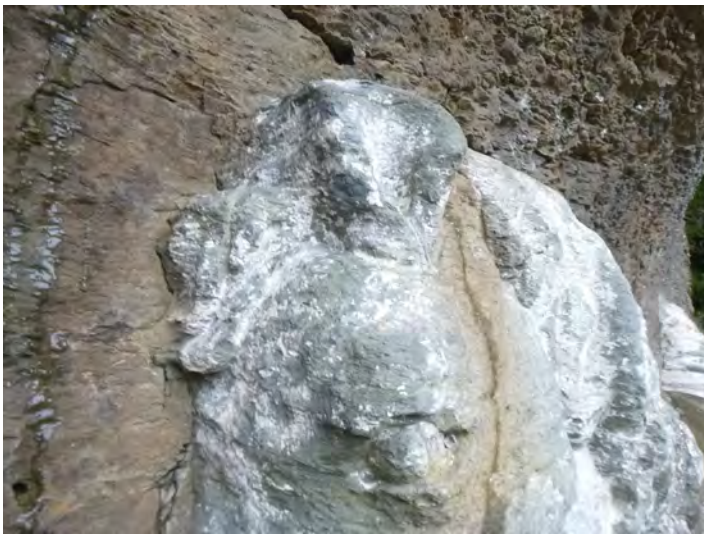
0-12 Stone\_Coating Coating Failed 2021-4

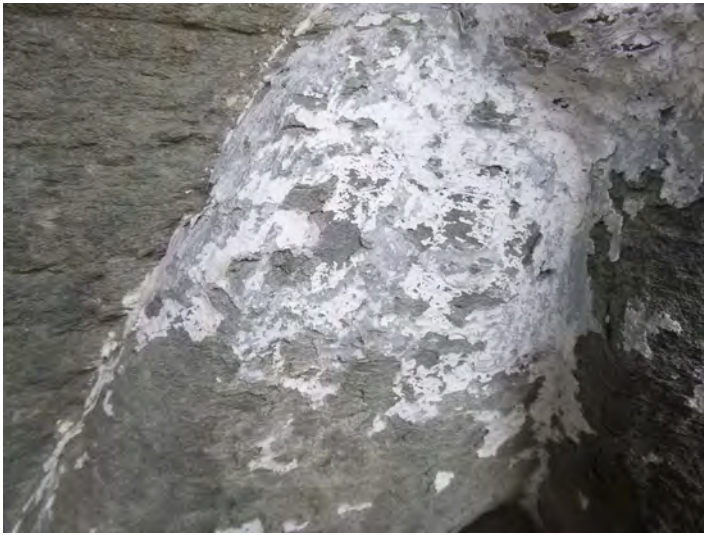
0-12 Stone\_Coating Coating Failed 2021-6

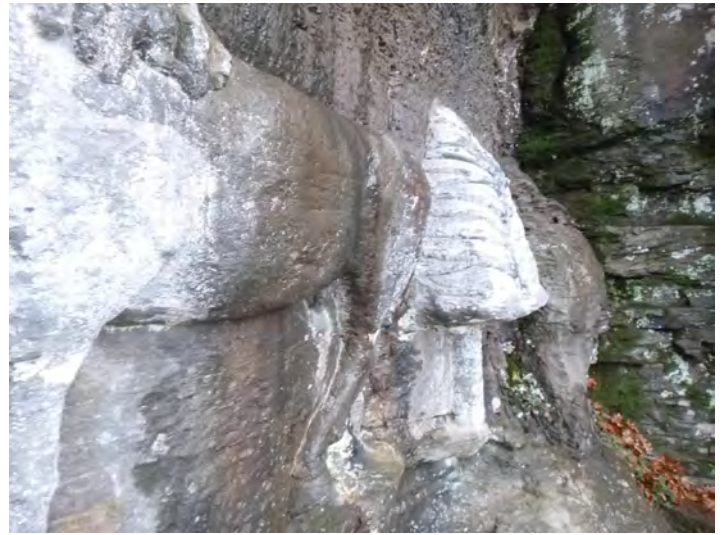
0-12 Stone\_Coating Coating Failed 2021-7

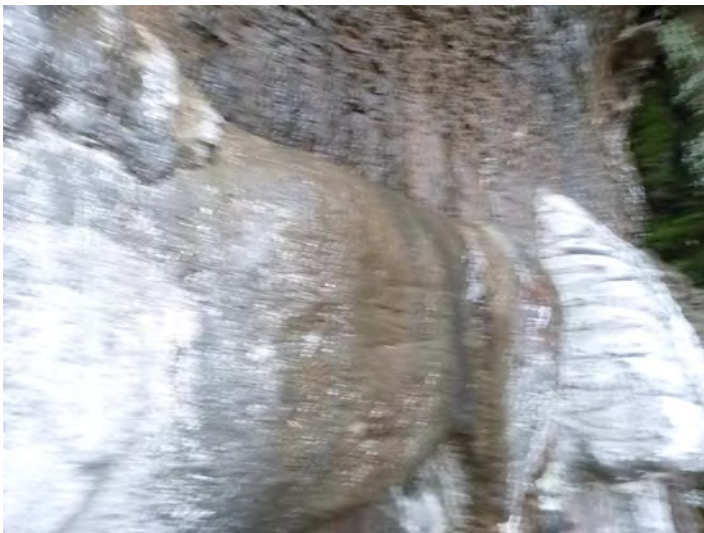
0-13 Stone\_Note Photo-water seepage 2021-1

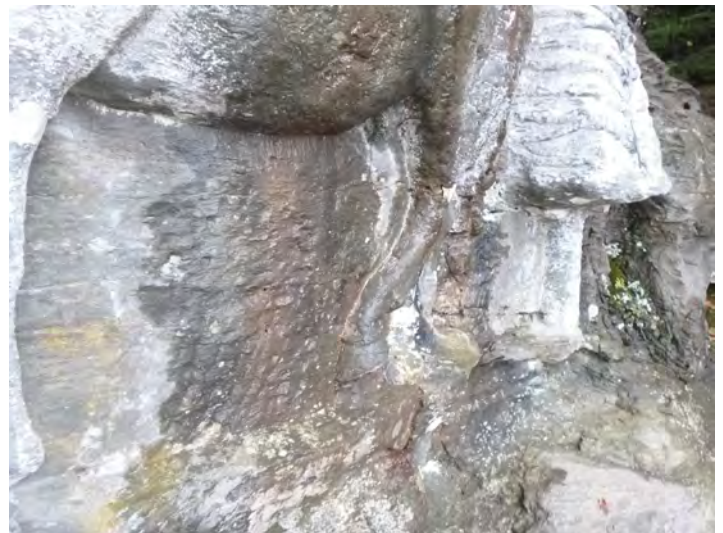
0-13 Stone\_Note Photo-water seepage 2021-2

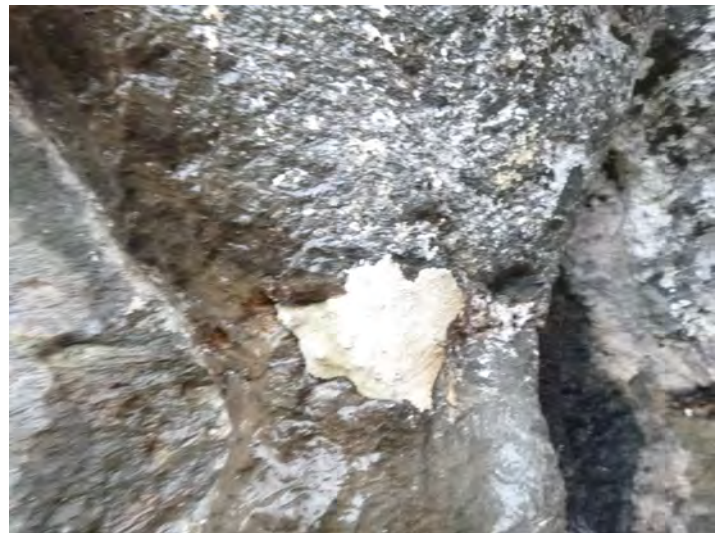
1-11 Stone\_SoilStain Biological 2021-4

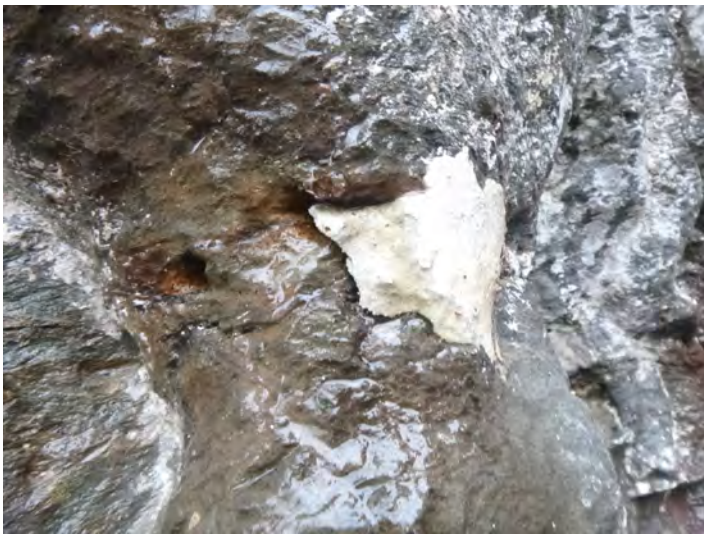
1-12 Stone\_Repair Patch Failed 2021-1

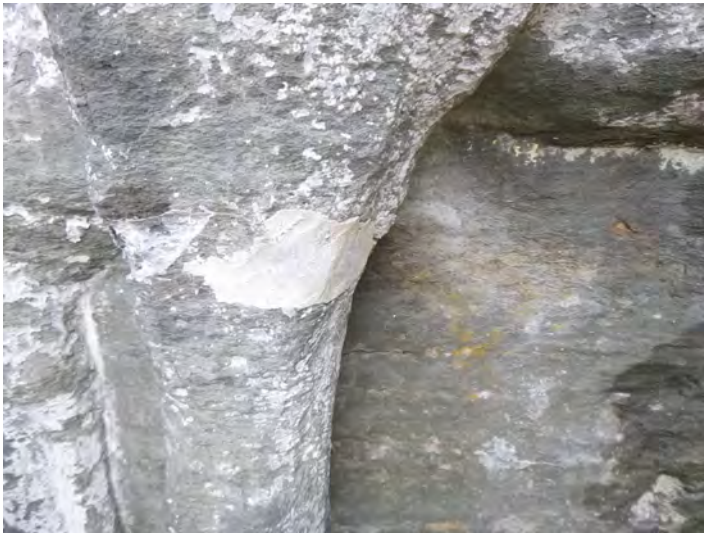
1-12 Stone\_Repair Patch Sound 2021-1

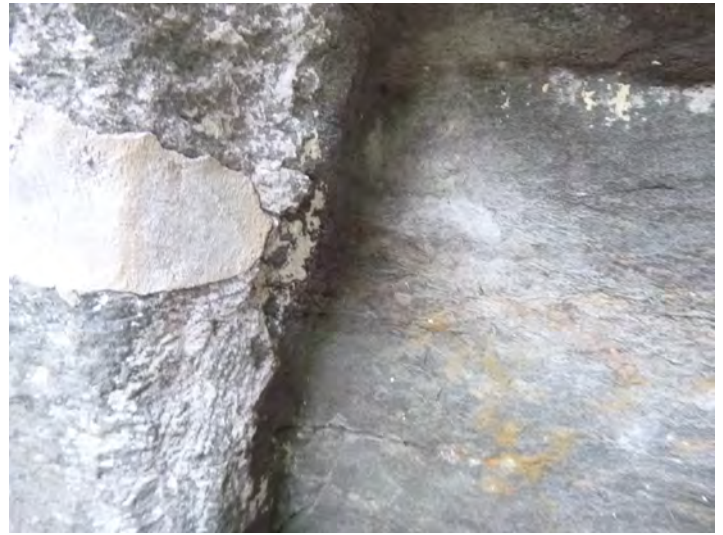
1-12 Stone\_Repair Patch Sound 2021-2

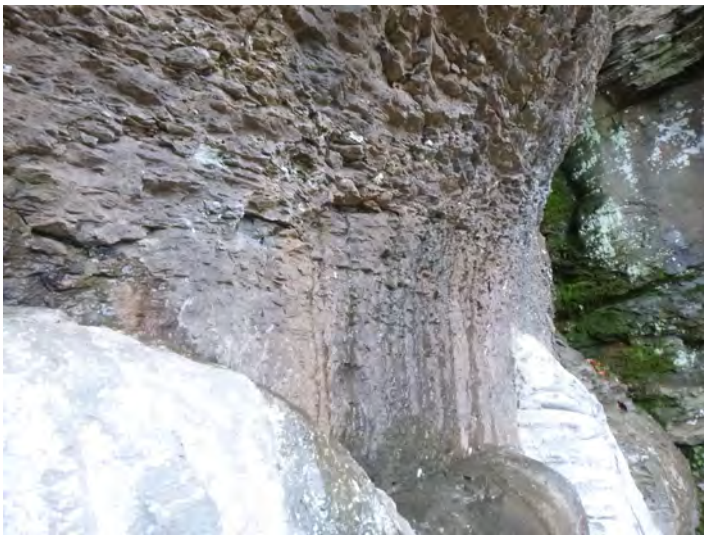
1-12 Stone\_Repair Patch Sound 2021-3

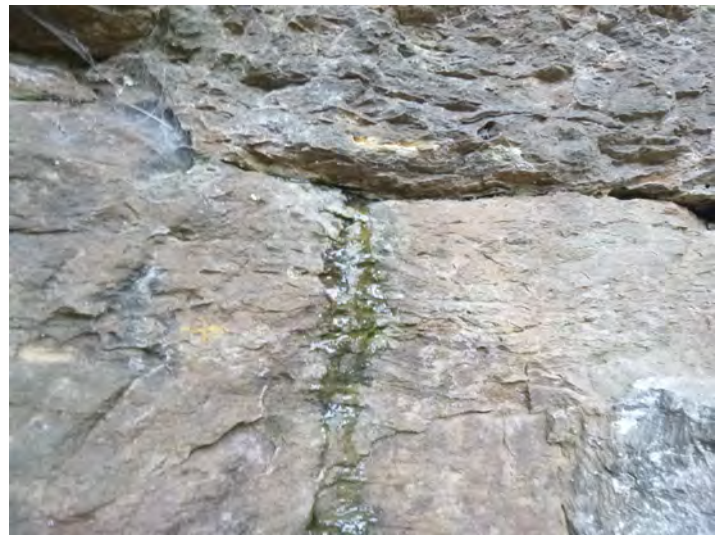
1-15 Stone\_Note Photo-water seepage 2021-1

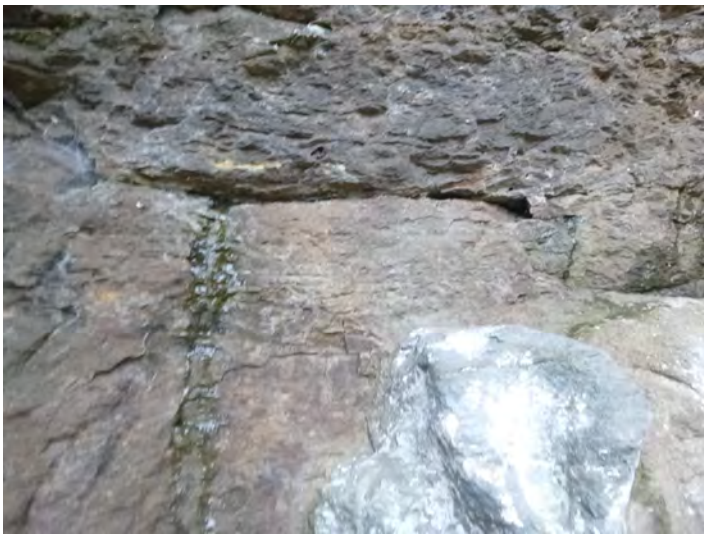
1-15 Stone\_Note Photo-water seepage 2021-2

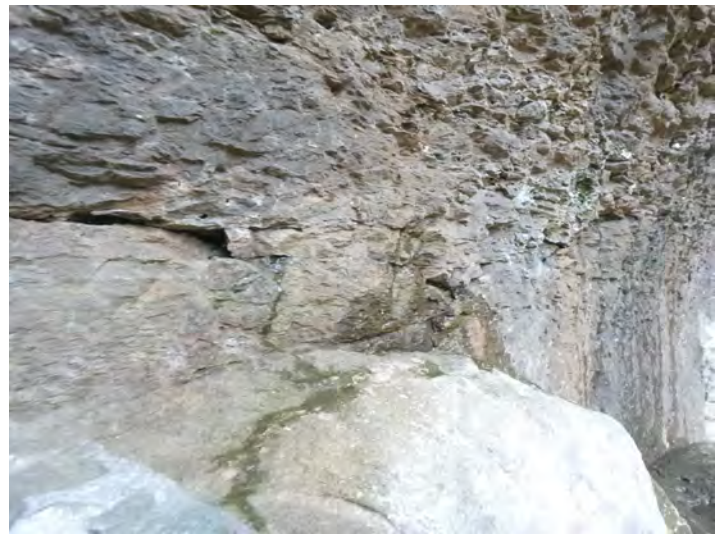
1-15 Stone\_Note Photo-water seepage 2021-3

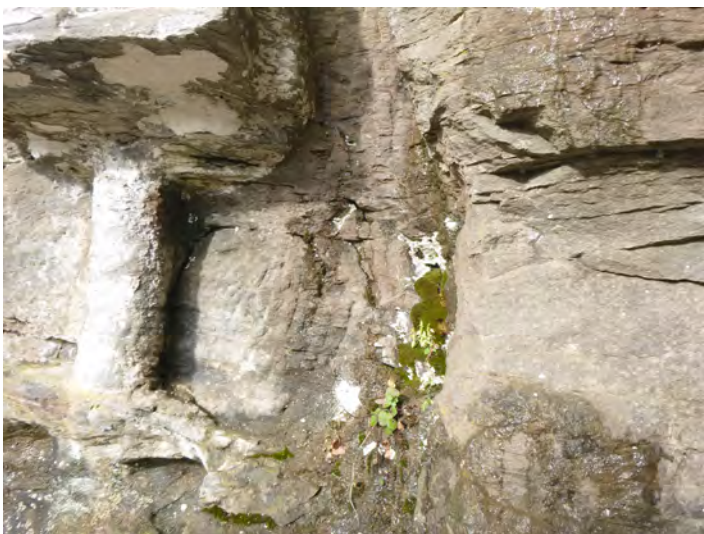
2-12 Stone\_Crack System units 2021-1

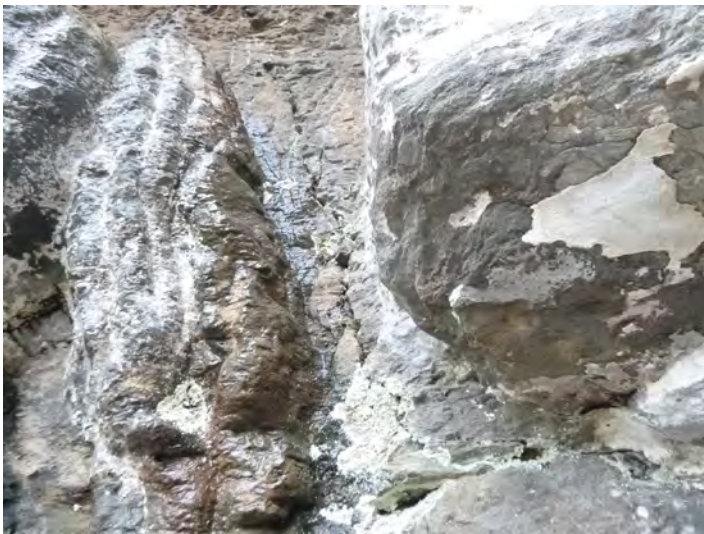
3-13 Stone\_Crack System units 2021-1

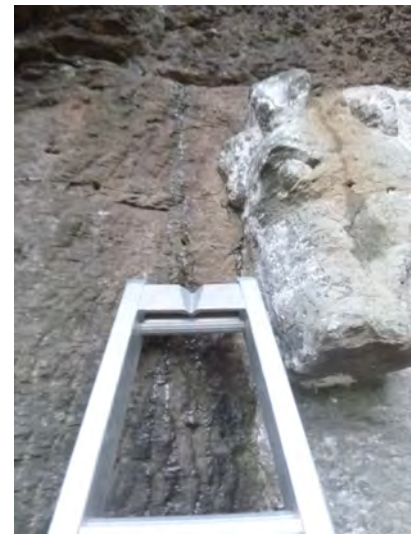
3-13 Stone\_Crack System units 2021-2

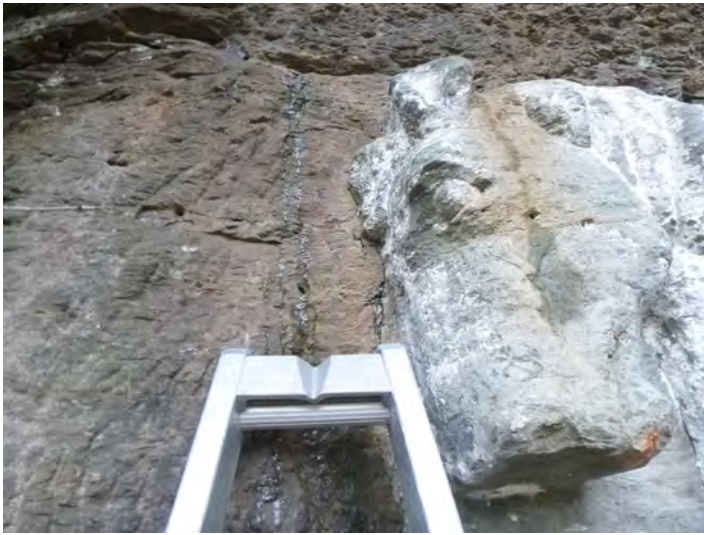
3-13 Stone\_Note Photo-water seepage 2021-1

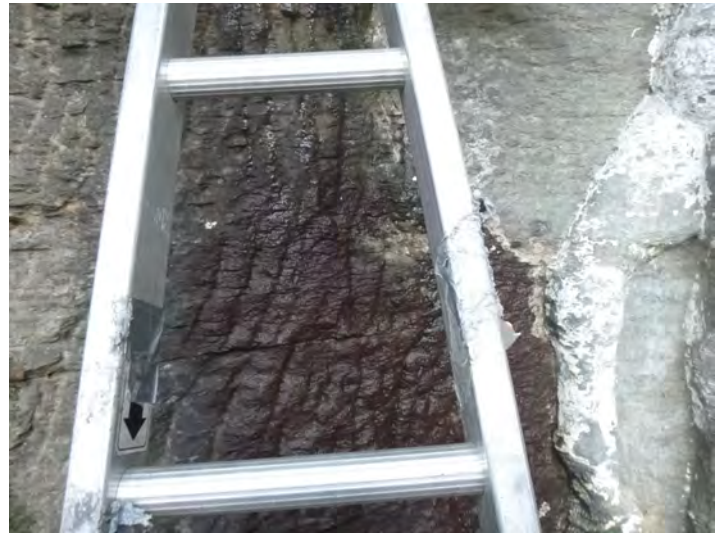
3-13 Stone\_Note Photo-water seepage 2021-2

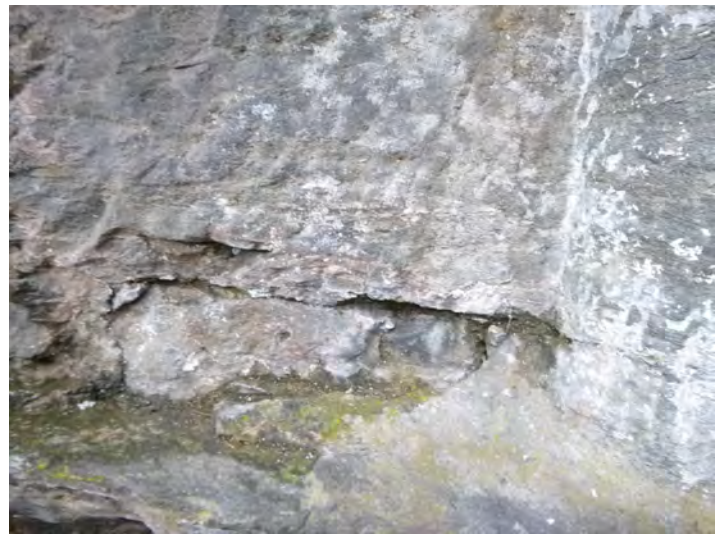
4-10 Stone\_SoilStain Biological 2021-1

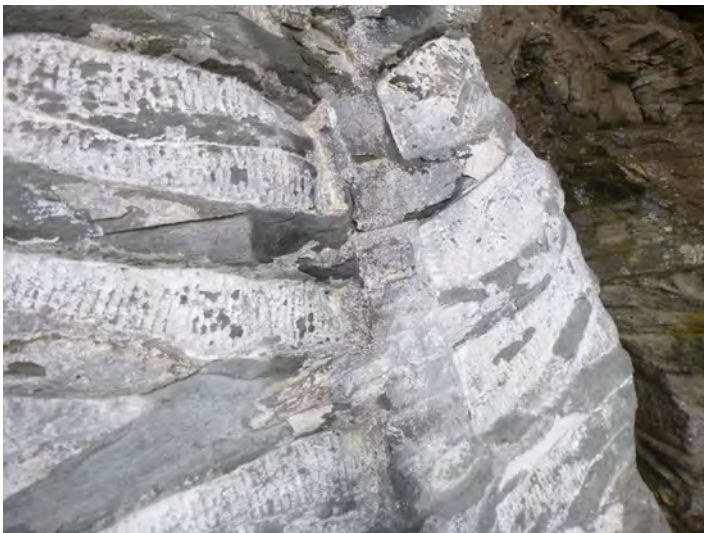
4-13 Stone\_Coating Coating Failed 2021-1

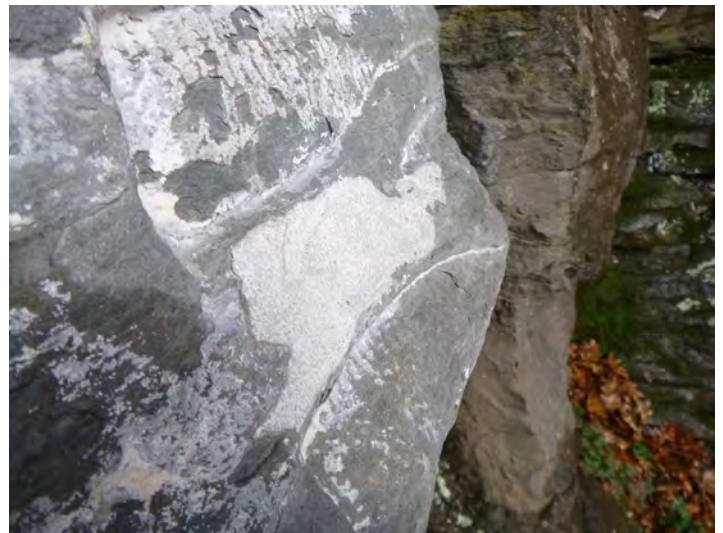
4-13 Stone\_Coating Coating Failed 2021-2

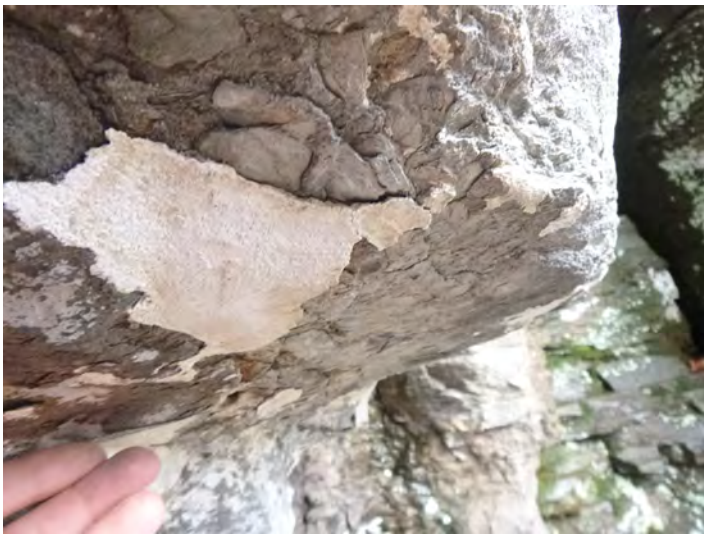
4-13 Stone\_Coating Coating Failed 2021-3

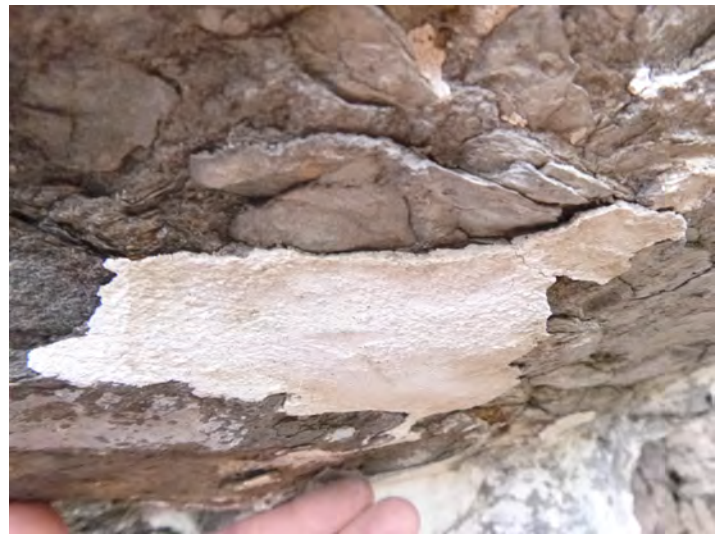
4-13 Stone\_Coating Coating Failed 2021-4

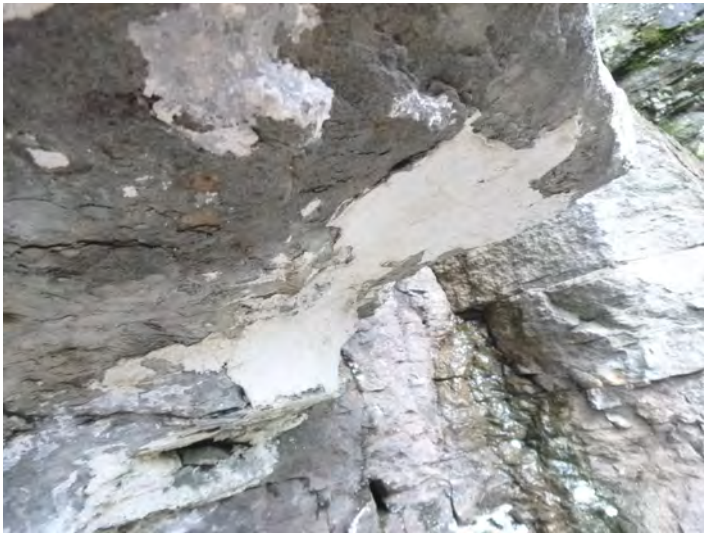
4-13 Stone\_Coating Coating Failed 2021-5

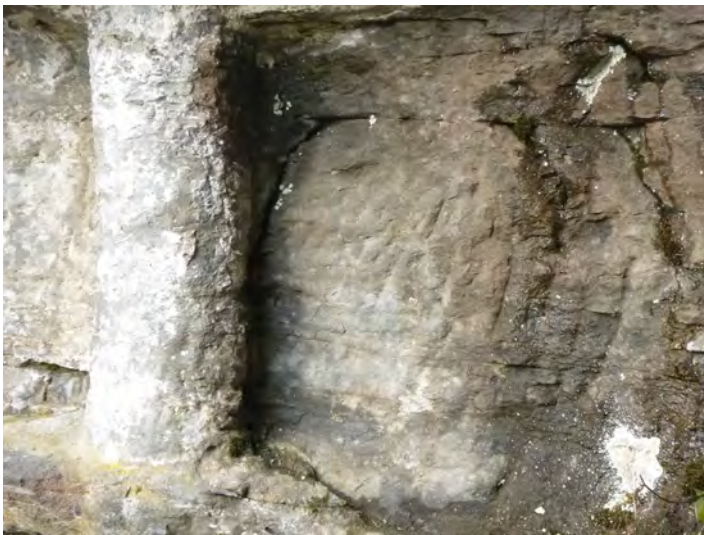
5-11 Stone\_Crack System units 2021-1

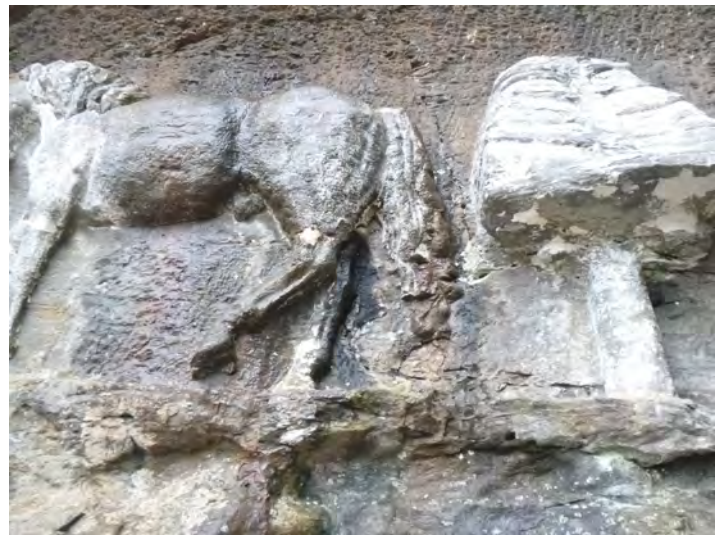
5-11 Stone\_Crack System units 2021-2

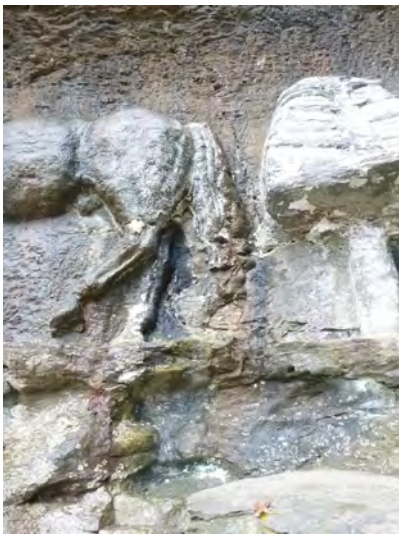
5-11 Stone\_Note Photo-water seepage 2021-1

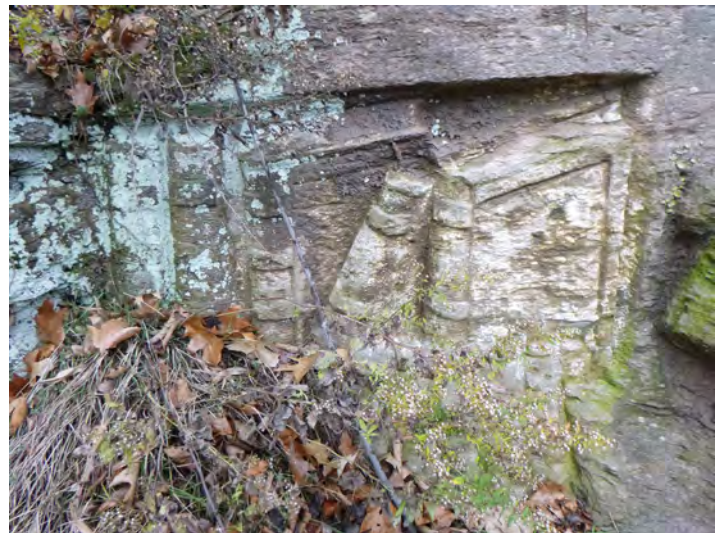
6-19 Stone\_SoilStain Biological 2021-2

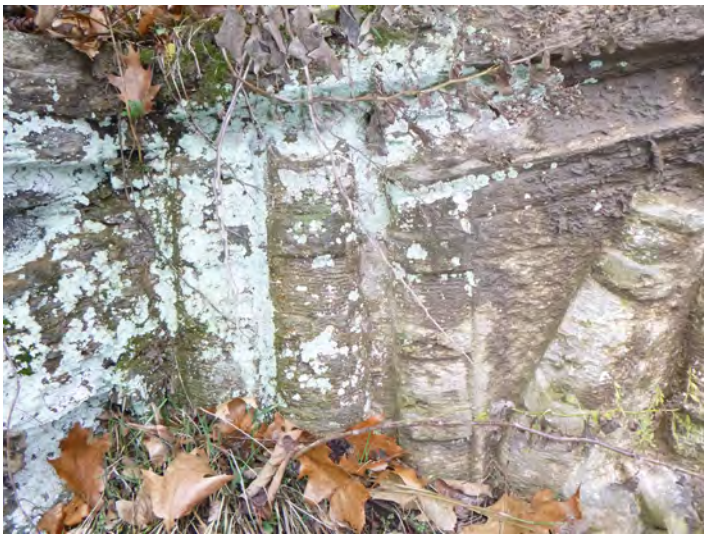
9-20 Stone\_Coating Coating Failed 2021-1

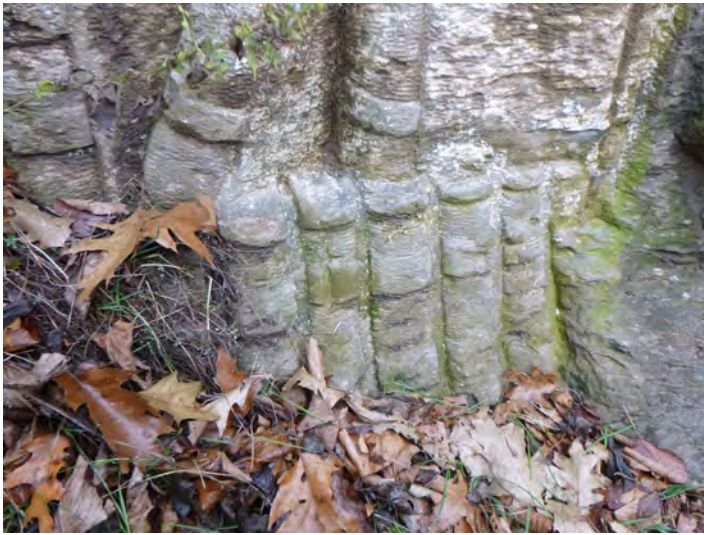
9-20 Stone\_Coating Coating Failed 2021-3

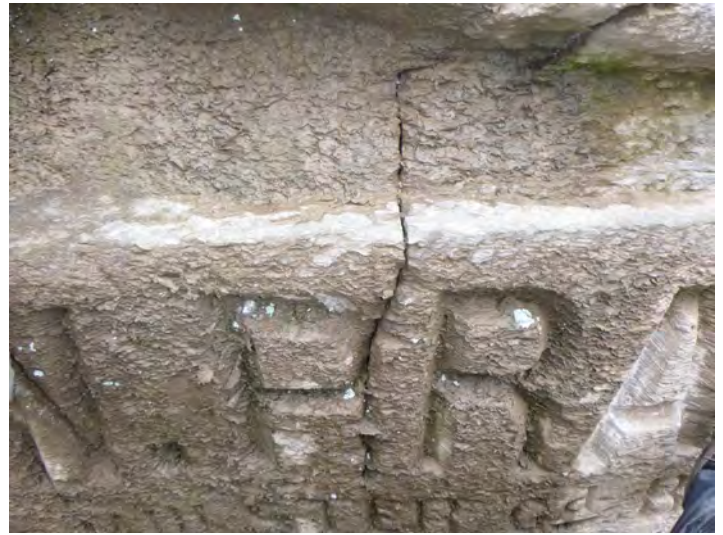
9-20 Stone\_Coating Coating Failed 2021-4

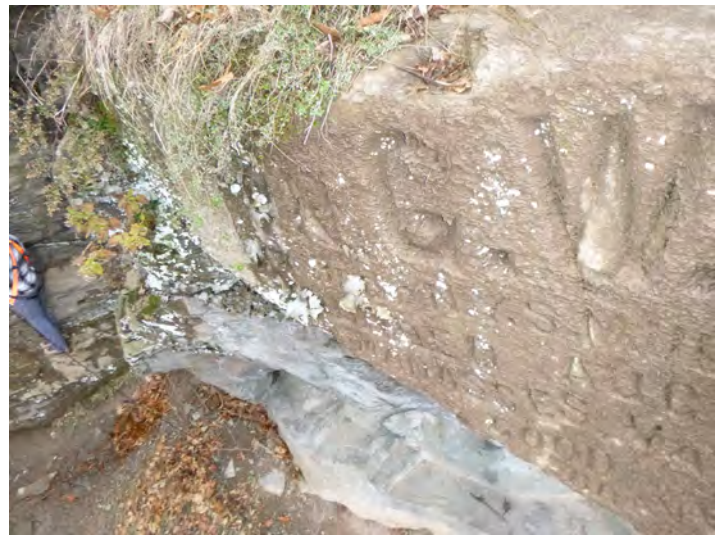
10-18 Stone\_Crack Single unit 2021-2

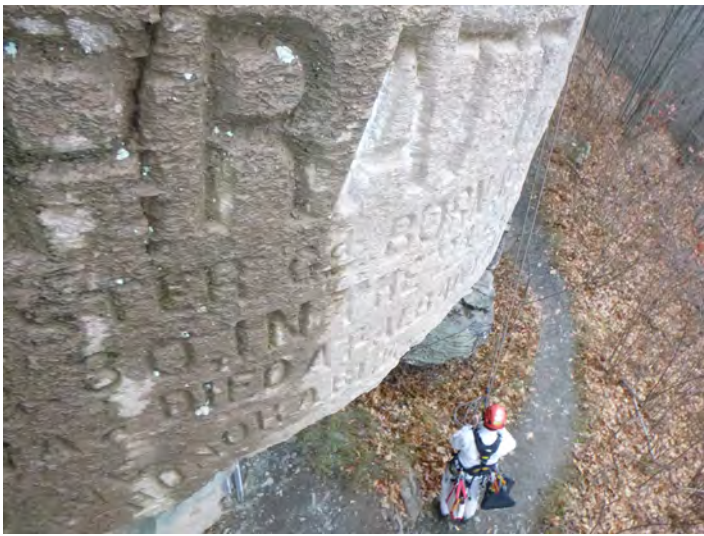
12-18 Stone\_Coating Coating Failed 2021-1

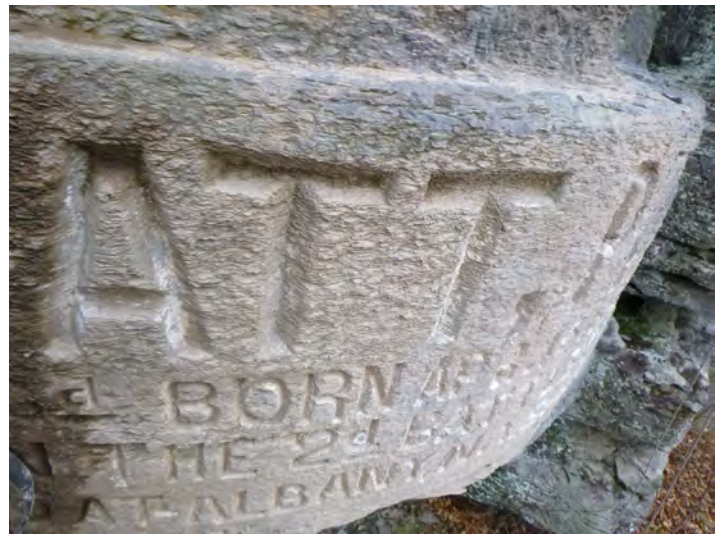
12-18 Stone\_Coating Coating Failed 2021-2

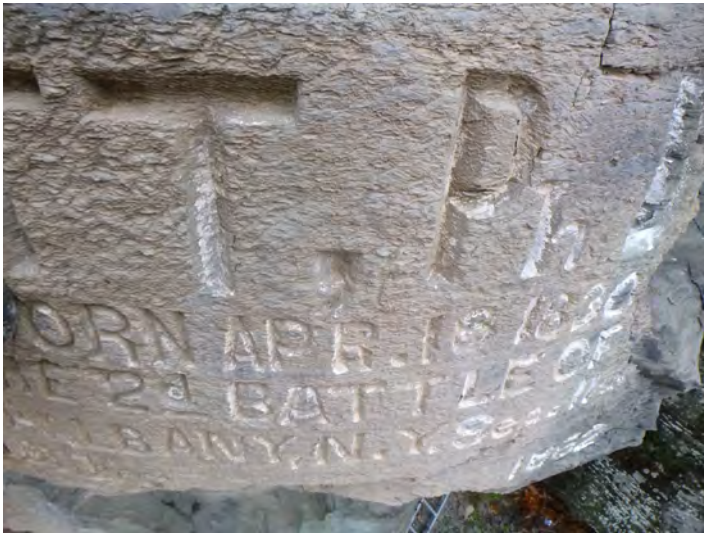
12-18 Stone\_Coating Coating Failed 2021-3

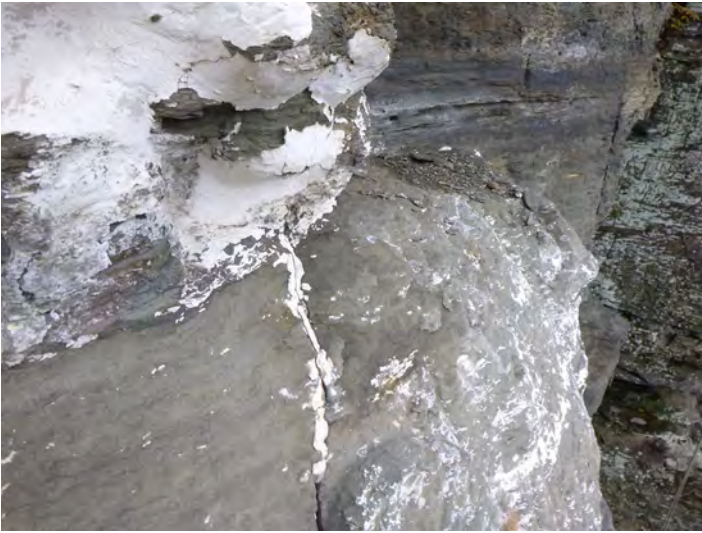
13-20 Stone\_Crack Repair failed 2021-1

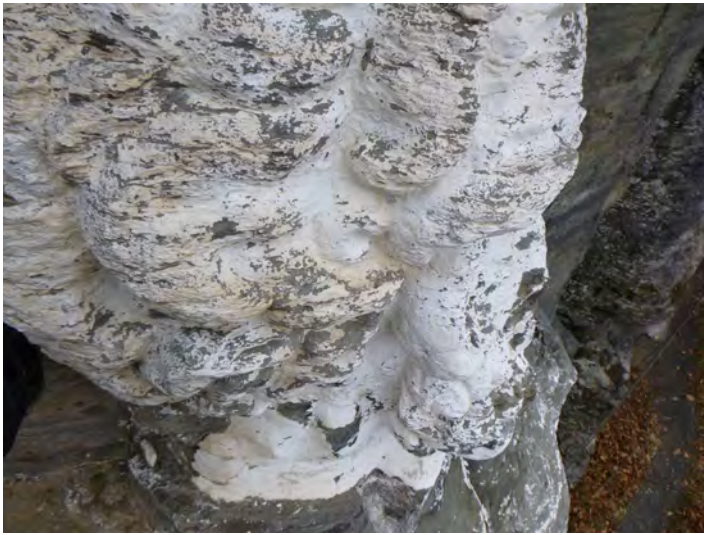
13-23 Stone\_Coating Coating Failed 2021-1

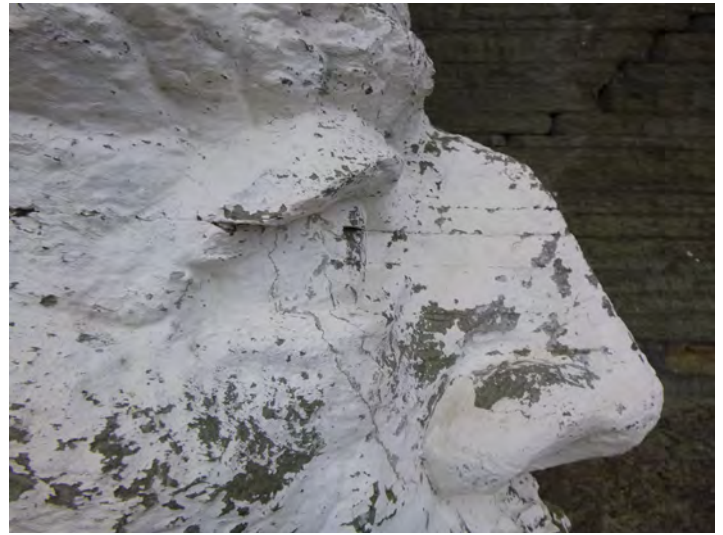
13-23 Stone\_Coating Coating Failed 2021-2

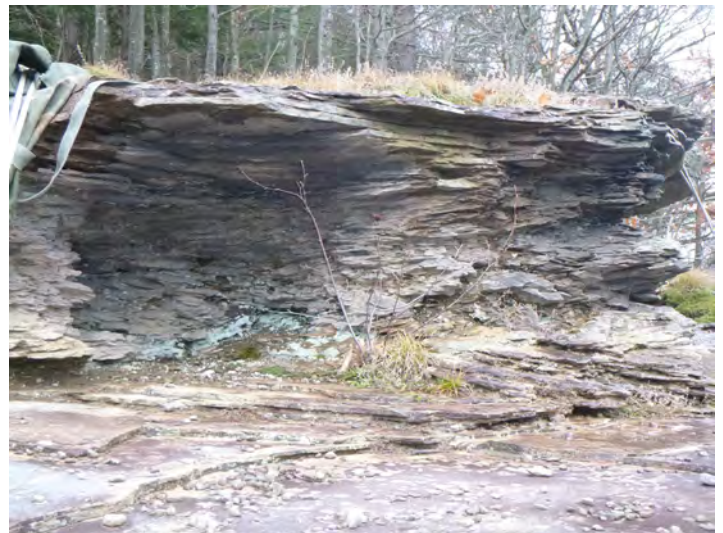
13-39 Stone\_Note Photo- undermined 2021-1

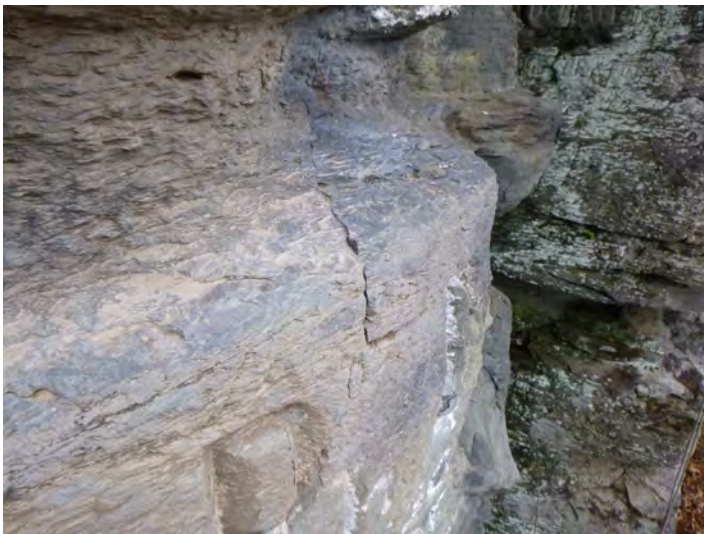
13-39 Stone\_Note Photo- undermined 2021-2

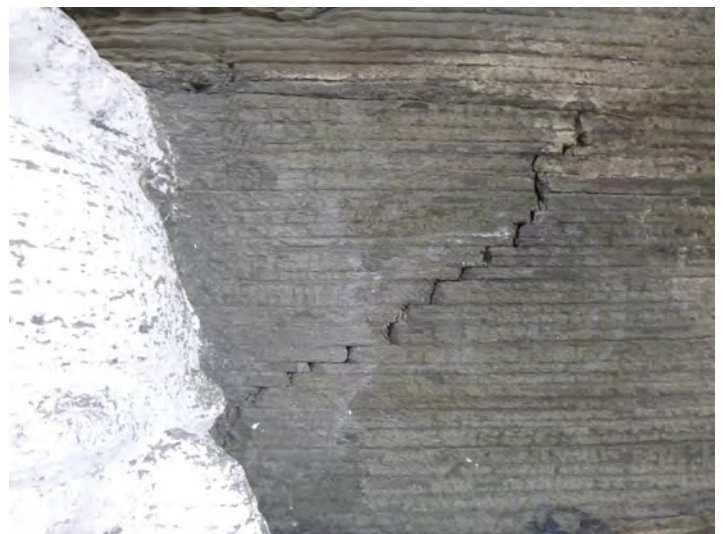
16-18 Stone\_Spall Missing 2021-2

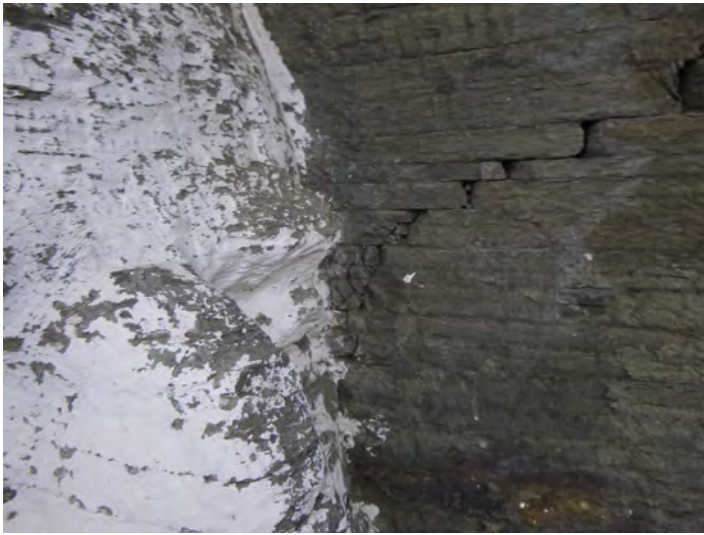
16-23 Stone\_Crack Single unit 2021-1

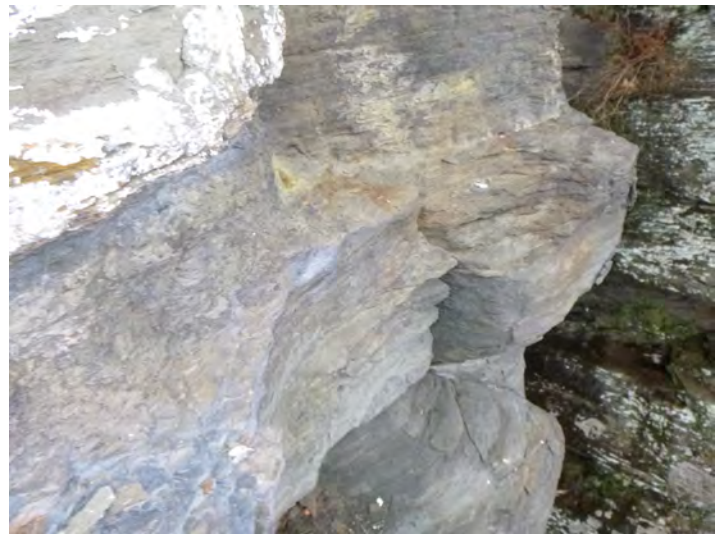
16-24 Stone\_Unsecured Removed 2021-4

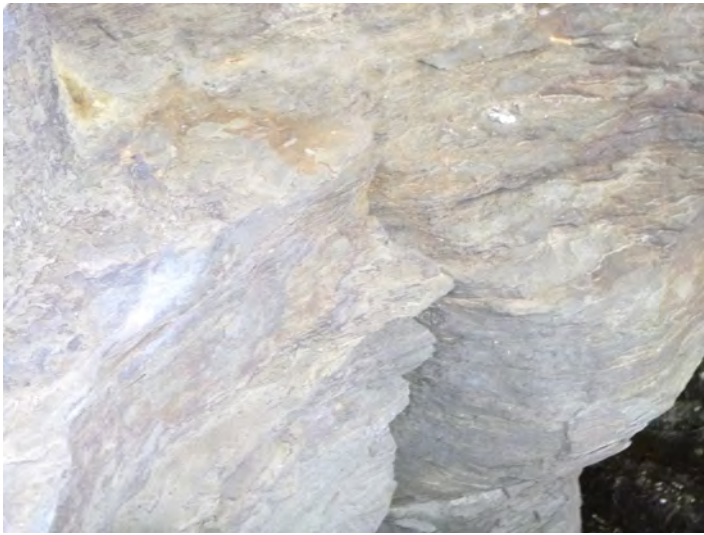
17-17 Stone\_Crack Single unit 2021-1

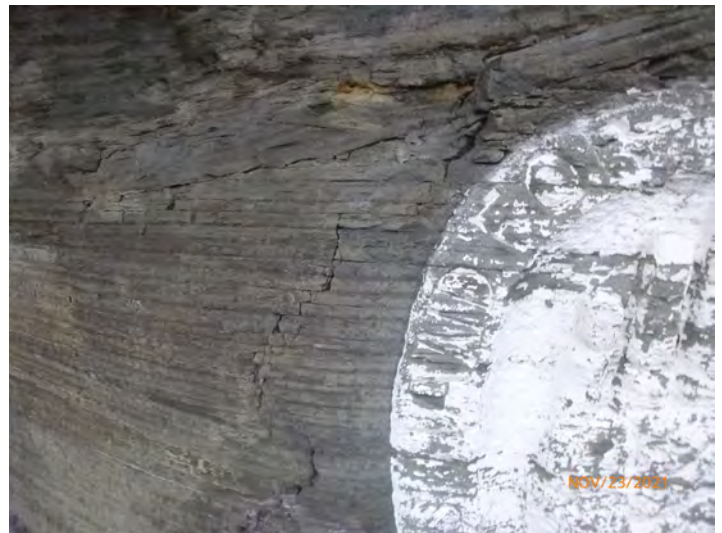
19-15 Stone\_Unsecured LooseBeddingPlane 2021-1

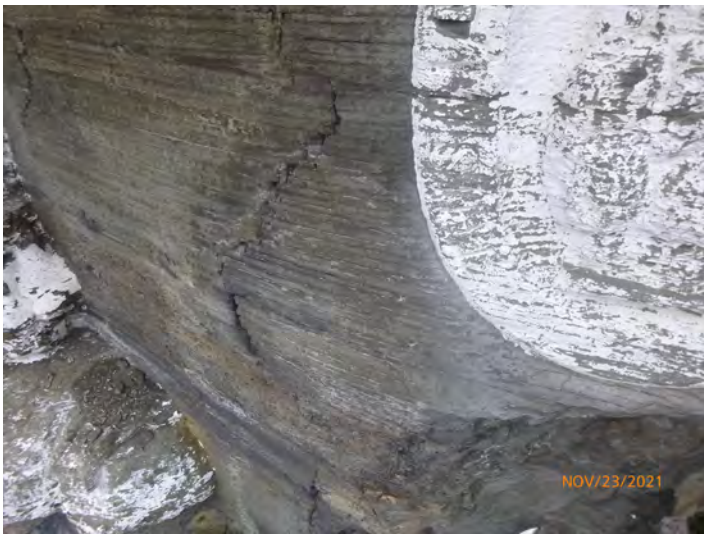
19-22 Stone\_Crack Single unit 2021-1

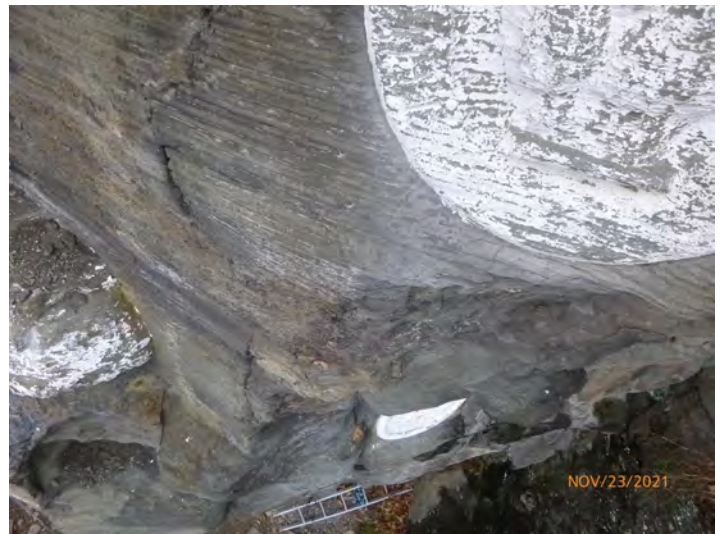
19-22 Stone\_Crack Single unit 2021-2

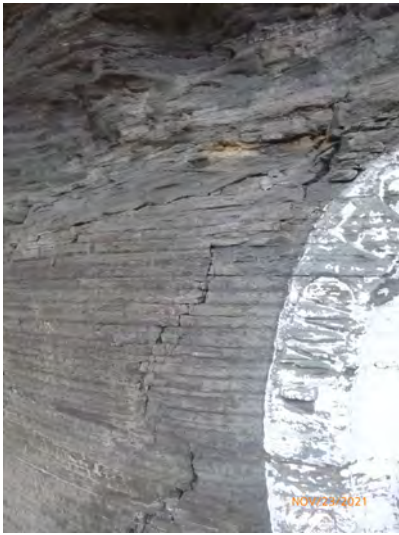
19-22 Stone\_Crack Single unit 2021-3

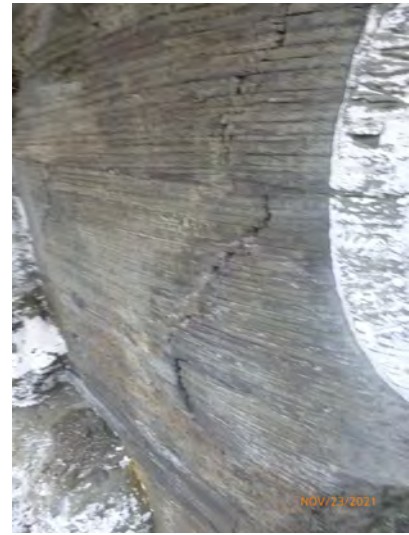
19-22 Stone\_Crack Single unit 2021-4

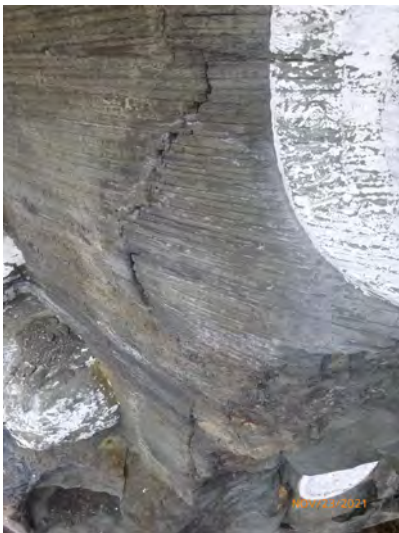
19-22 Stone\_Crack Single unit 2021-5

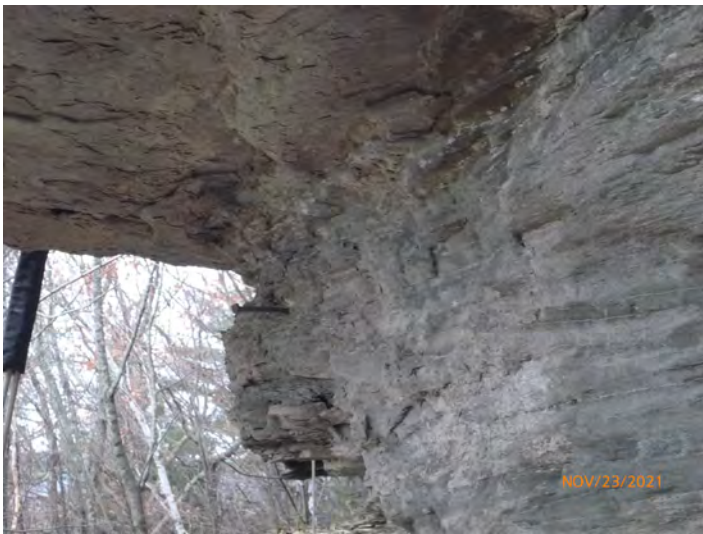
19-22 Stone\_SoilStain Biological 2021-1

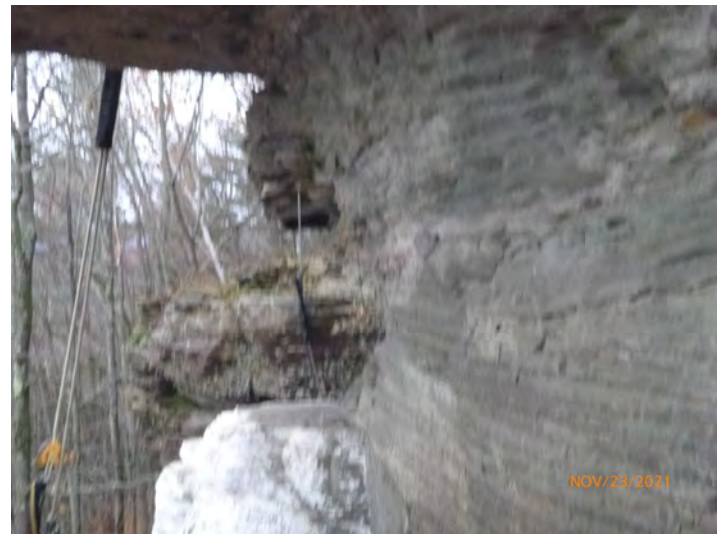
19-27 Stone\_Embedment Ferrous Embedment 2021-1

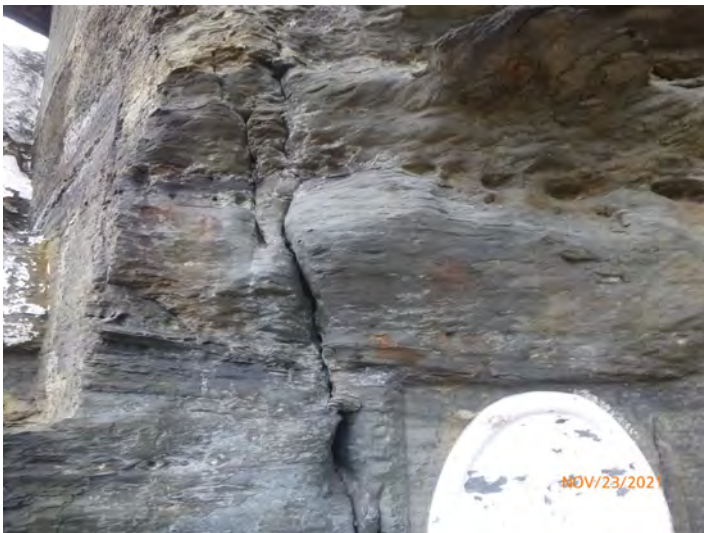
21-17 Stone\_SurfLoss Exfoliated 2021-2

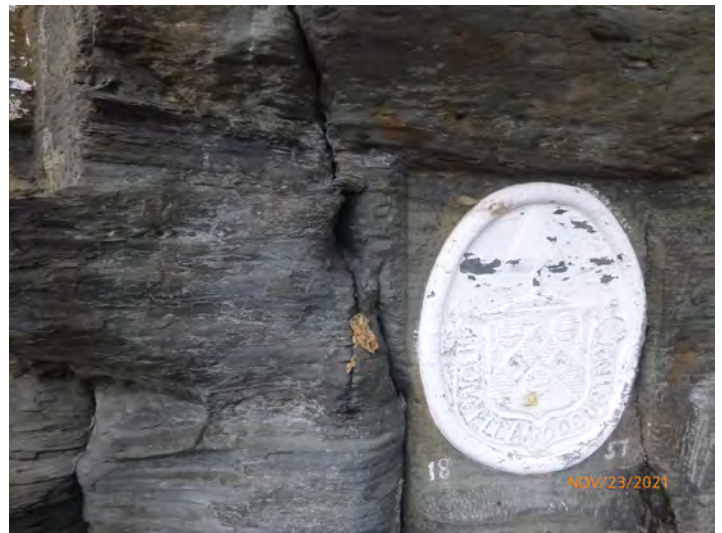
21-18 Stone\_Crack Single unit 2021-1

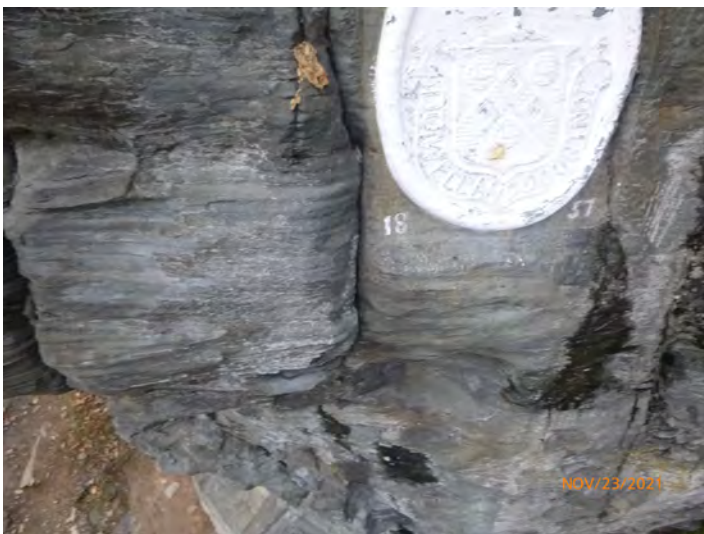
21-18 Stone\_Crack Single unit 2021-2

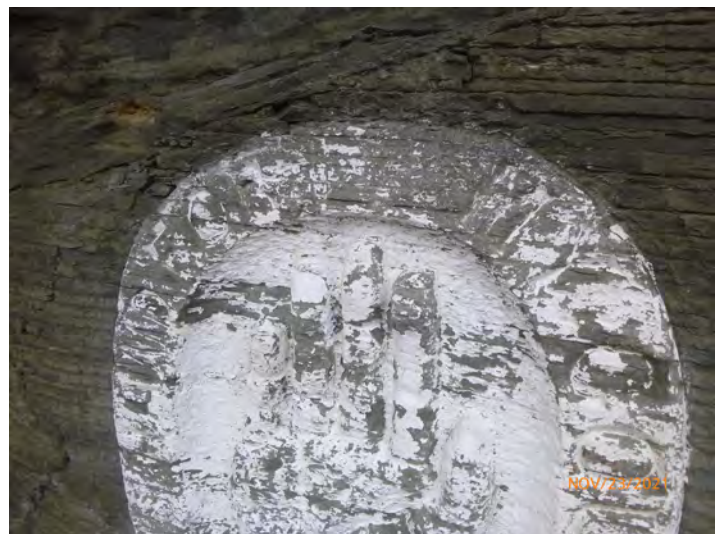
21-18 Stone\_Crack Single unit 2021-3

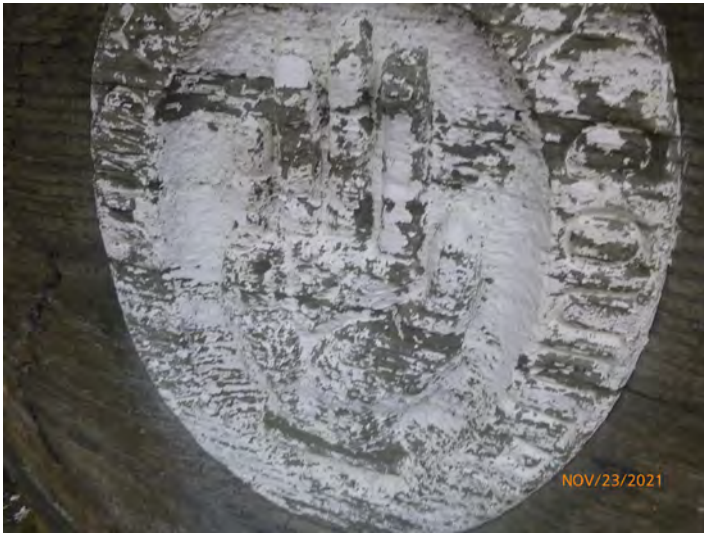
21-22 Stone\_Coating Coating Failed 2021-1

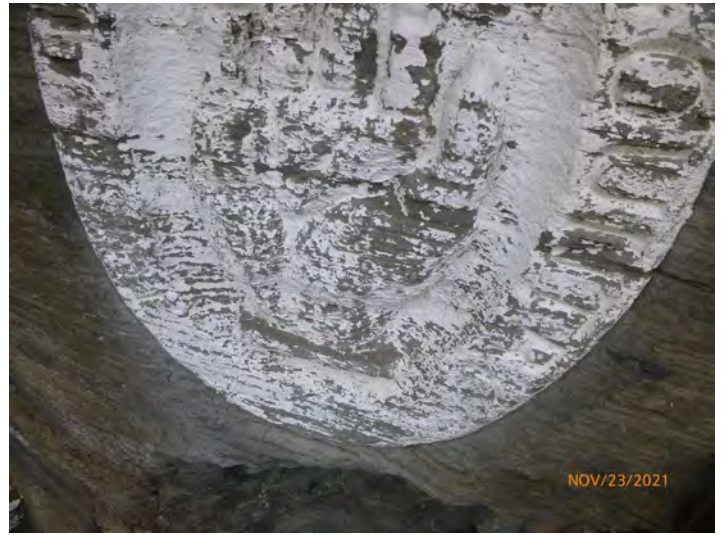
21-22 Stone\_Coating Coating Failed 2021-2

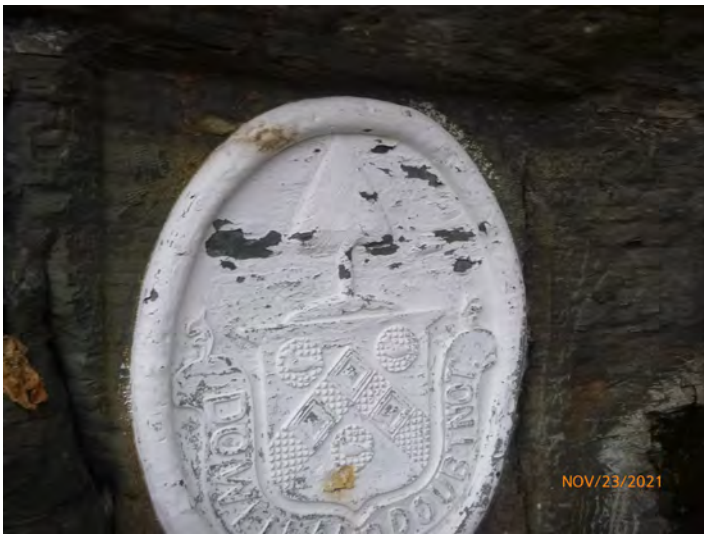
21-26 Stone\_SoilStain Biological 2021-2

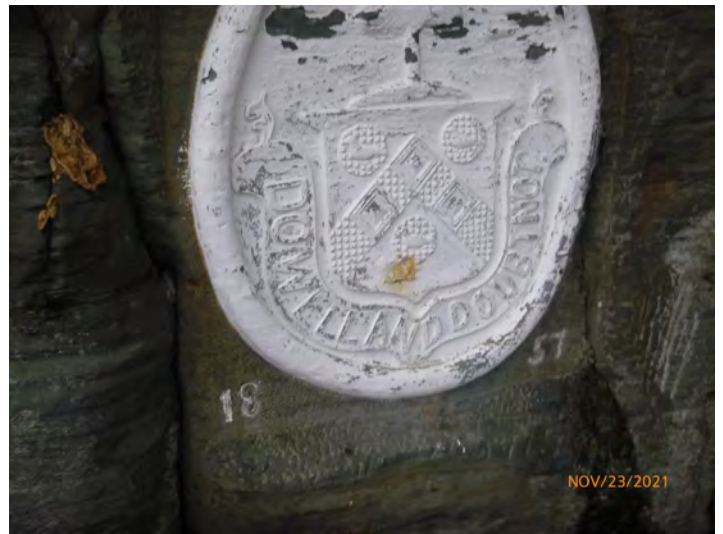
22-16 Stone\_Coating Coating Failed 2021-1

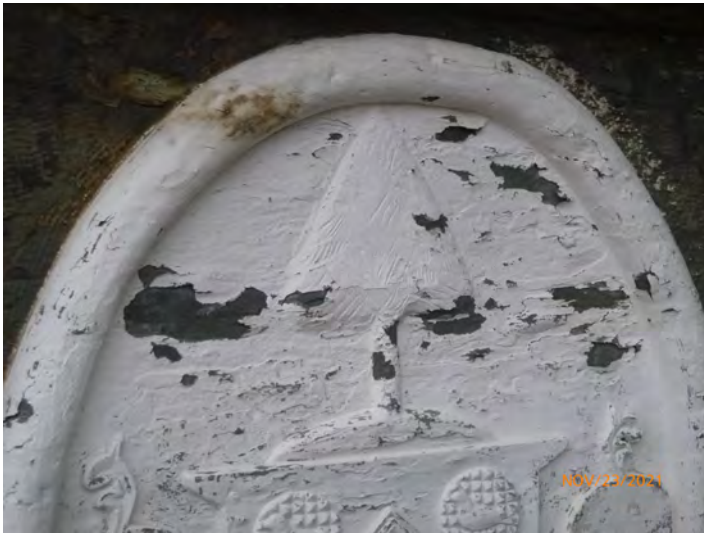
22-16 Stone\_Coating Coating Failed 2021-2
