## **PRATT ROCK PARK**

Phase 1: Initial Needs Assessment  
Pratt Rock Park, Prattsville, New York

prepared for:  
Pratt Park Committee  
Prattsville, New York

April 18, 2022

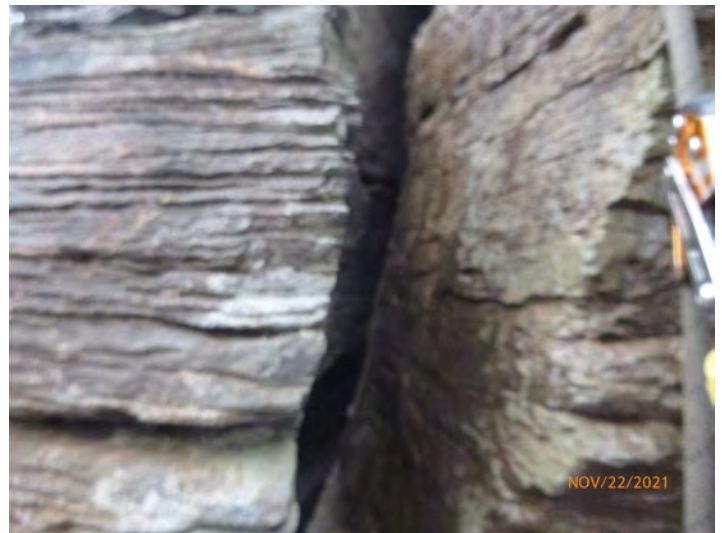
22-34 Stone\_Note Photo-fissure above carving 2021-1

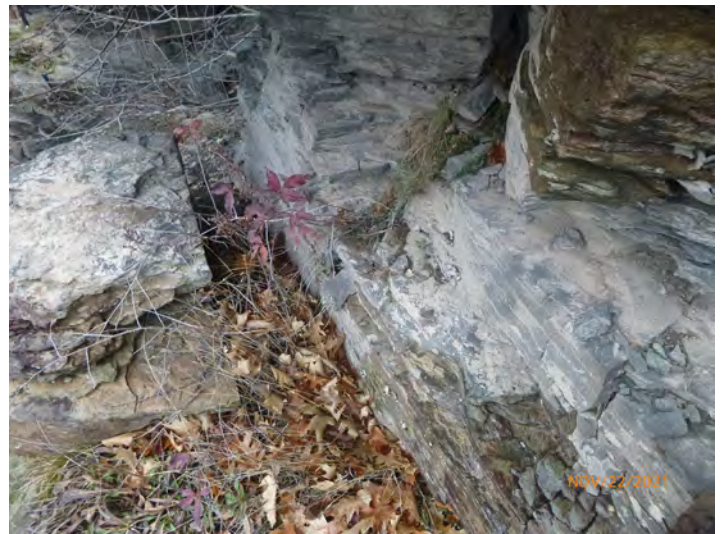
22-34 Stone\_Note Photo-fissure above carving 2021-3

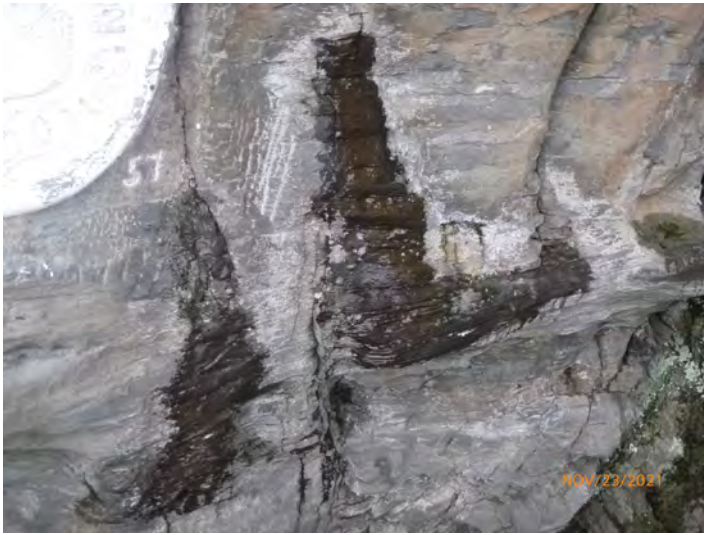
24-14 Stone\_Note Photo-water seepage 2021-1

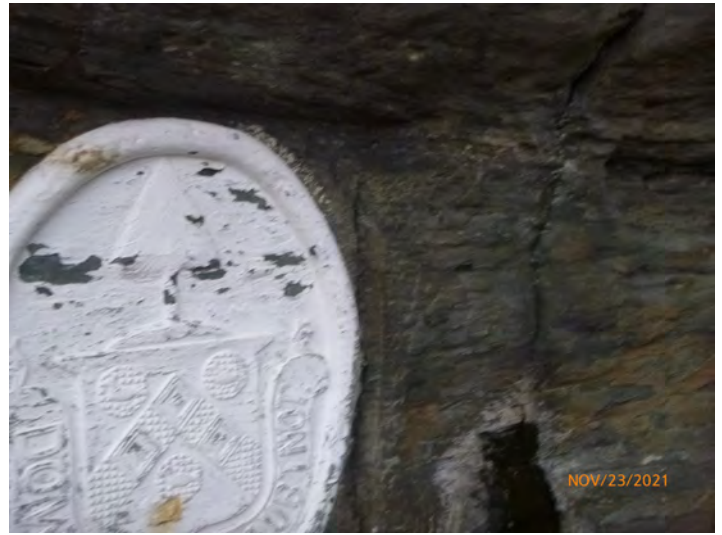
24-17 Stone\_Crack Single unit 2021-1

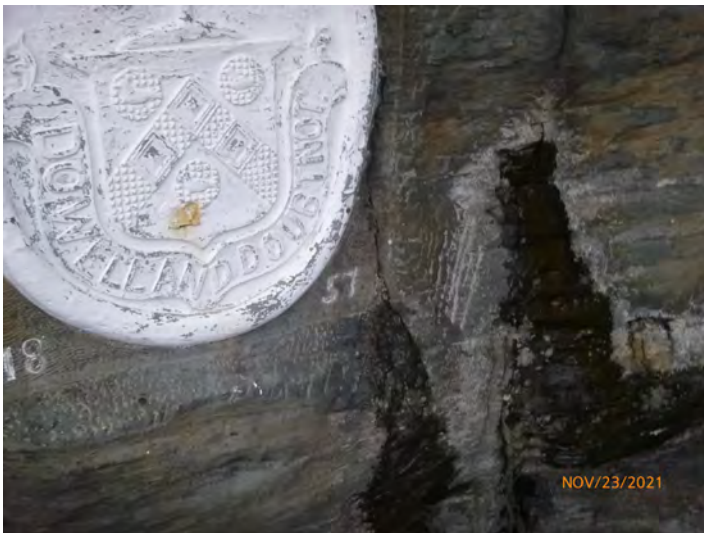
24-17 Stone\_Crack Single unit 2021-2

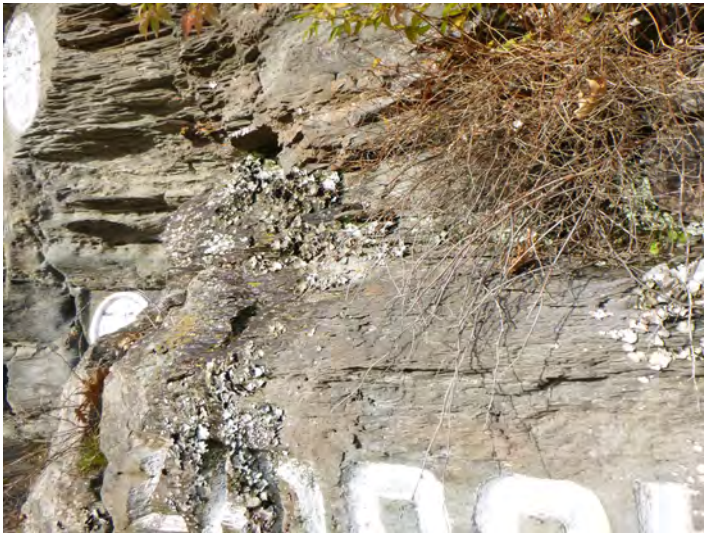
31-18 Stone\_Note Photo- Water Seepage 2021-1

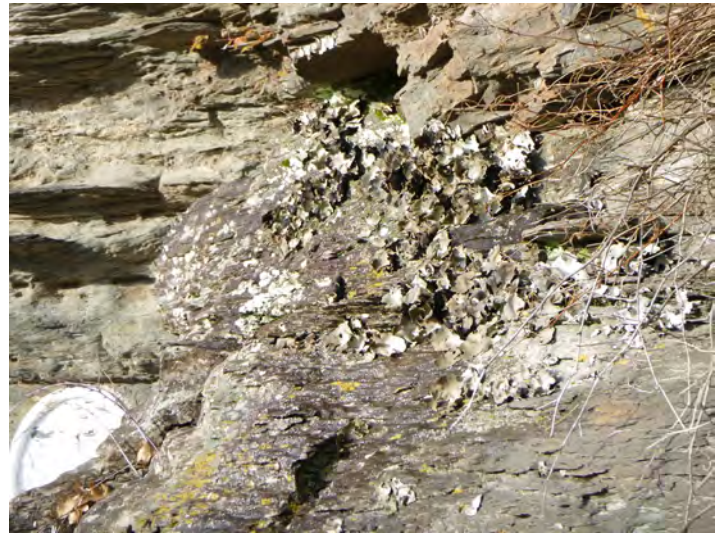
31-18 Stone\_Note Photo- Water Seepage 2021-2

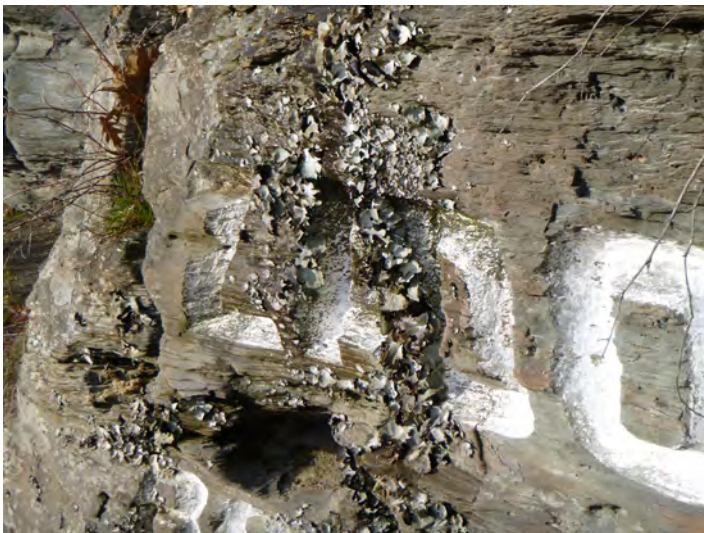
31-18 Stone\_Note Photo- Water Seepage 2021-3

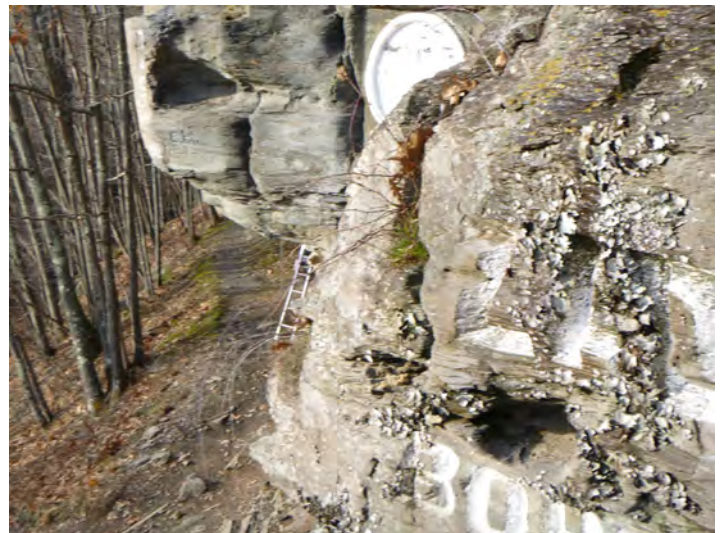
32-17 Stone\_Crack Single unit 2021-1

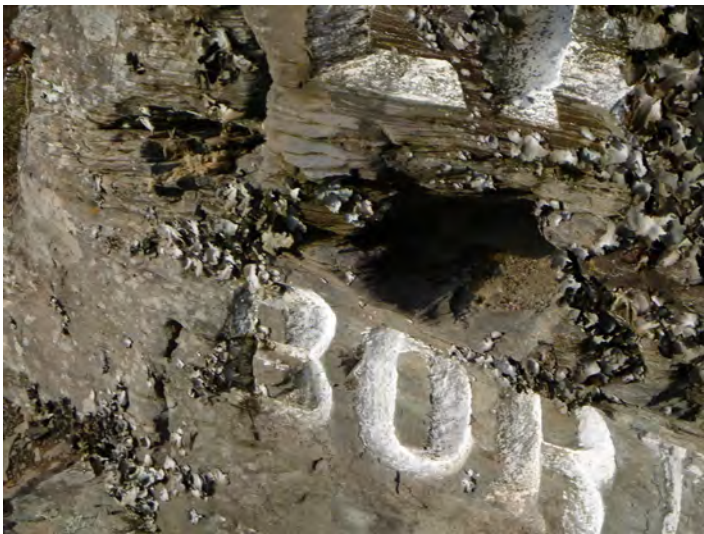
32-17 Stone\_Crack Single unit 2021-2

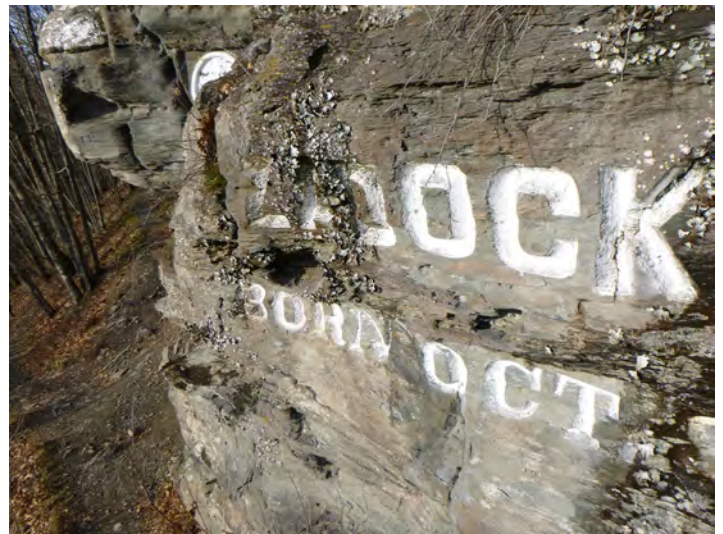
36-14 Stone\_Coating Coating Failed 2021-1

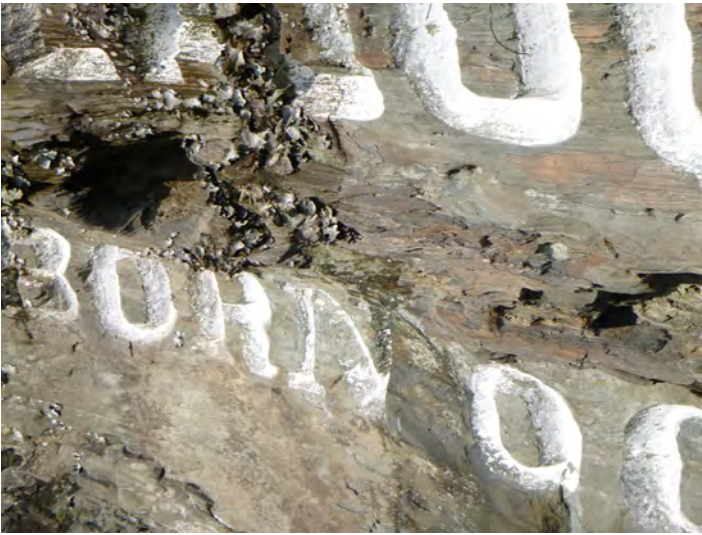
36-14 Stone\_Coating Coating Failed 2021-2

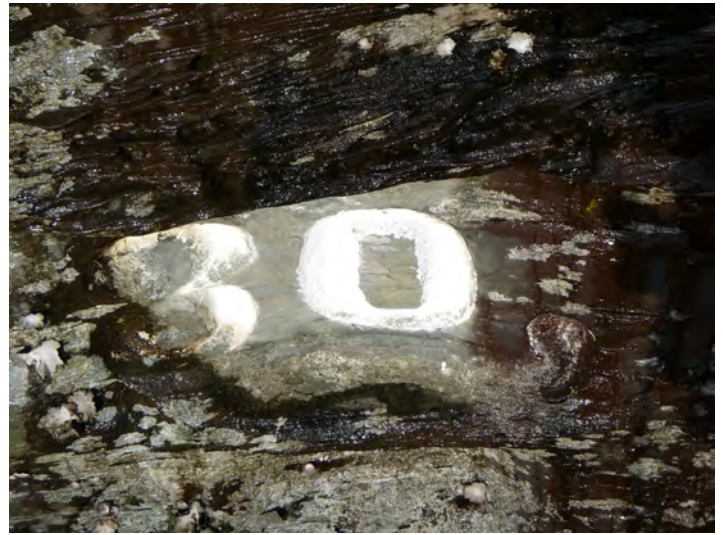
36-14 Stone\_Coating Coating Failed 2021-3

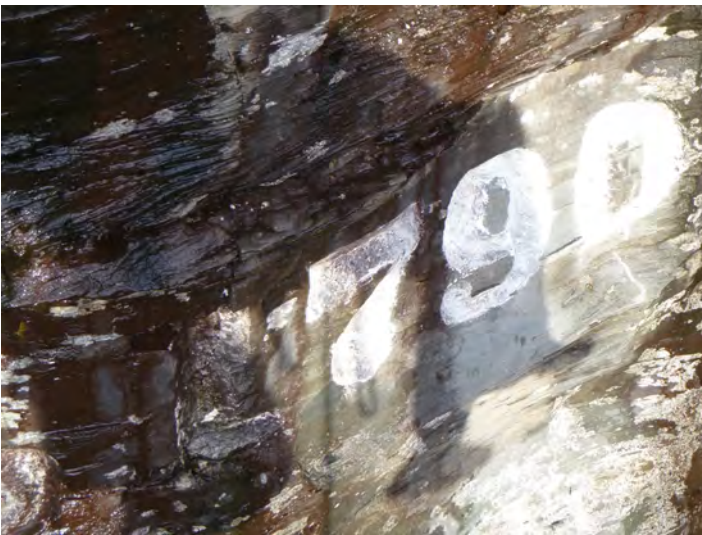
36-14 Stone\_Coating Coating Failed 2021-4

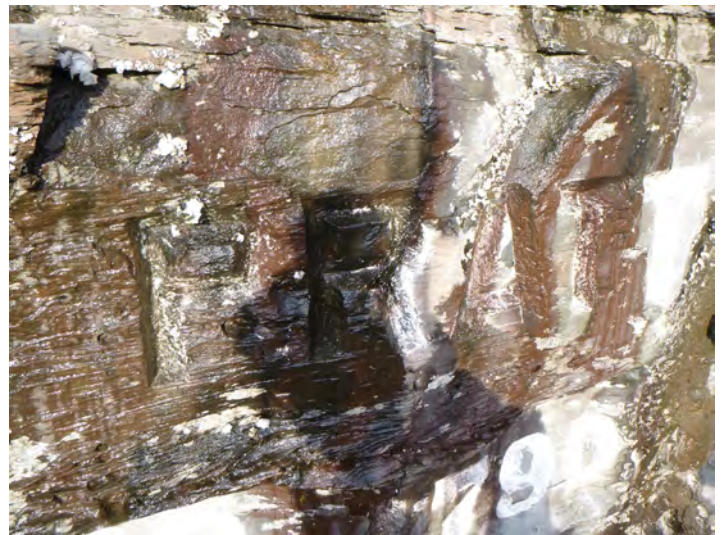
36-14 Stone\_Coating Coating Failed 2021-5

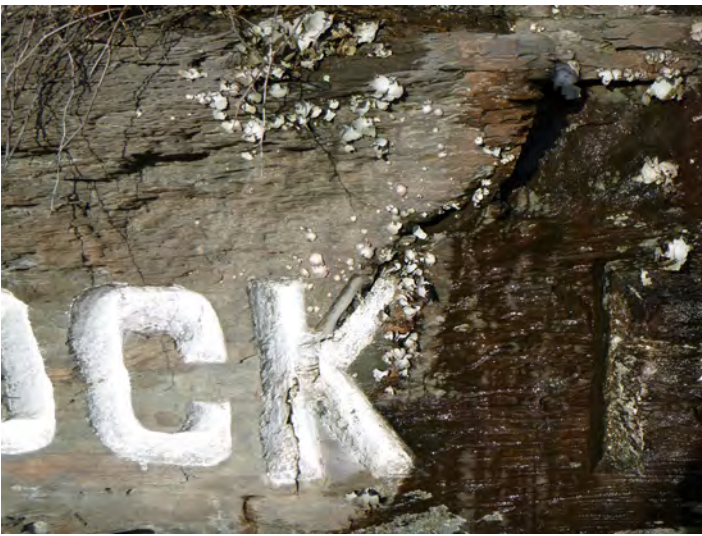
37-17 Stone\_Crack Single unit 2021-1

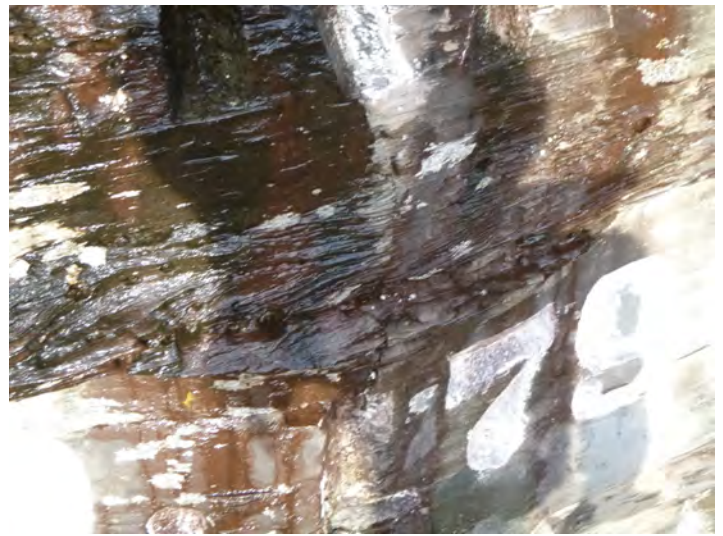
39-13 Stone\_Crack Single unit 2021-1

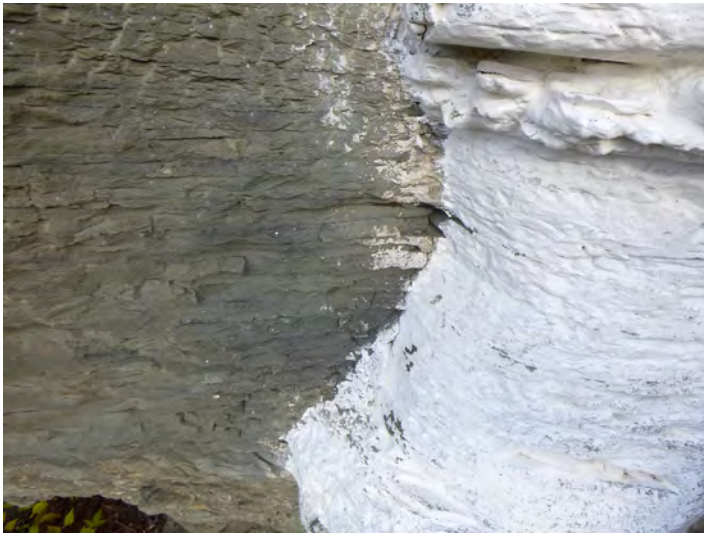
39-24 Stone\_Crack Single unit 2021-1

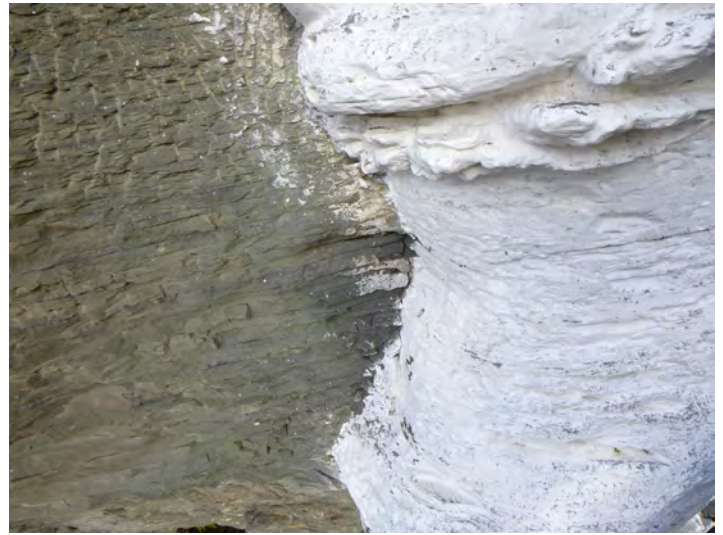
39-24 Stone\_Crack Single unit 2021-2

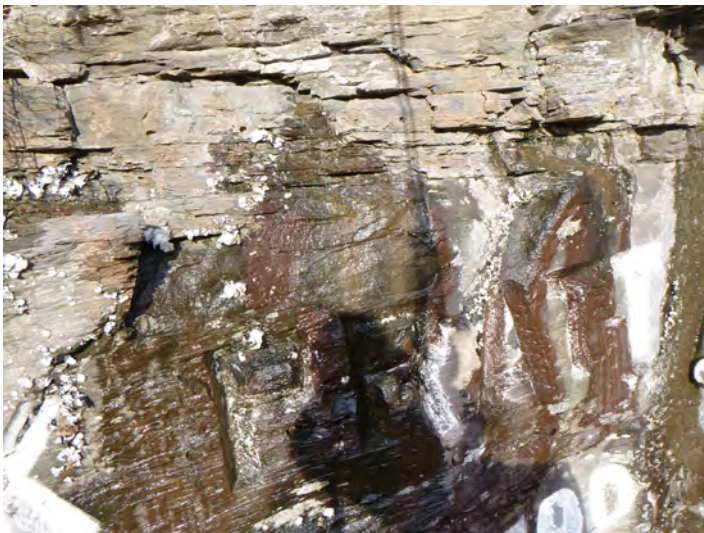
40-17 Stone\_Note Photo- Water seepage 2021-1

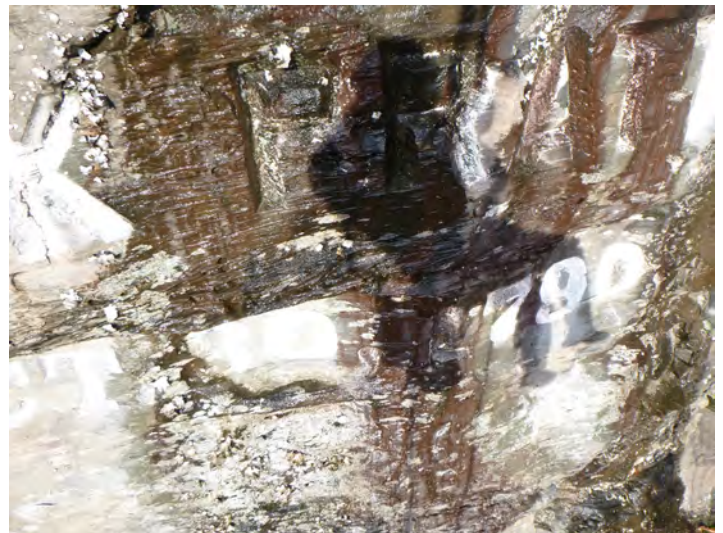
40-17 Stone\_Note Photo- Water seepage 2021-2

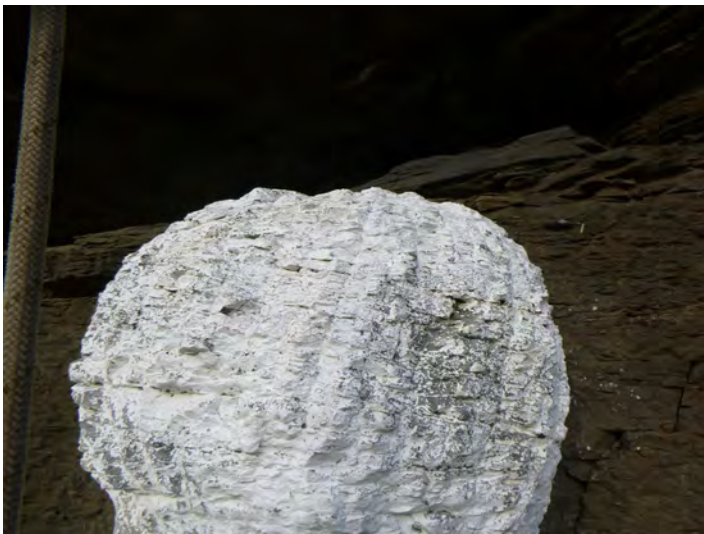
41-27 Stone\_Coating Coating Failed 2021-1

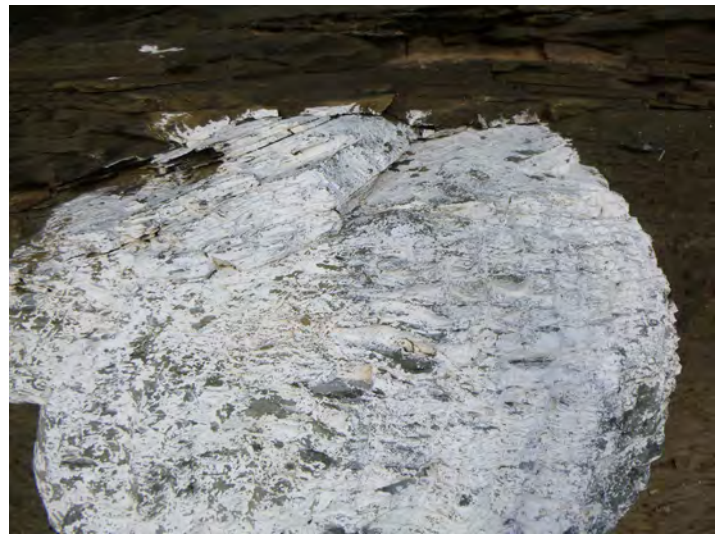
41-27 Stone\_Coating Coating Failed 2021-2

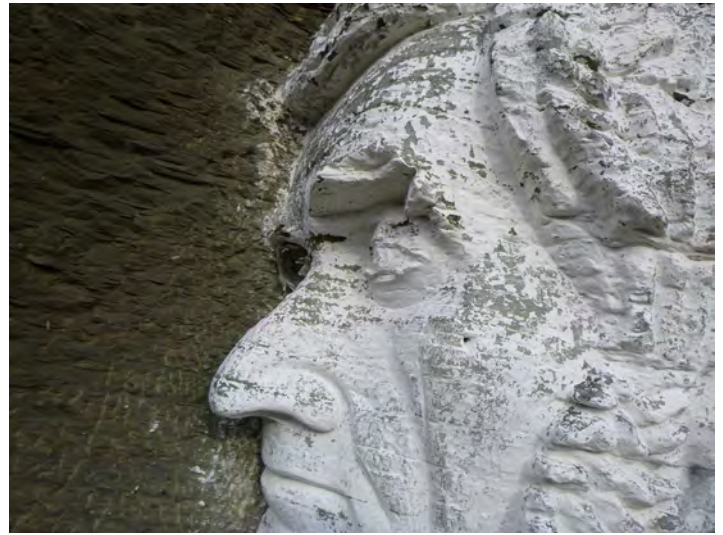
41-27 Stone\_Coating Coating Failed 2021-3

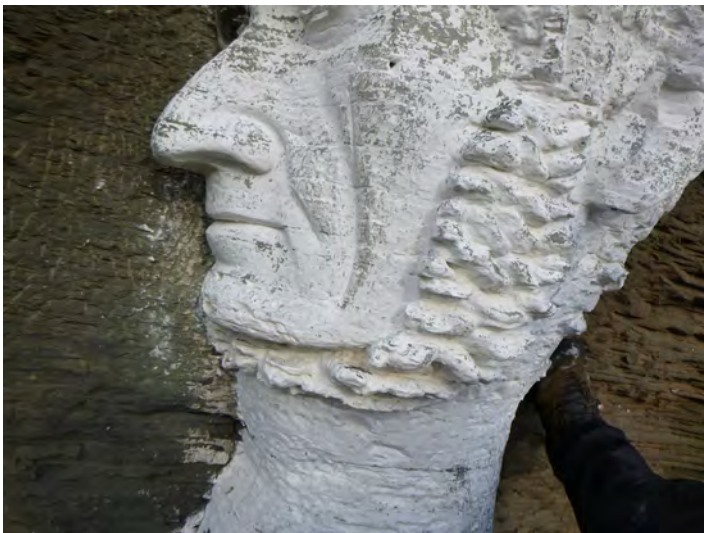
41-27 Stone\_Coating Coating Failed 2021-4

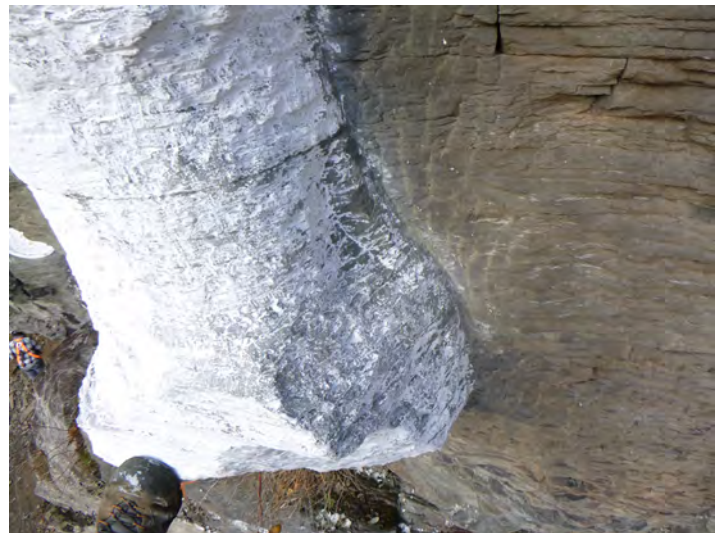
41-27 Stone\_Coating Coating Failed 2021-5

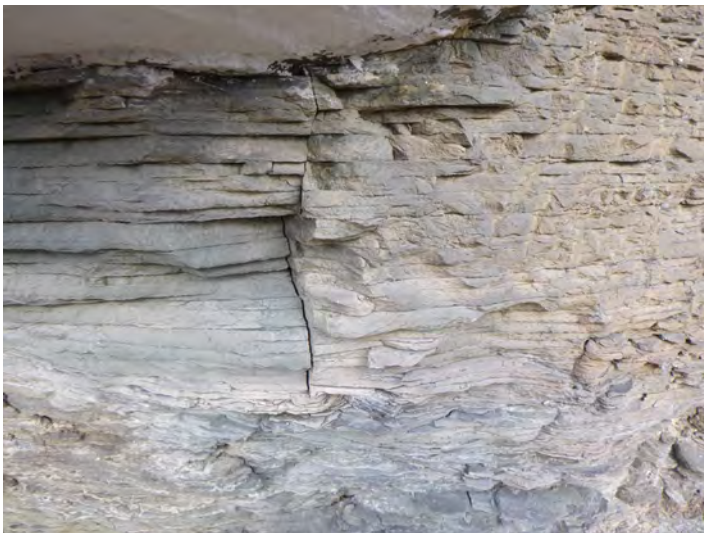
41-28 Stone\_Note Photo-general 2021-4

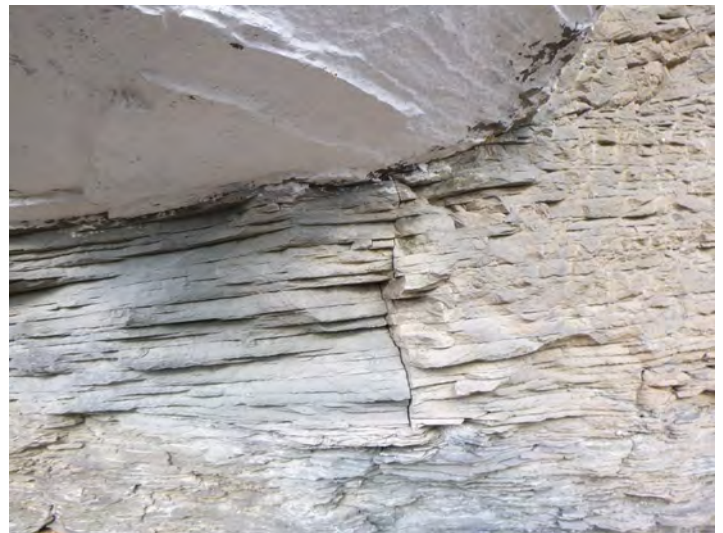
42-22 Stone\_Crack Single unit 2021-1

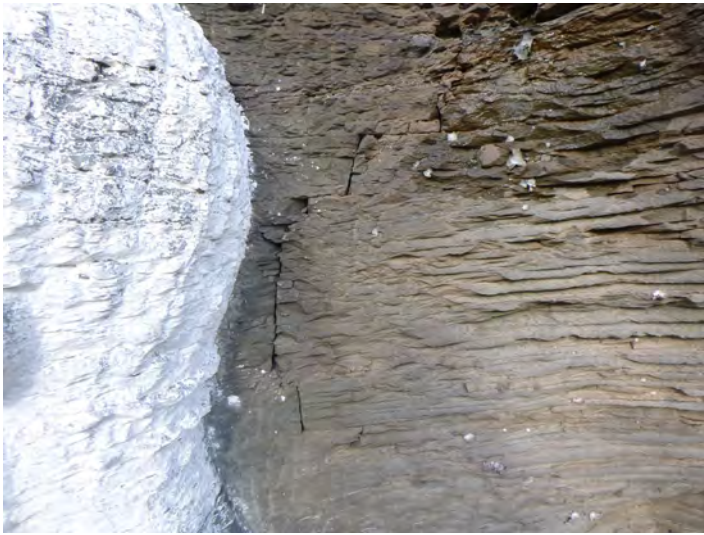
43-11 Stone\_Note Photo-overall 2021-2

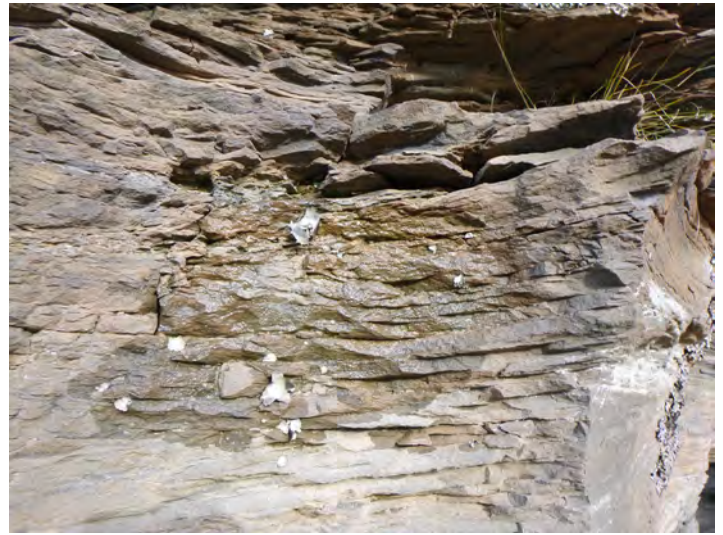
43-26 Stone\_Crack Single unit 2021-1

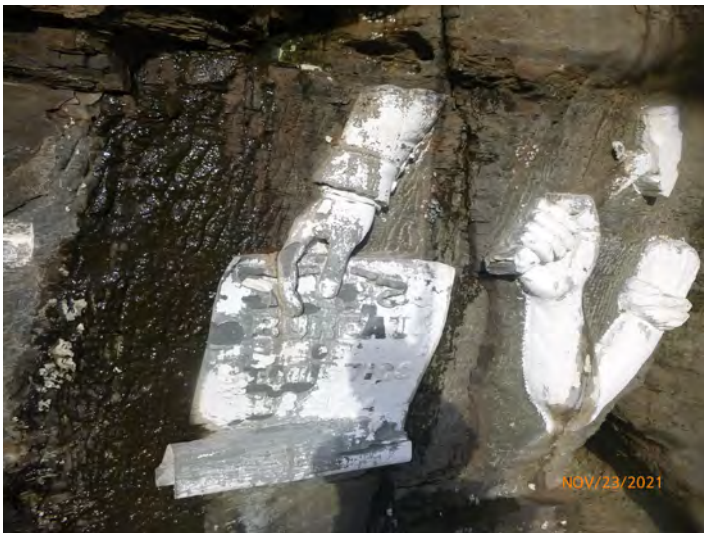
43-27 Stone\_Note Photo- Water seepage 2021-1

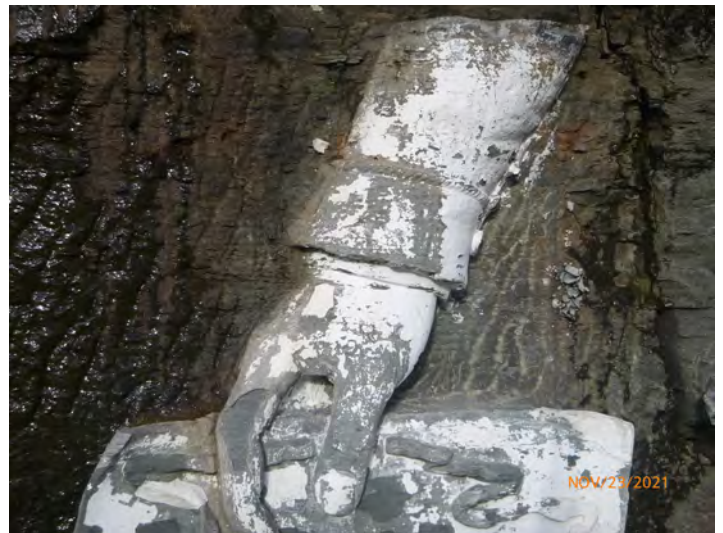
44-9 Stone\_Coating Coating Failed 2021-1

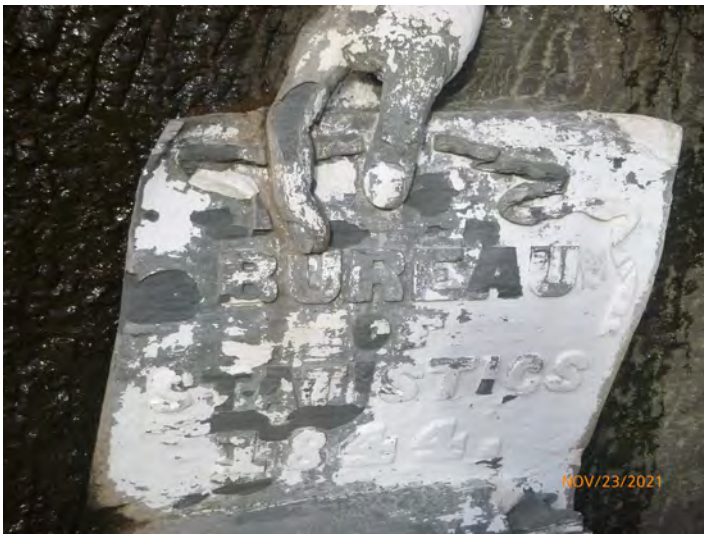
44-9 Stone\_Coating Coating Failed 2021-2

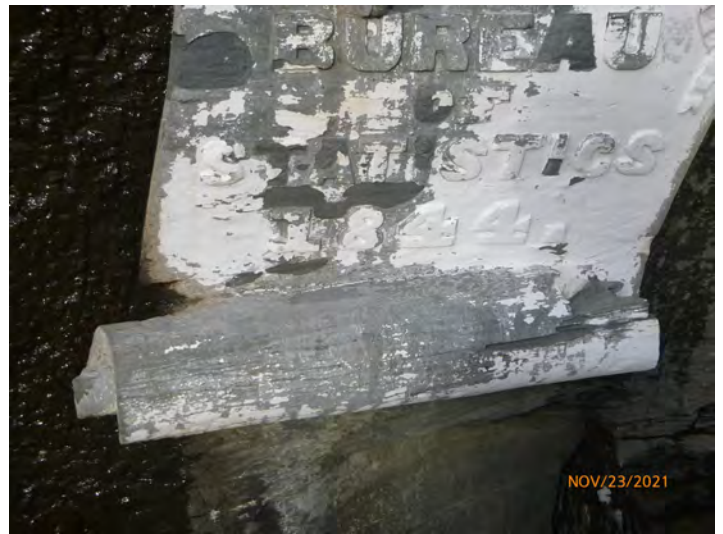
44-9 Stone\_Coating Coating Failed 2021-3

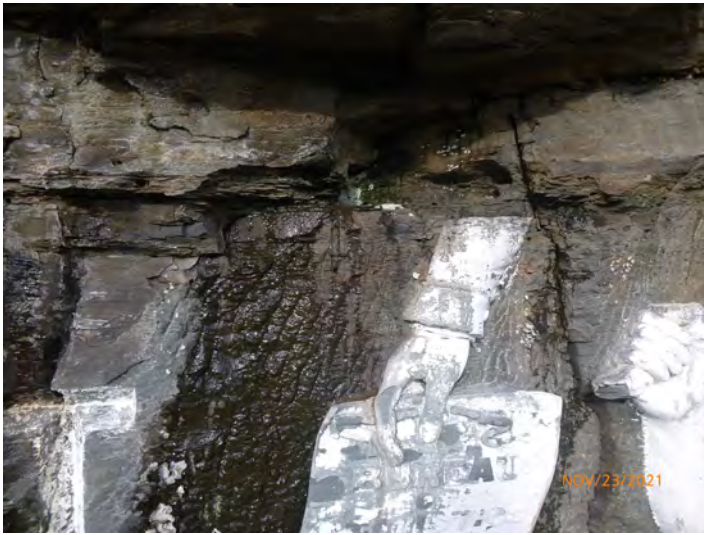
44-9 Stone\_Coating Coating Failed 2021-4

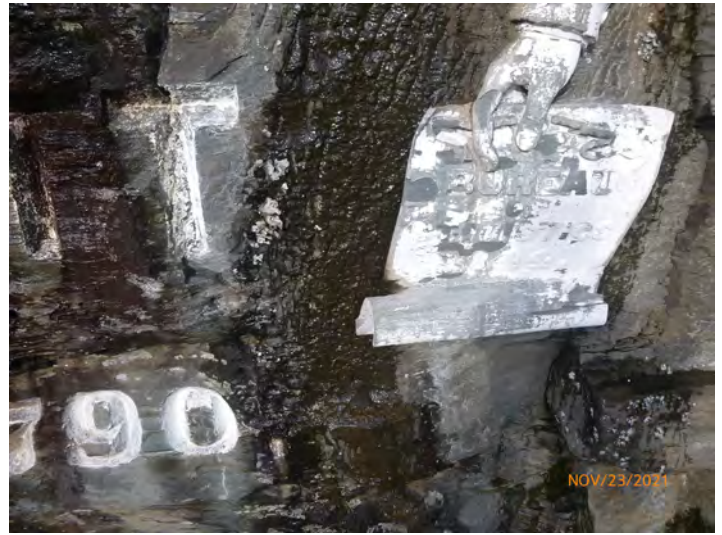
44-12 Stone\_Note Photo-water seepage 2021-1

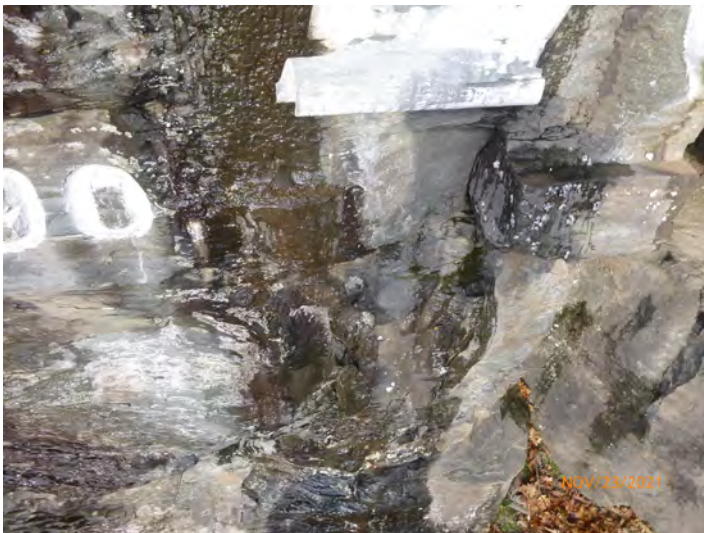
44-12 Stone\_Note Photo-water seepage 2021-2

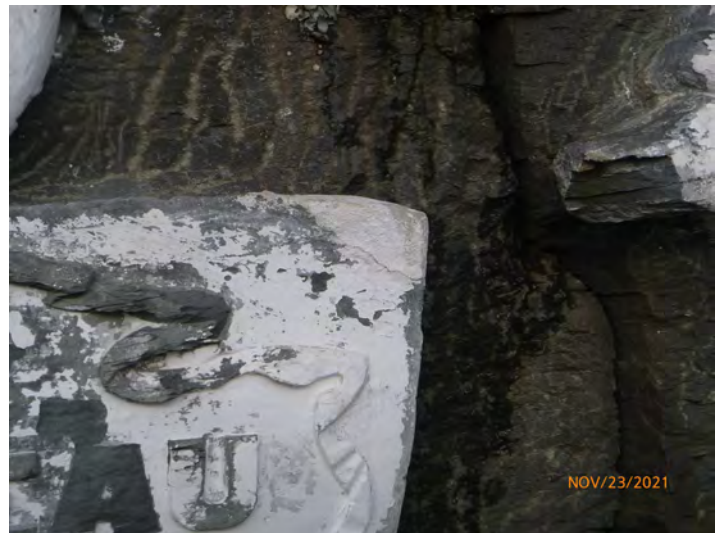
47-11 Stone\_SurfLoss Exfoliated 2021-1

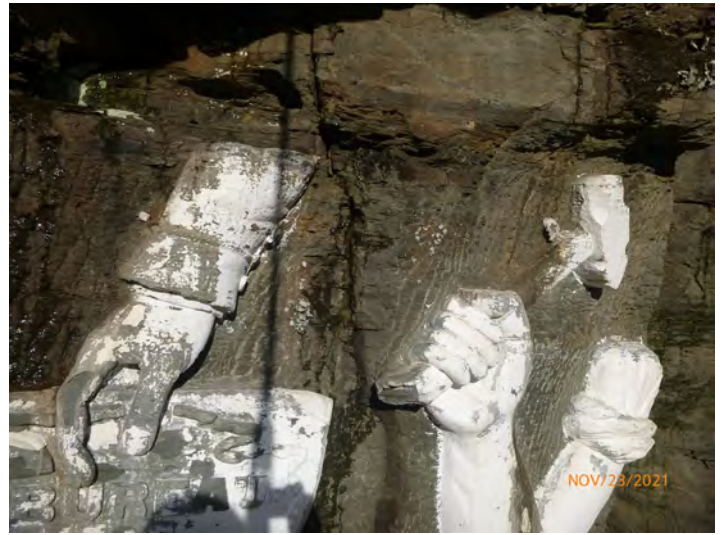
48-12 Stone\_Spall Missing 2021-1

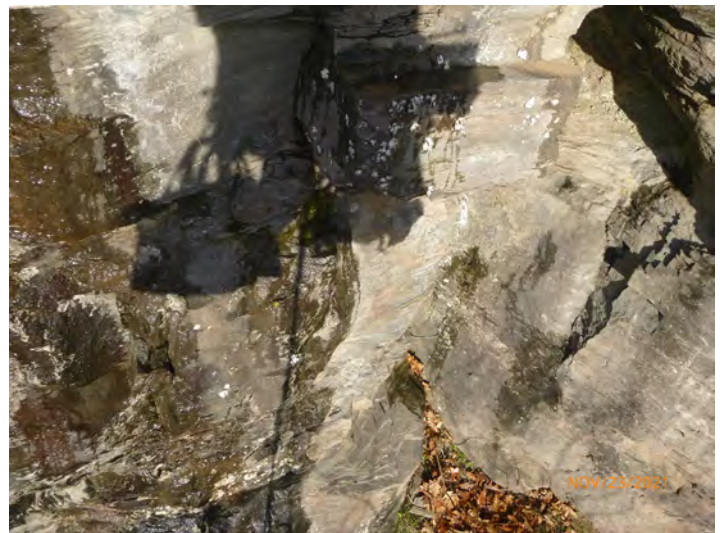
48-13 Stone\_Note Photo-water seepage 2021-2

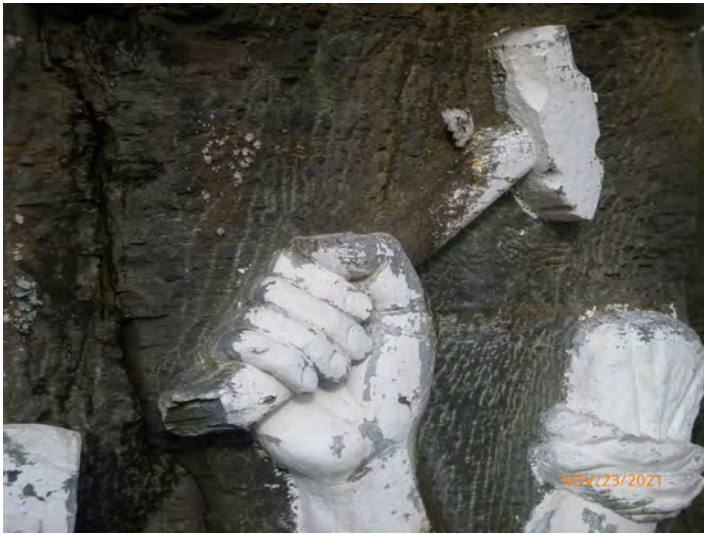
50-8 Stone\_Coating Coating Failed 2021-1

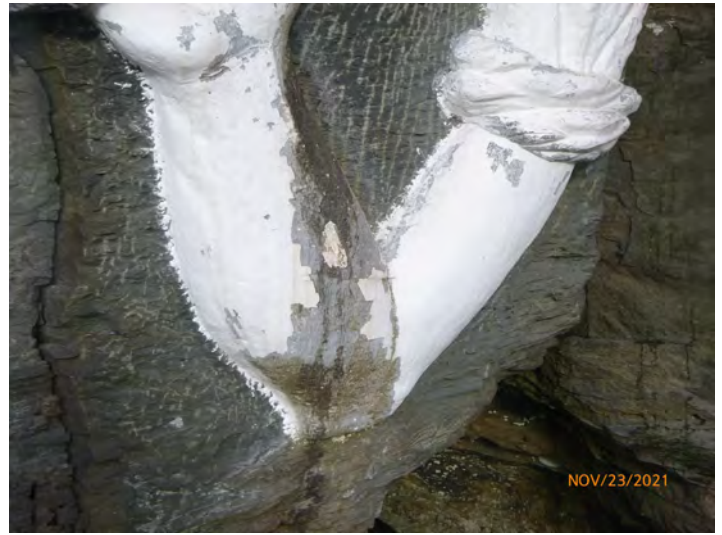
50-8 Stone\_Coating Coating Failed 2021-2

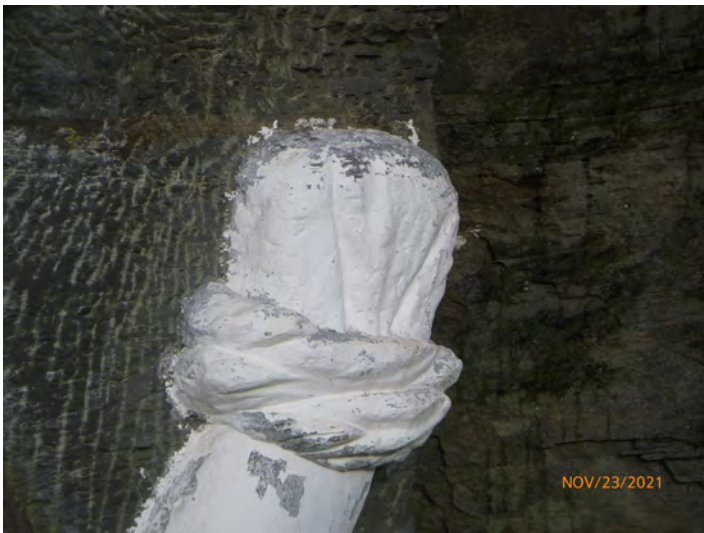
50-8 Stone\_Coating Coating Failed 2021-3

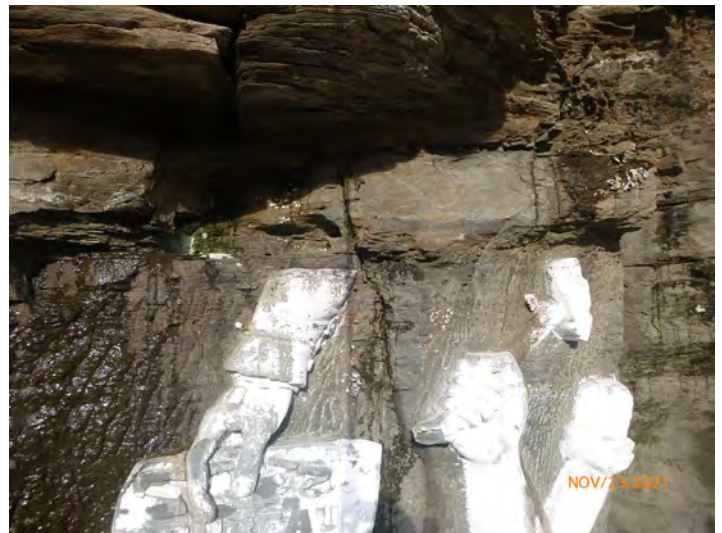
50-8 Stone\_Crack Single unit 2021-1

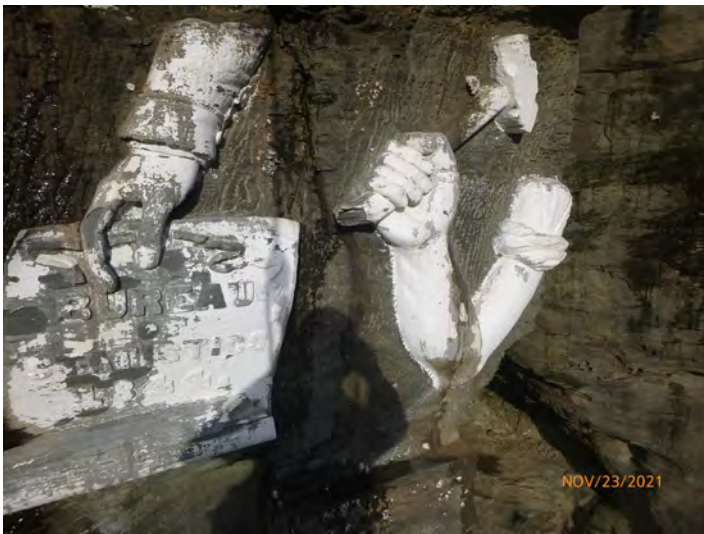
50-8 Stone\_Crack Single unit 2021-2

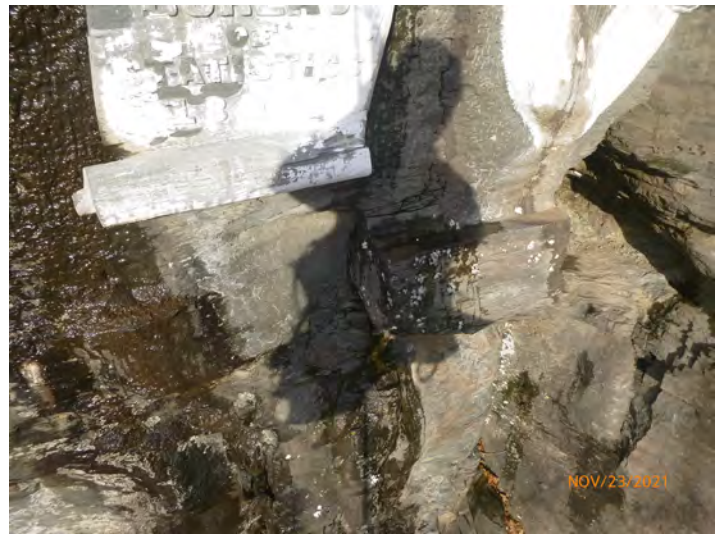
50-8 Stone\_Crack Single unit 2021-3

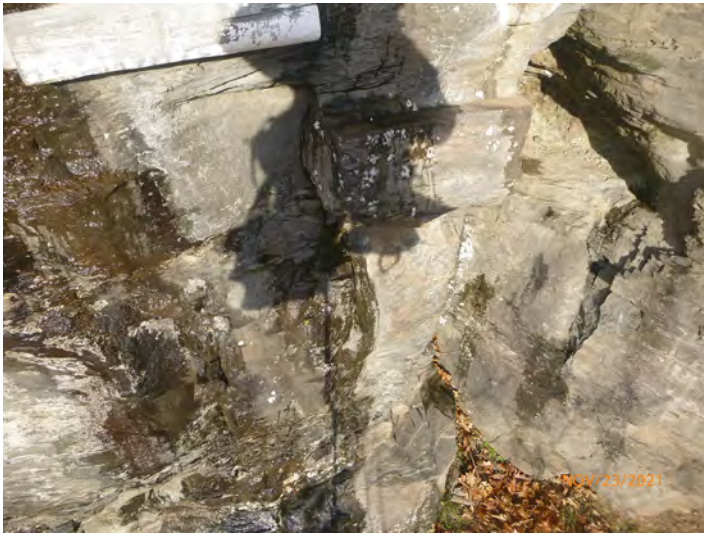
50-8 Stone\_Crack Single unit 2021-4

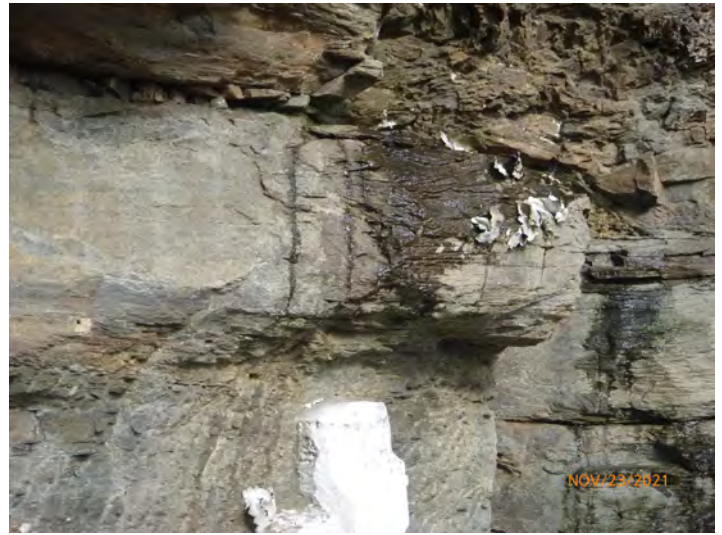
50-12 Stone\_Note Photo-water seepage 2021-1

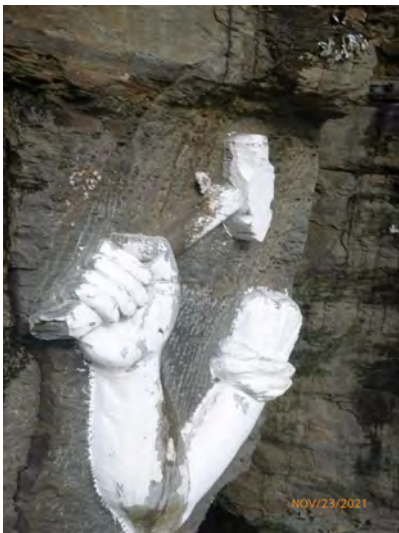
50-12 Stone\_Note Photo-water seepage 2021-2

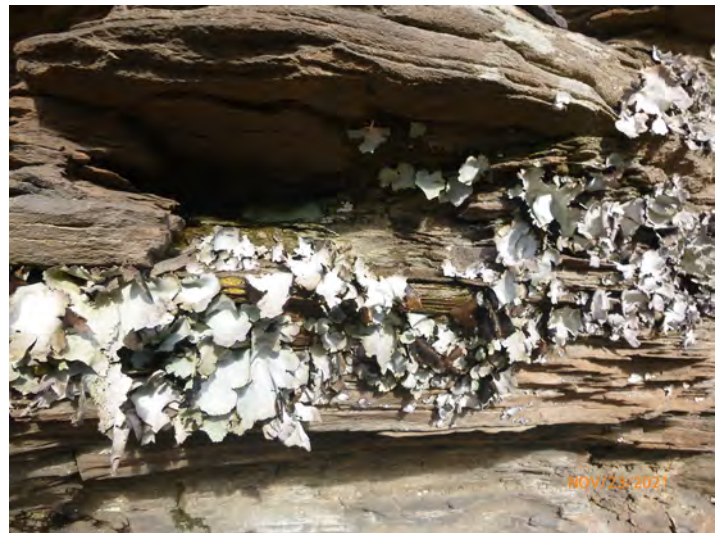
50-13 Stone\_Note Photo-water seepage 2021-1

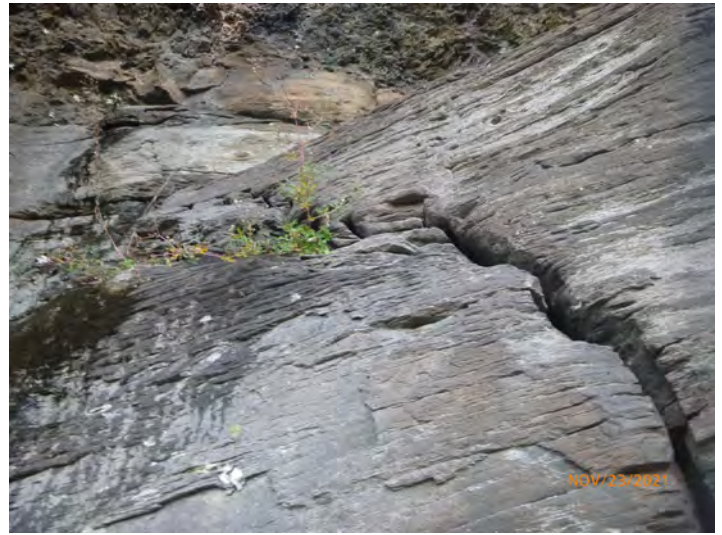
54-15 Stone\_Crack Single unit 2021-1

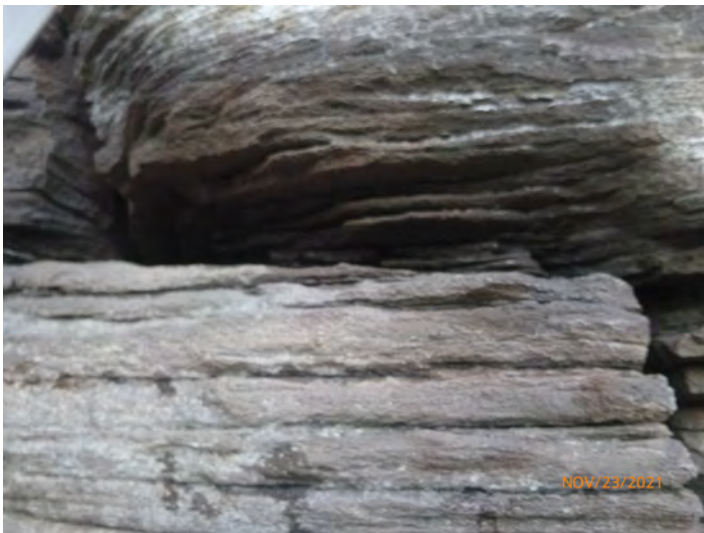
54-15 Stone\_Crack Single unit 2021-2

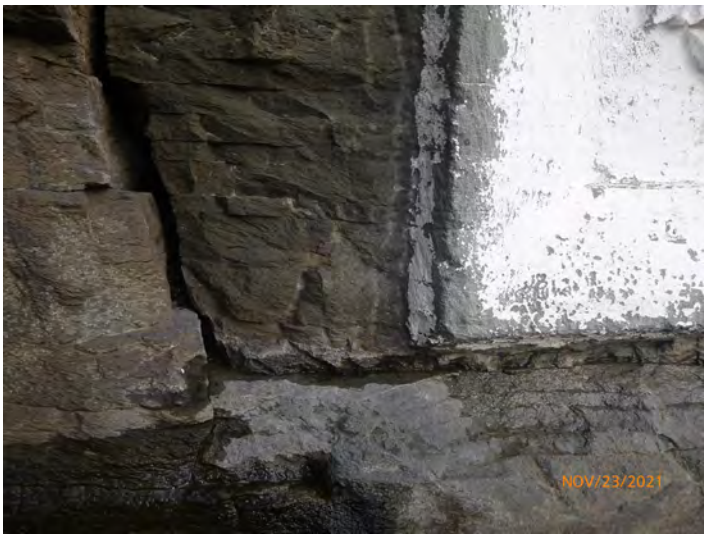
54-15 Stone\_Crack Single unit 2021-4

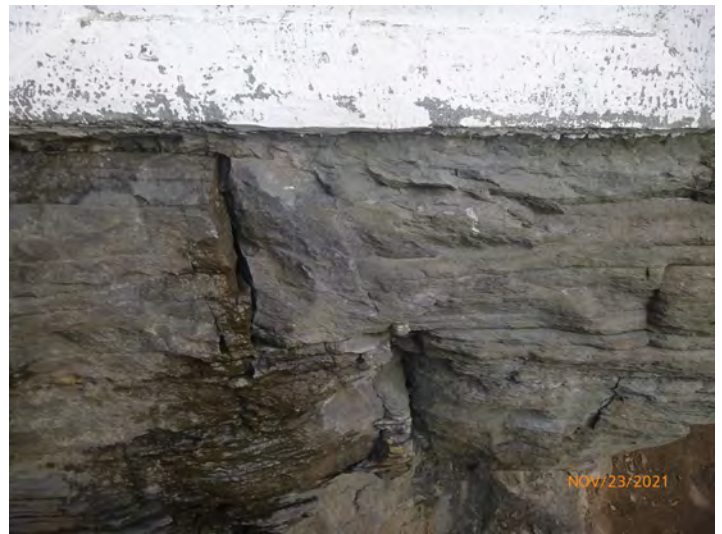
54-15 Stone\_Crack Single unit 2021-5

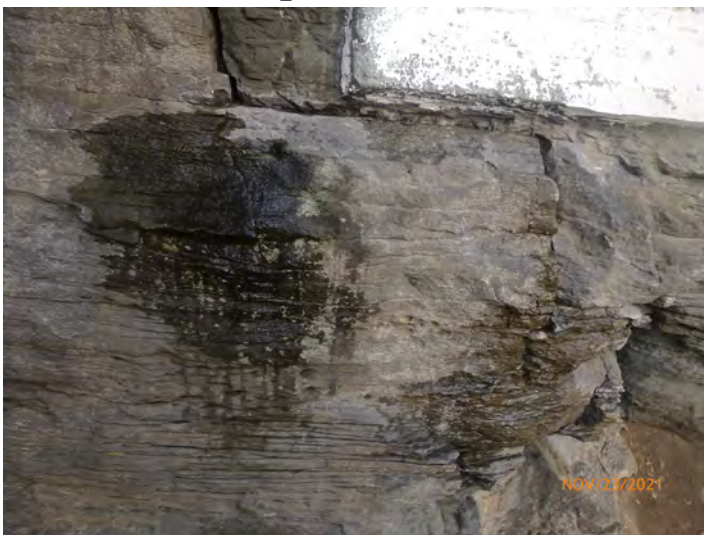
57-10 Stone\_Note Photo-water seepage 2021-1

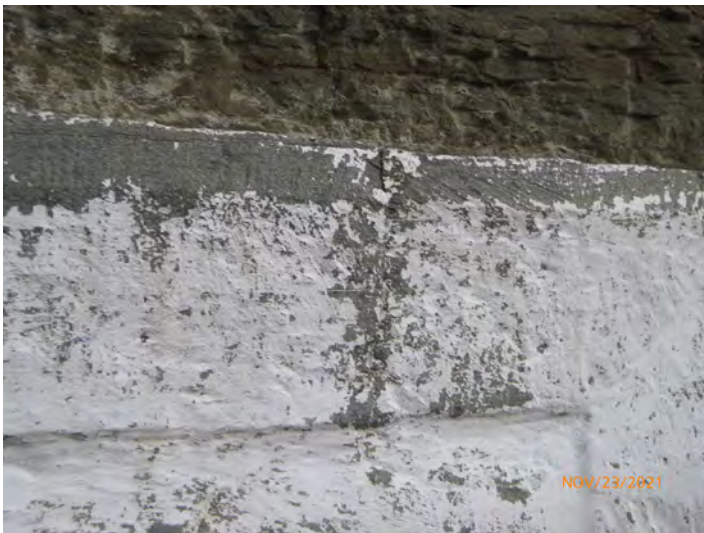
59-15 Stone\_Crack Single unit 2021-1

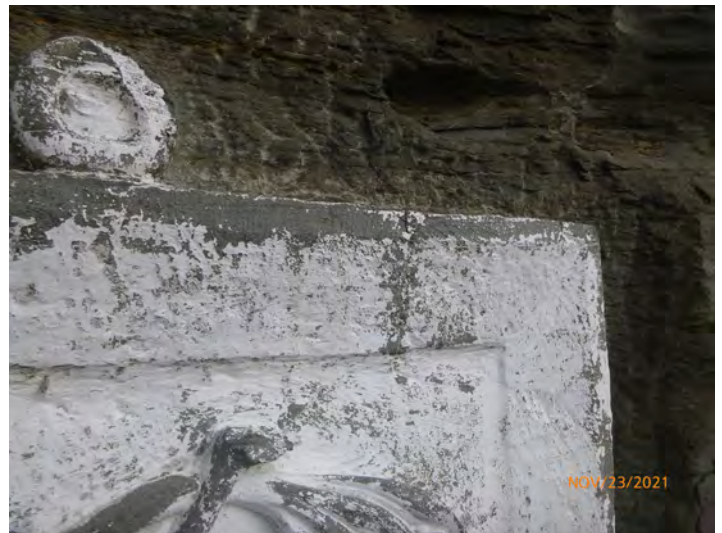
59-15 Stone\_Crack Single unit 2021-2

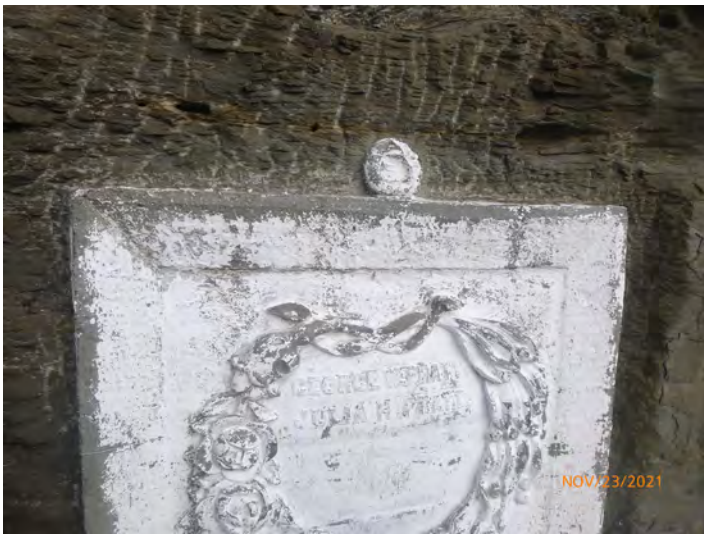
60-14 Stone\_Coating Coating Failed 2021-1

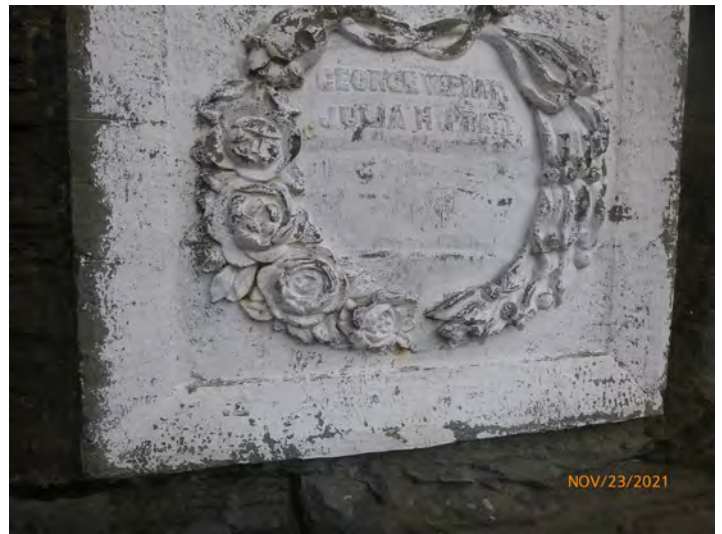
60-14 Stone\_Coating Coating Failed 2021-2
