## **PRATT ROCK PARK**

Phase 1: Initial Needs Assessment  
Pratt Rock Park, Prattsville, New York

prepared for:  
Pratt Park Committee  
Prattsville, New York

April 18, 2022

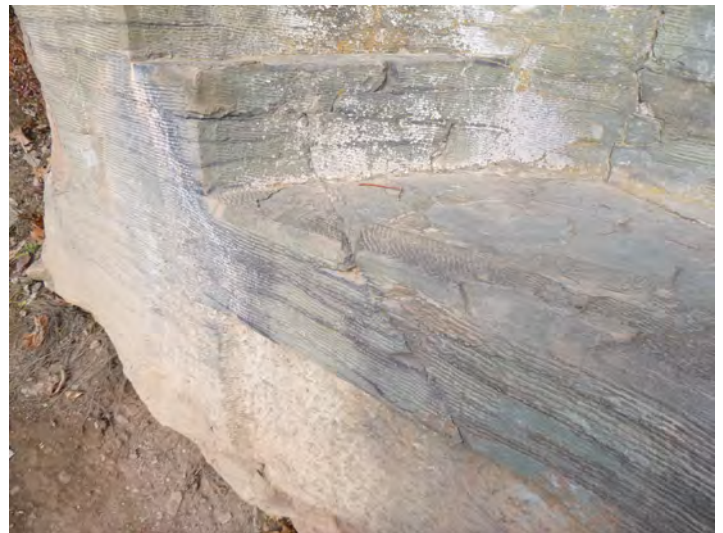
130-25 Stone\_Note Photo-general-encroaching trees 2021-1

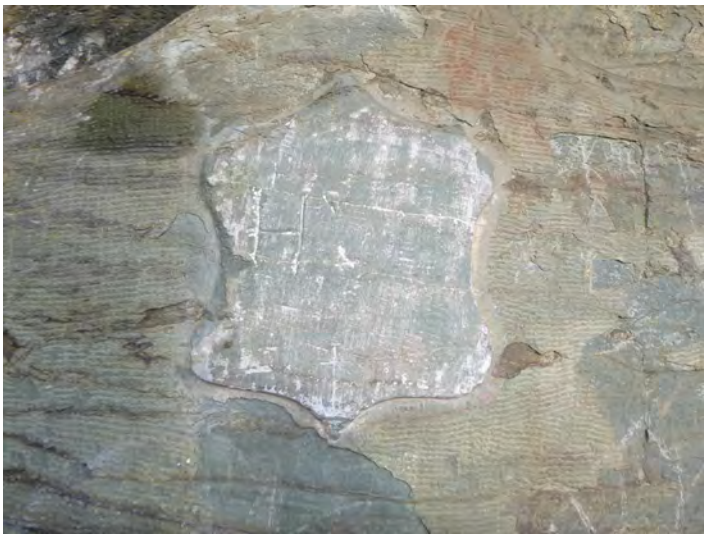
138-14 Stone\_SurfLoss Exfoliated 2021-4

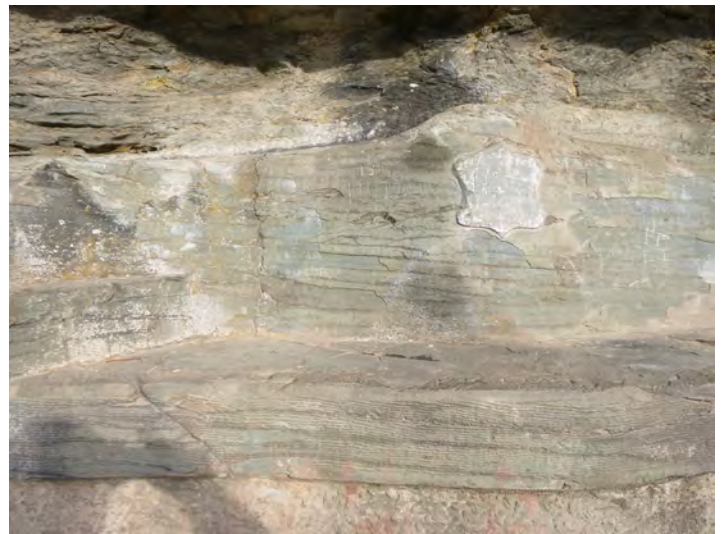
138-25 Stone\_SoilStain Biological 2021-1

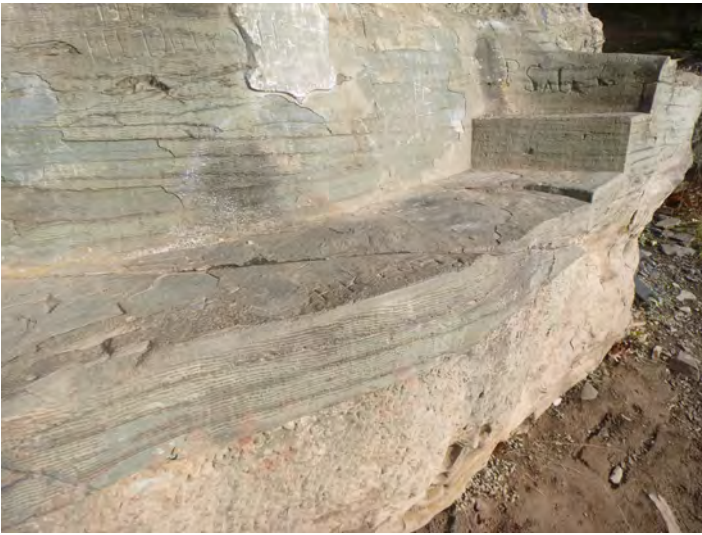
139-14 Stone\_Crack System units 2021-1

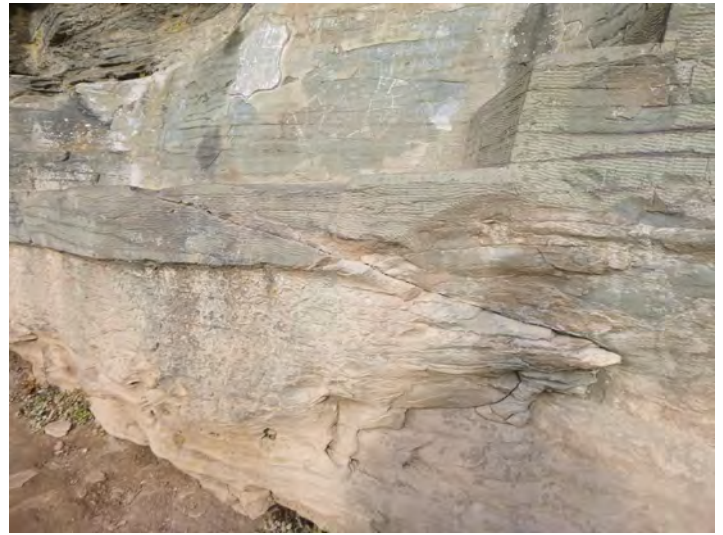
139-14 Stone\_Crack System units 2021-2

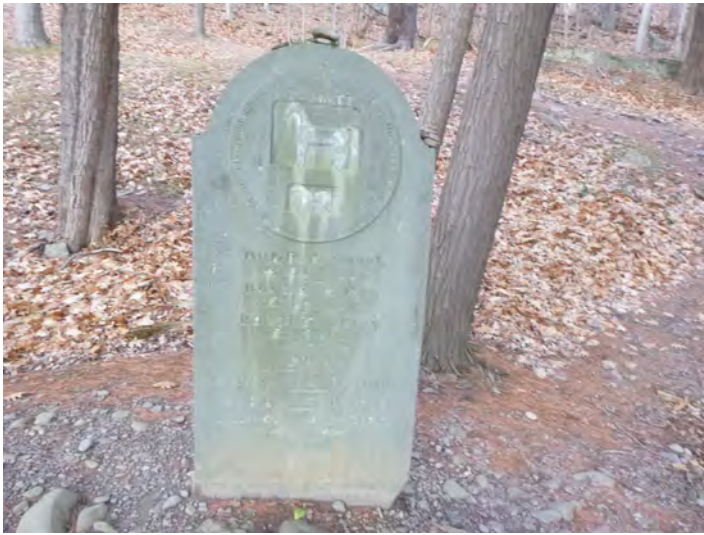
145-22 Stone\_Note Photo-general 2021-2

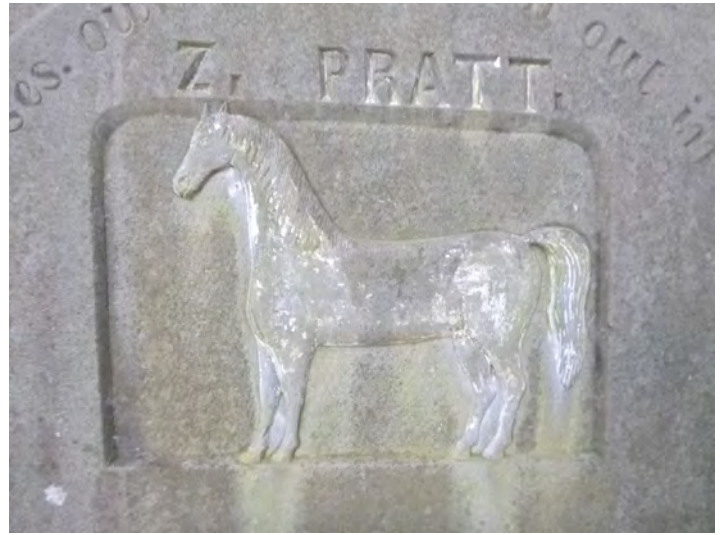
145-27 Stone\_Coating Coating Failed 2021-1

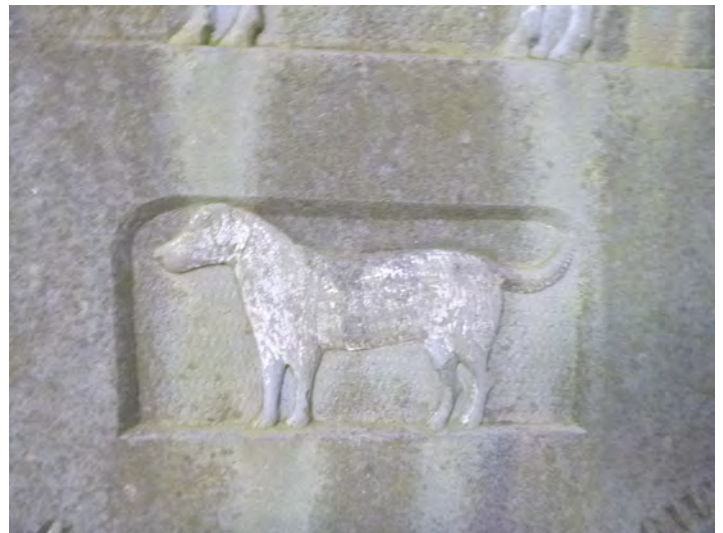
145-27 Stone\_Coating Coating Failed 2021-3

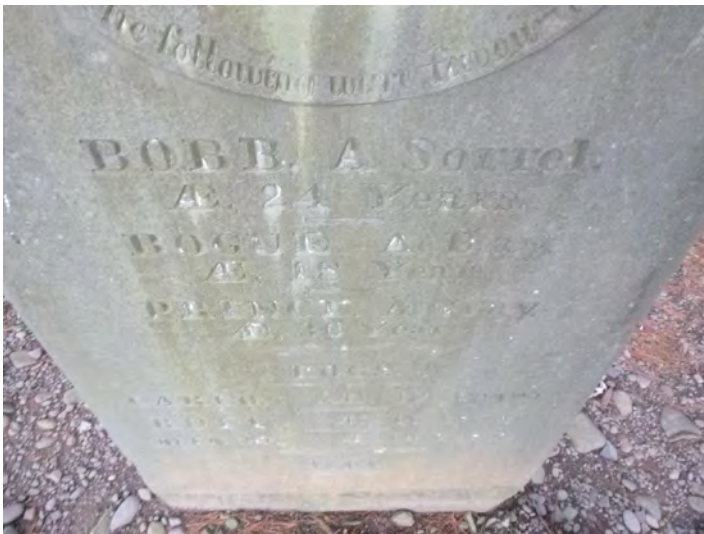
145-27 Stone\_Coating Coating Failed 2021-4

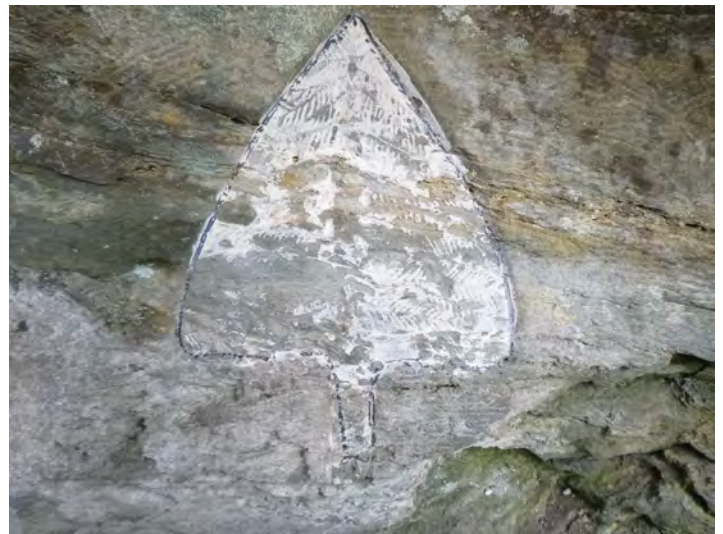
145-27 Stone\_Coating Coating Failed 2021-5

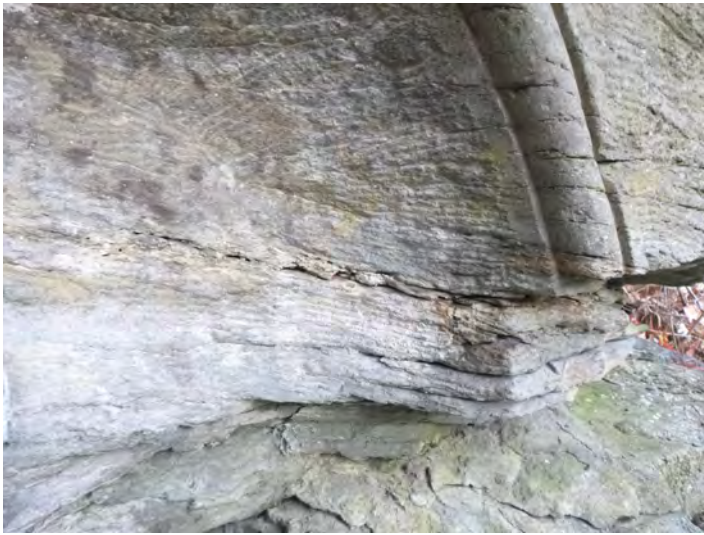
146-20 Stone\_Coating Coating Failed 2021-1

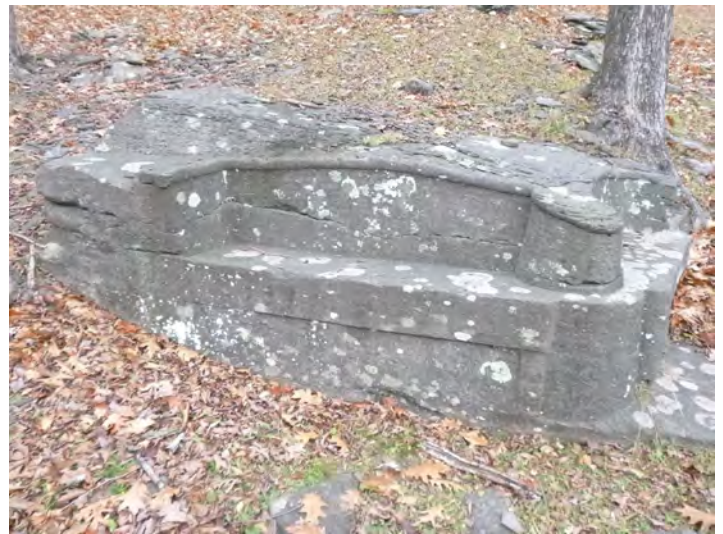
147-20 Stone\_Spall Missing 2021-2

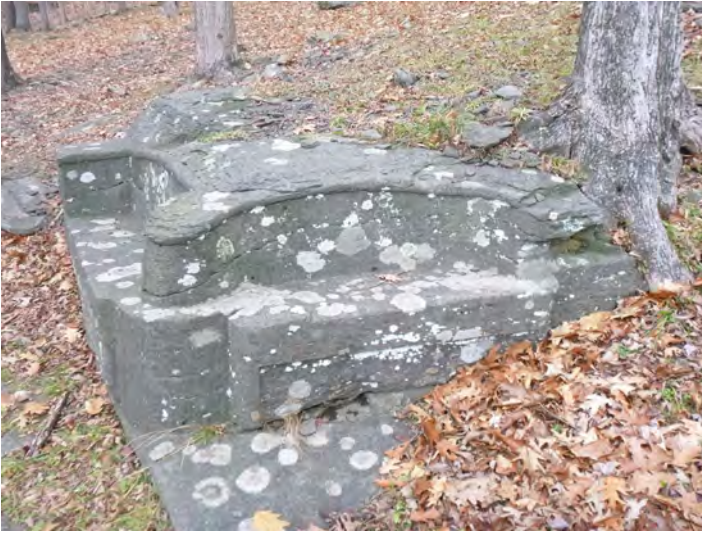
161-26 Stone\_Crack System units 2021-1

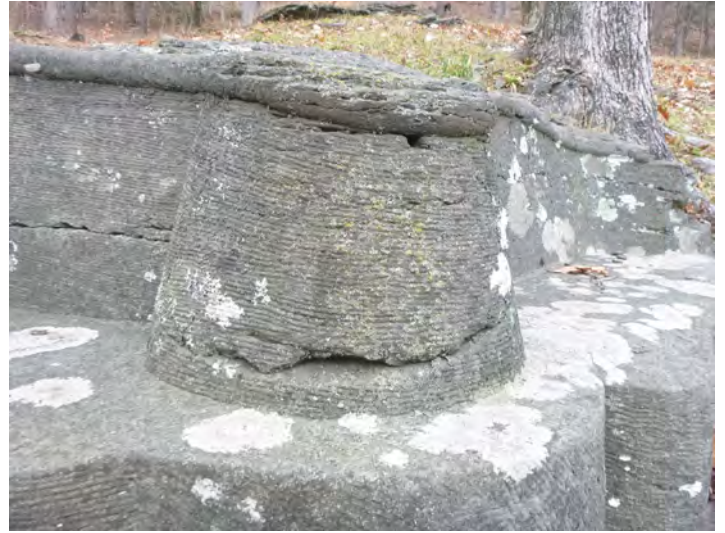
161-26 Stone\_Crack System units 2021-2

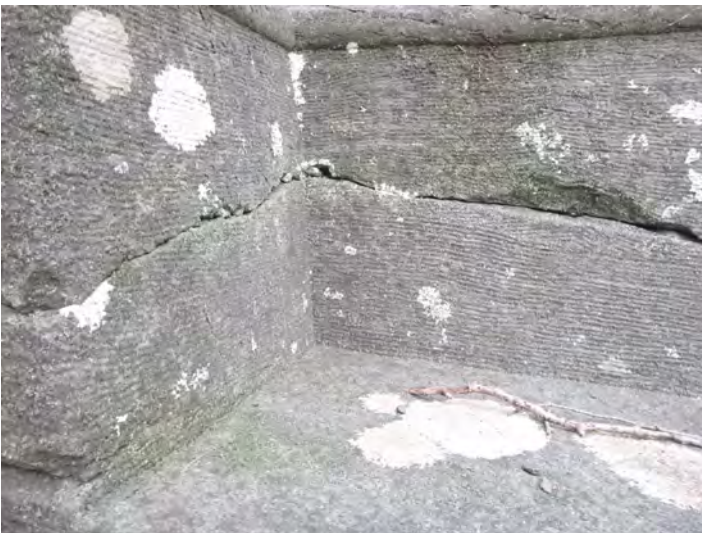
161-26 Stone\_Crack System units 2021-3

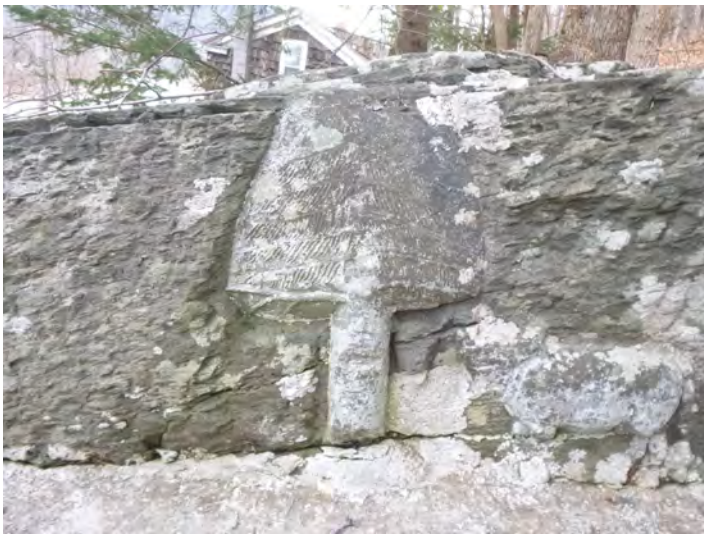
169-26 Stone\_Coating Coating Failed 2021-1

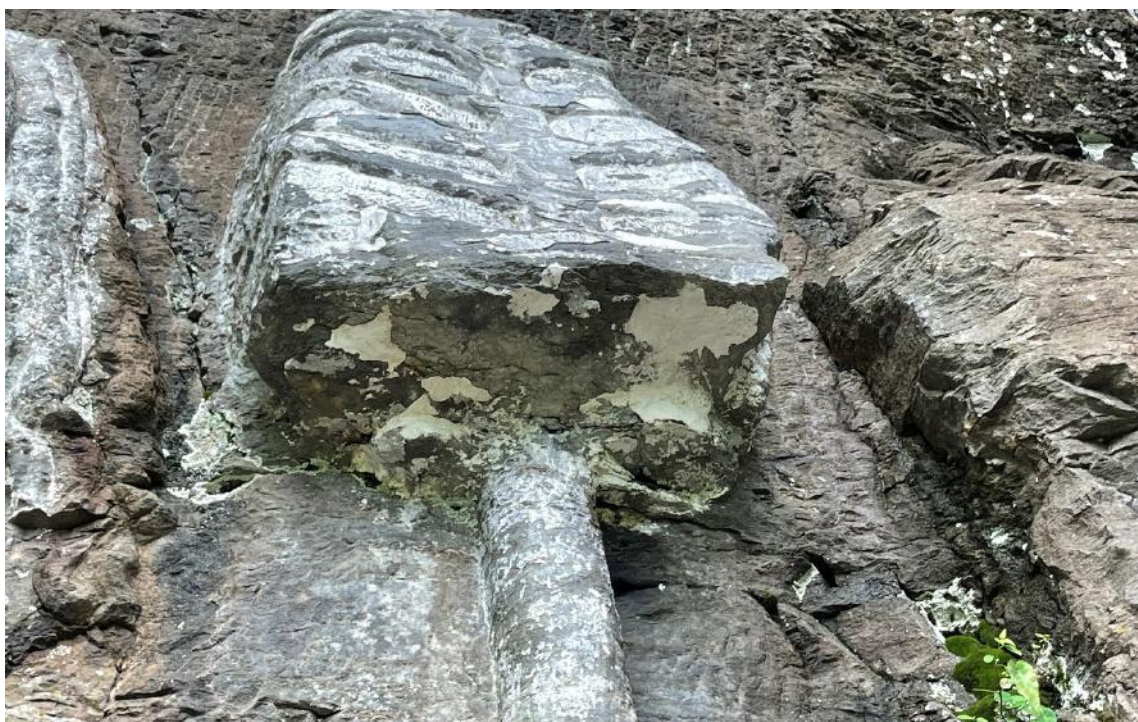
**Figure 2: "Hemlock Tree" Sculpture, Coating Sample 2-3 Locations**  
*Coating samples 2-3 were obtained by ICR on 8/28/21 at the tree trunk and underside of the branches respectively.*

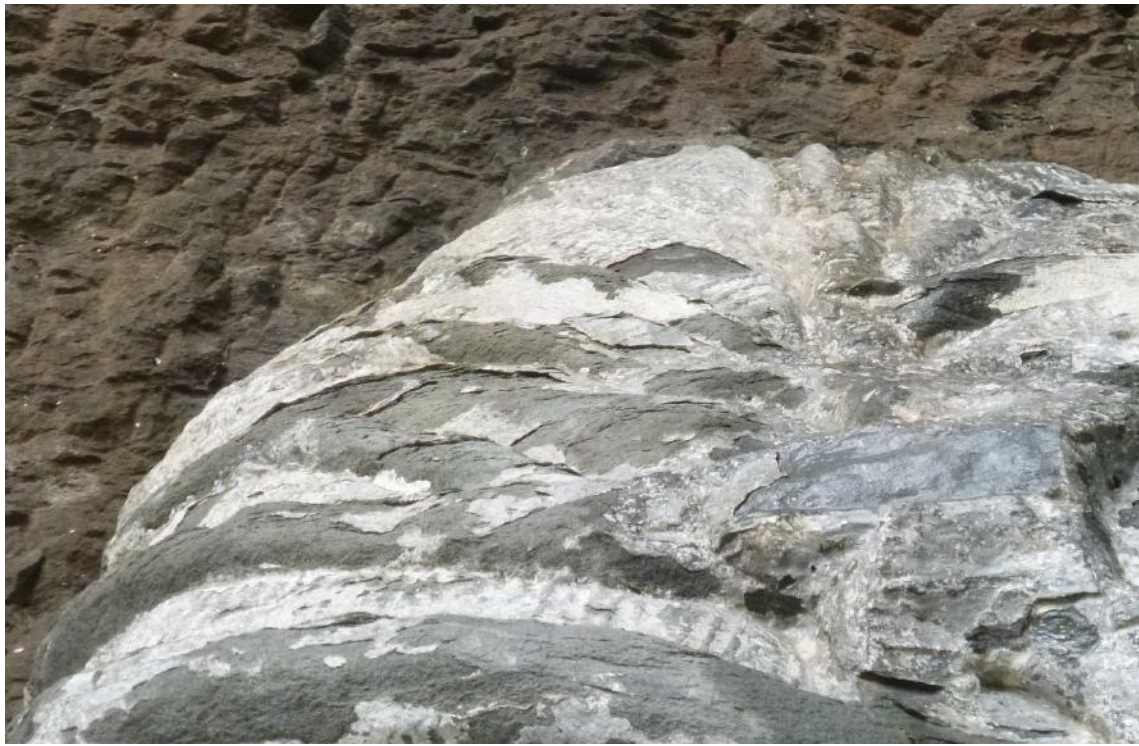
**Figure 3: "Hemlock Tree" Sculpture, Coating Sample 4 Location**  
*Coating sample was obtained by ICR on 11/22/21 from the top of the hemlock tree.*

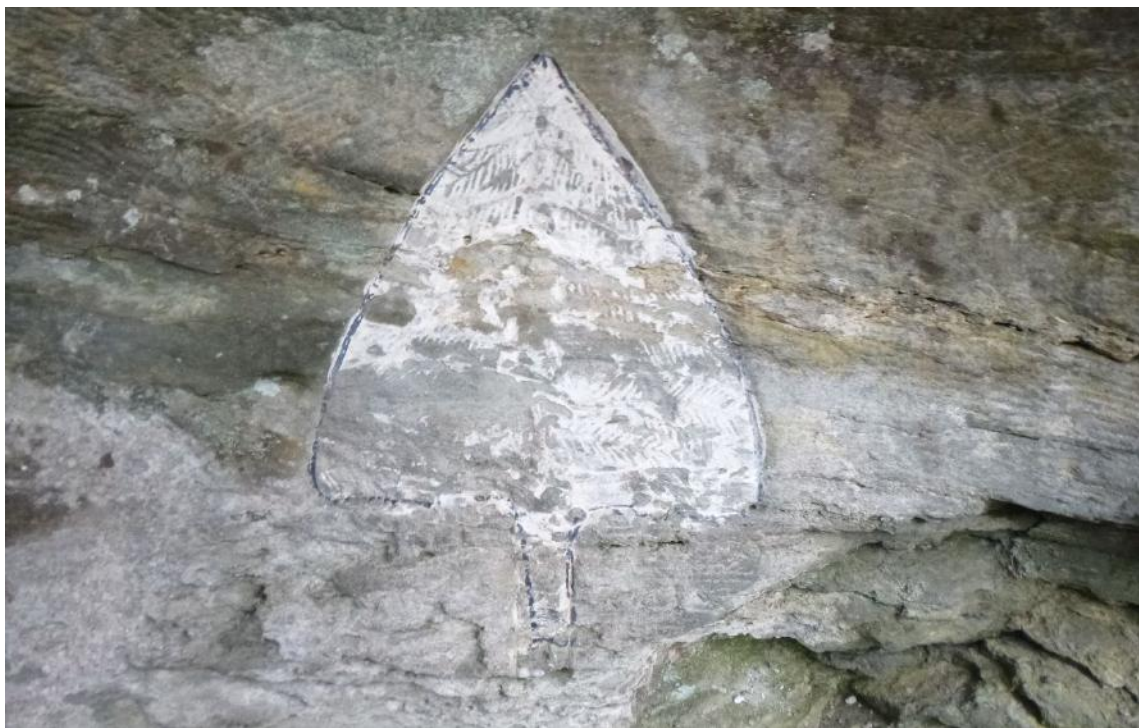
**Figure 4: "Bench C" Sculpture, Coating Sample 5 Location**  
*Coating sample was obtained by ICR on 11/22/21 from the hemlock tree detail of the bench.*

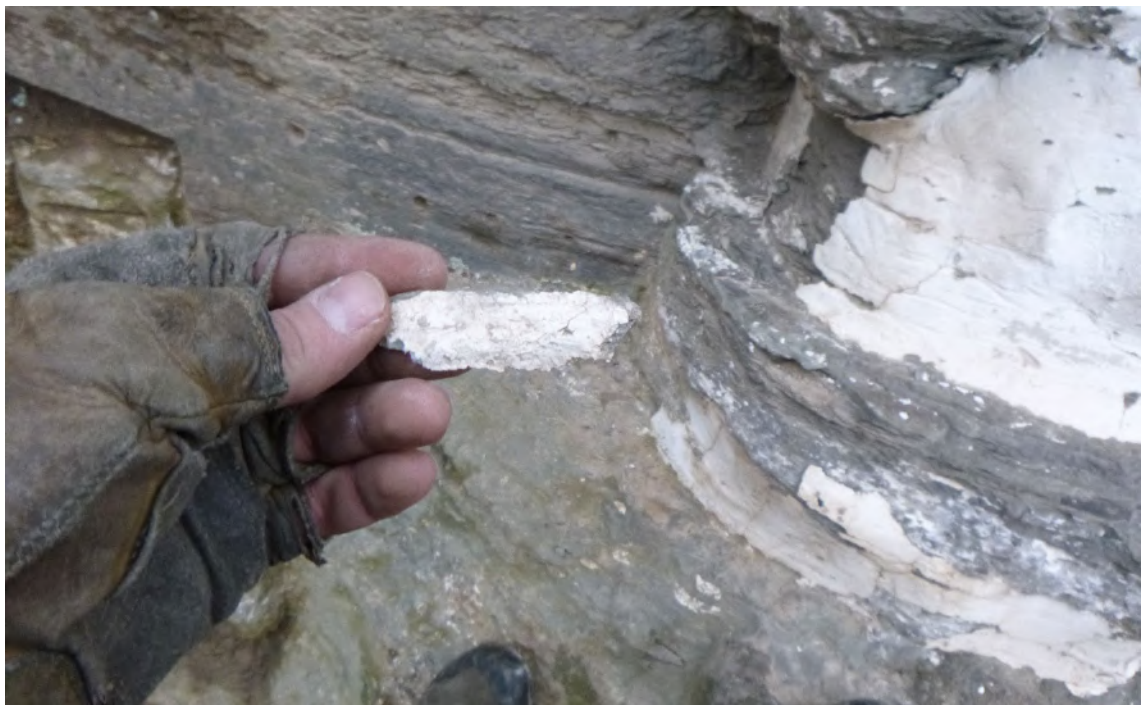
**Figure 5: "Portrait Bust of George W. Pratt," Coating Sample 6 Location**  
*Coating sample was obtained by VA on 11/22/21.*

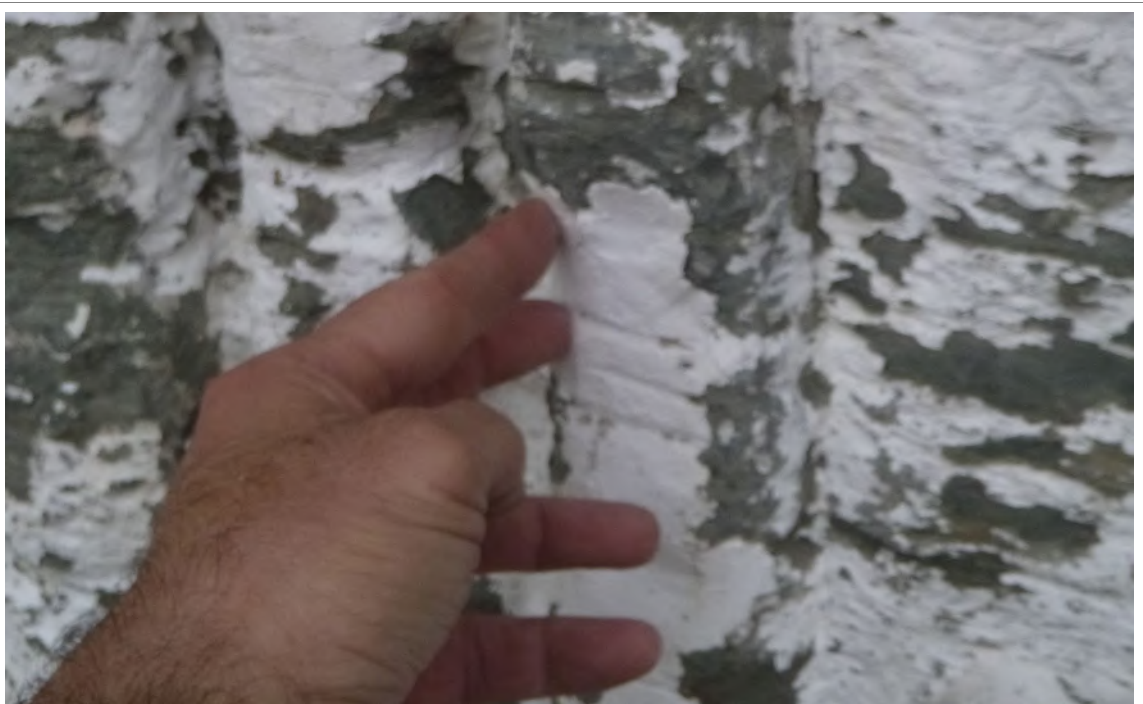
**Figure 6: "Medallion with Raised Hand," Coating Sample 7 Location**  
*Coating sample was obtained by VA on 11/22/21 from the right side of the sculpture.*

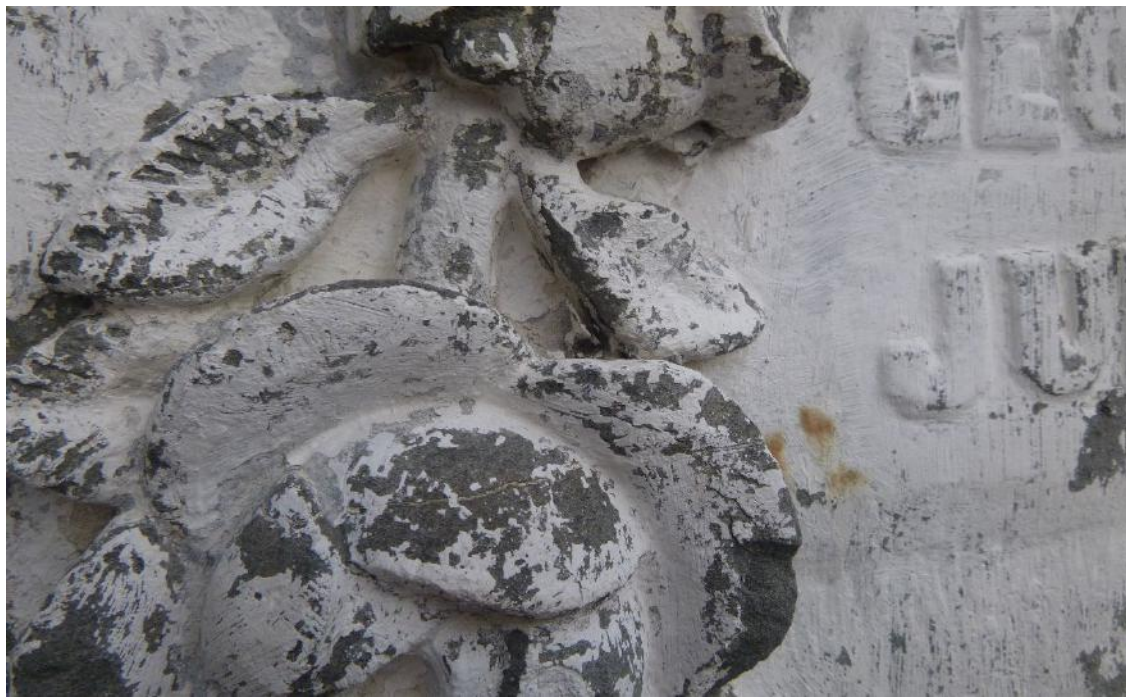
**Figure 7: "Plaque to George and Julia Pratt," Coating Sample 8 Location**  
*Coating sample was obtained by VA on 11/22/21 from the left side of the sculpture.*

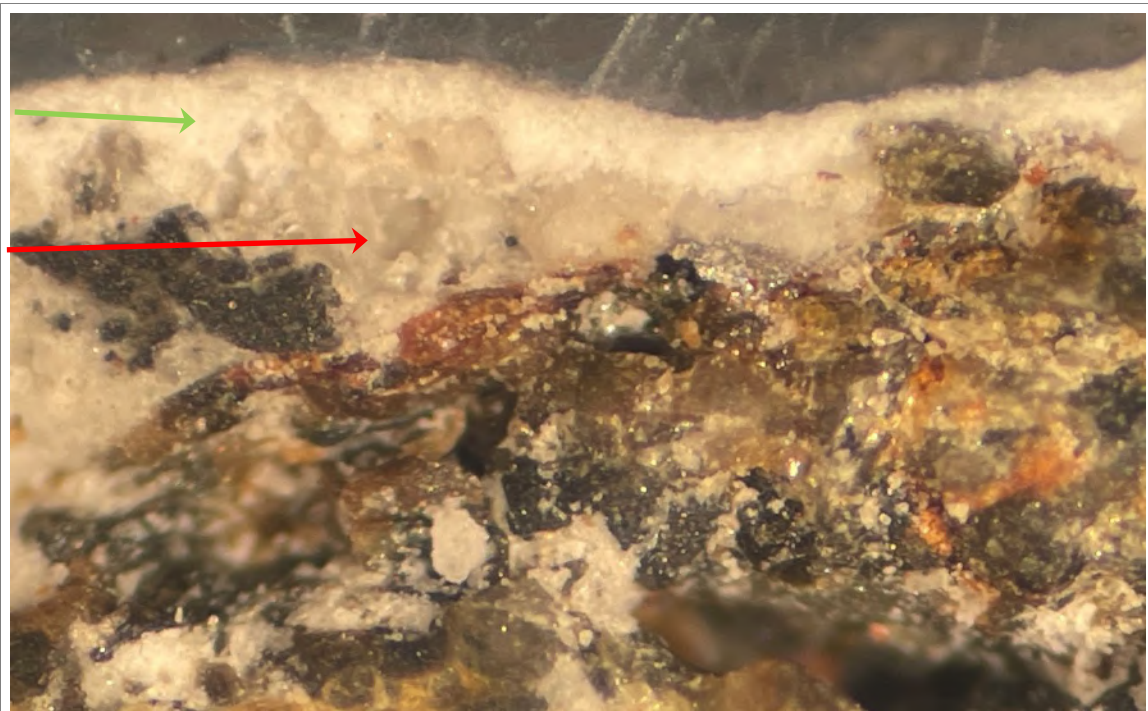
**Figure 10: “Hemlock Tree,” Underside of Tree Location, Microscopic Image of Coating Sample 3 in Cross Section**  
*Earliest extant layer appears to be a white cementitious skim coating (indicated in red), followed by a thin white layer (indicated in green), possibly a thin paint or laitance from the skim coating.*
