## **PRATT ROCK PARK**

Phase 1: Initial Needs Assessment  
Pratt Rock Park, Prattsville, New York

prepared for:  
Pratt Park Committee  
Prattsville, New York

April 18, 2022

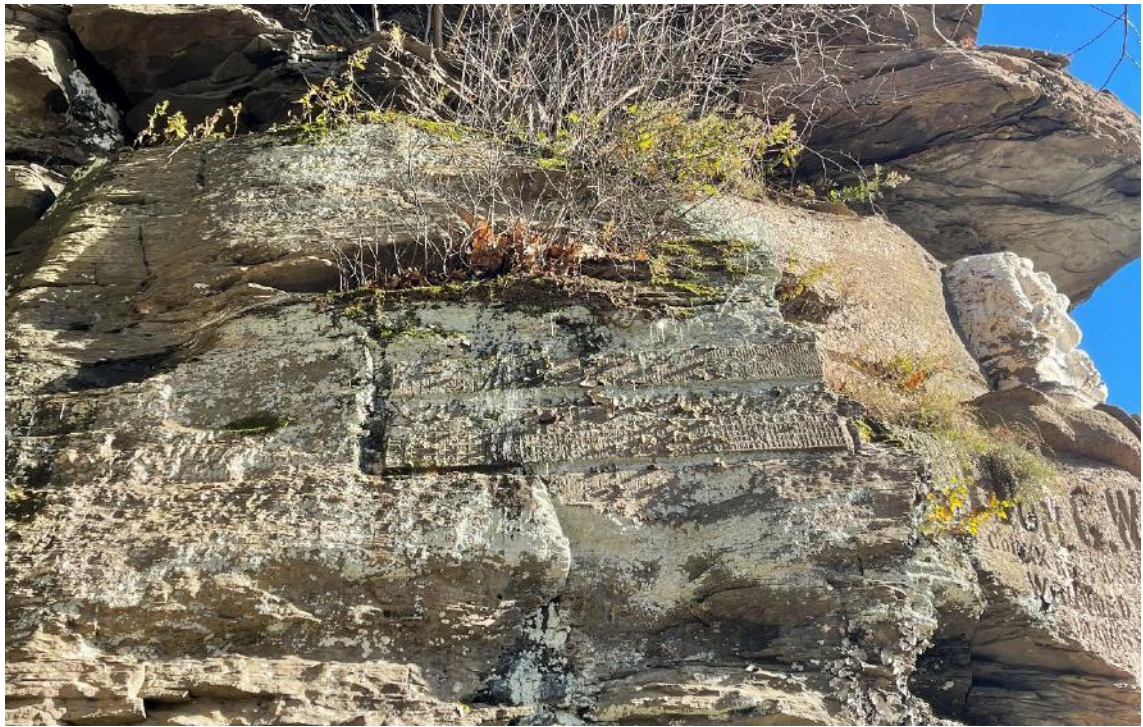
**Figure 10: Unnamed Sculpture 1**

*Heavy biological growth obscures most of this low-relief sculpture, but there appears to be a depiction of books and/or an architectural structure.*

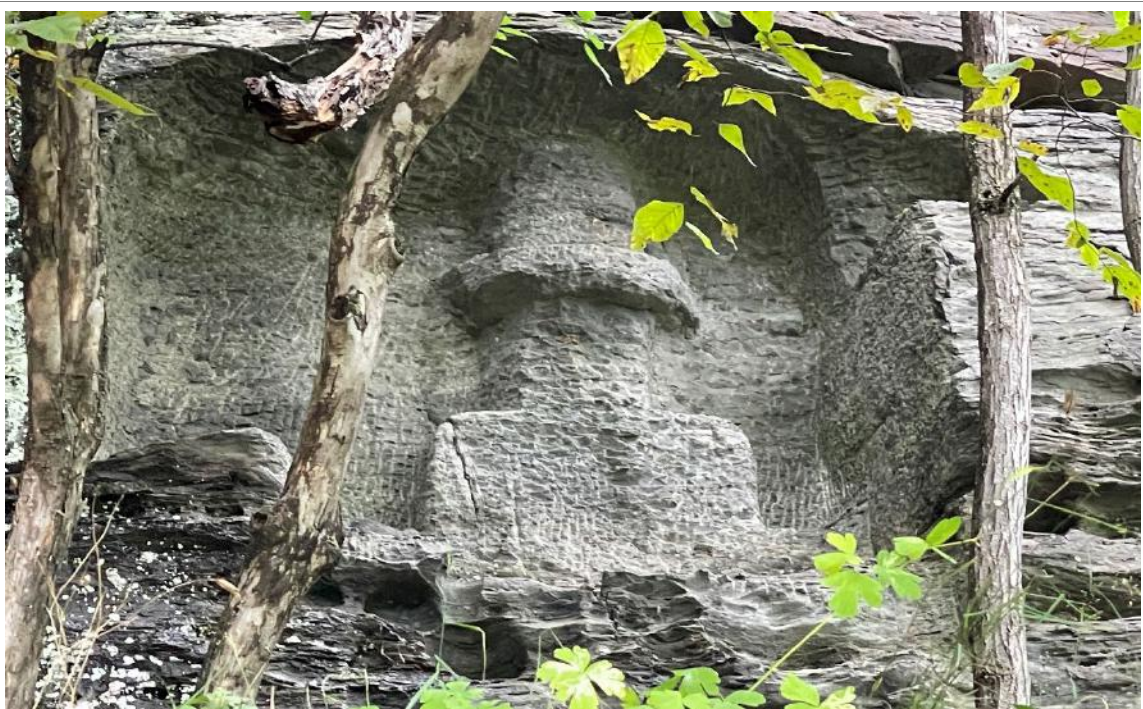
**Figure 11: Unnamed Sculpture 2**

*This sculpture is offset to the right of the main outcropping and is undetermined as to the original design intent and whether it was left unfinished.*

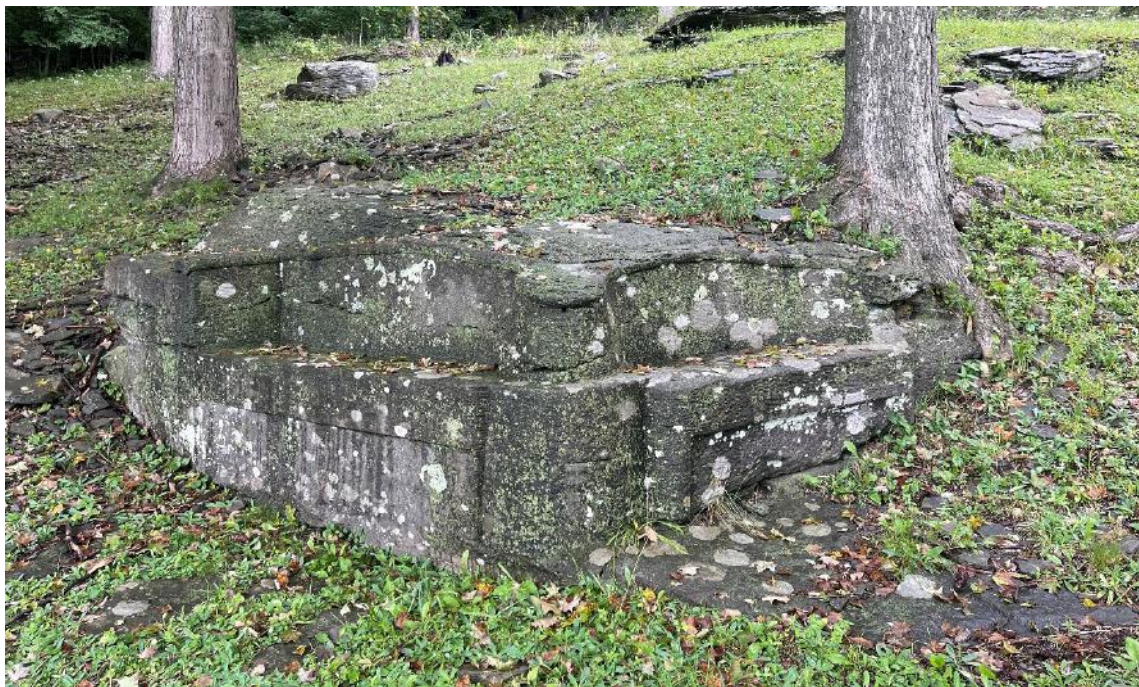
**Figure 13: Bench "B"**

*Note the encroaching tree adjacent.*

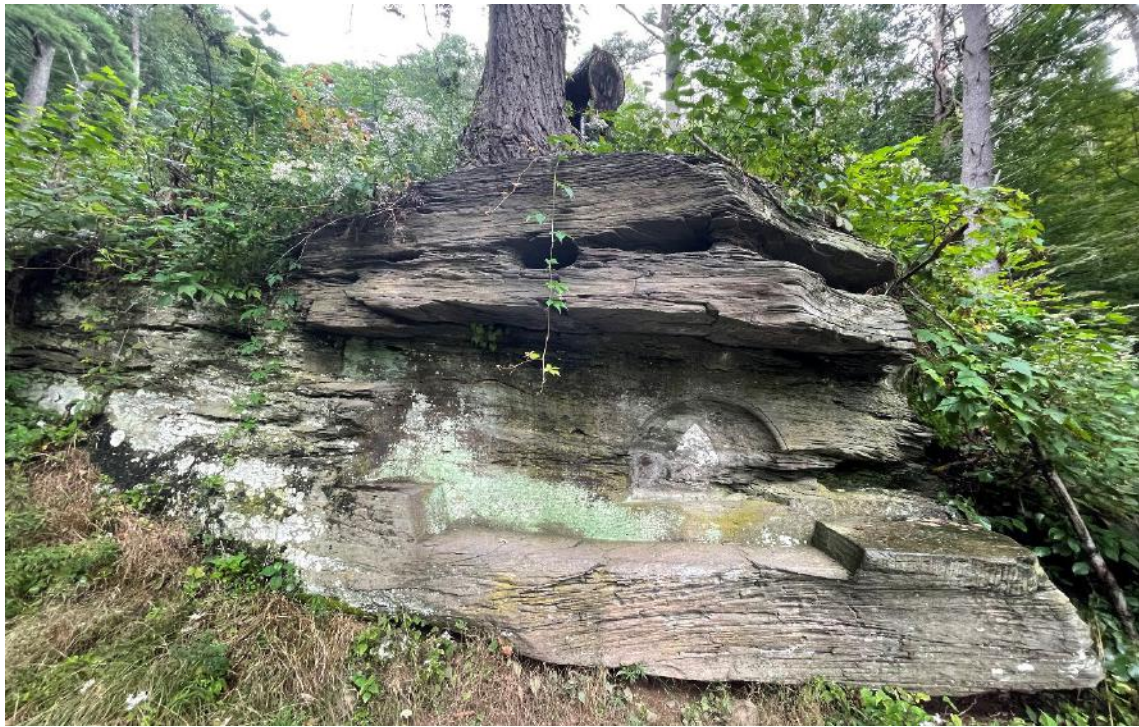
**Figure 14: Bench "C"**

*Note the small niche and hemlock tree carving at the backrest of the bench. Also note the extensive soil erosion and encroaching tree atop the feature.*

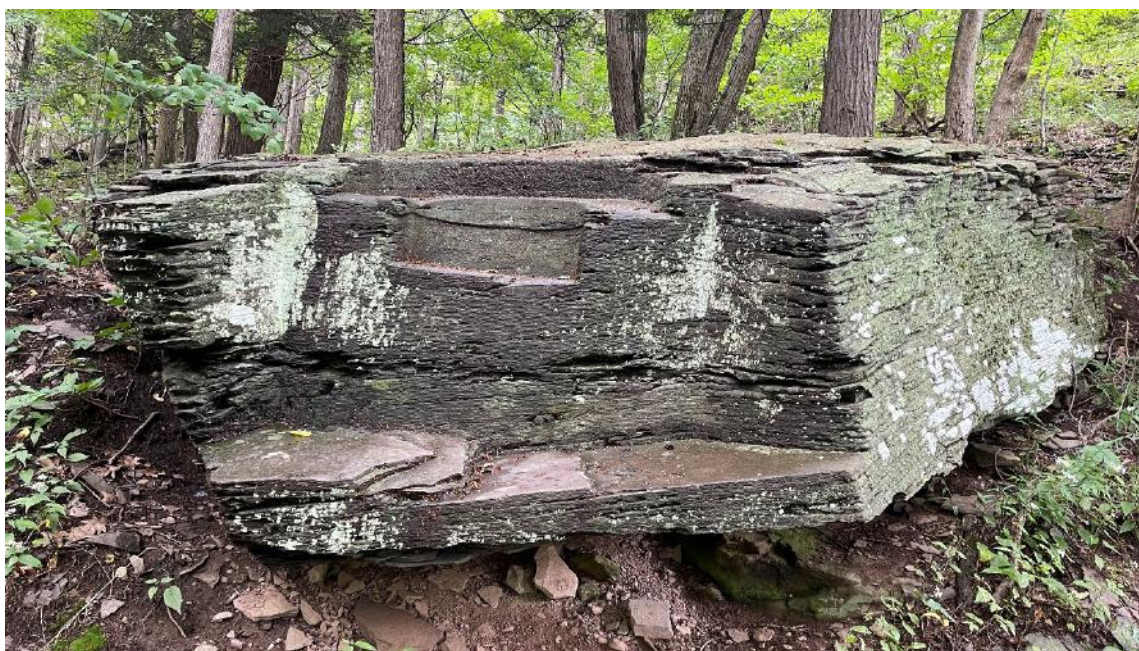
**Figure 15: Bench "D"**

*Note the extensive soil erosion beneath the feature.*

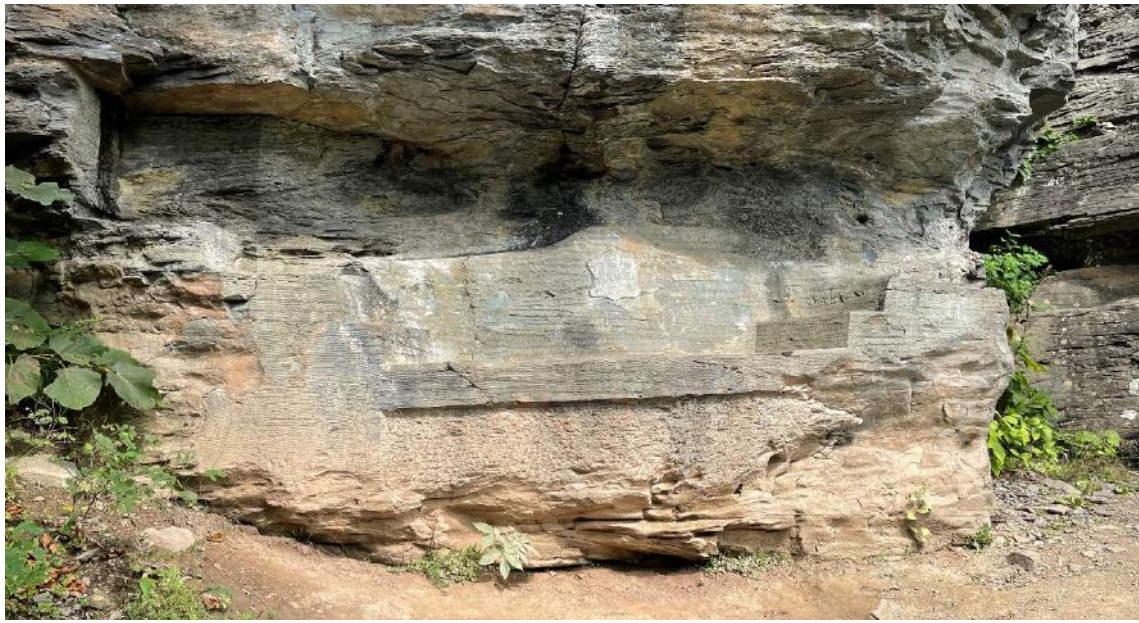
**Figure 16: Bench "E"**

*Note the low-relief sculptural crest/shield at the center of the bench. Also note the extensive soil erosion beneath the feature.*

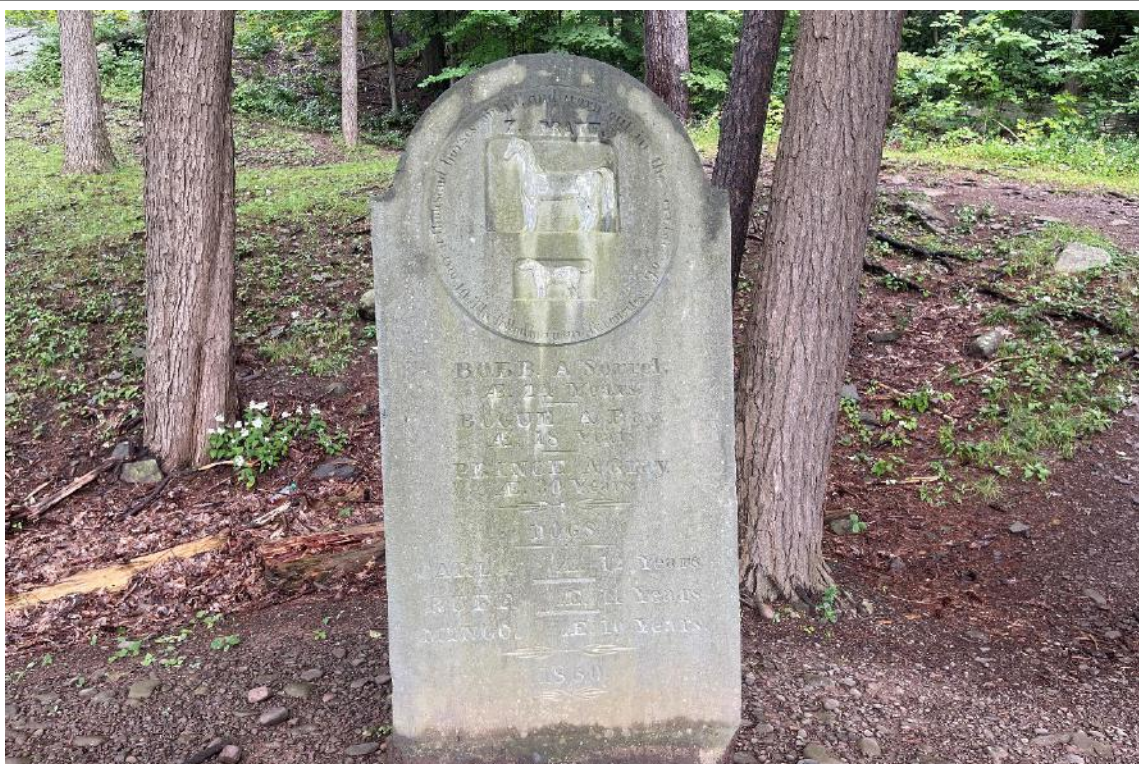
**Figure 17: Gravestone**

*Note the encroaching trees around the monument.*

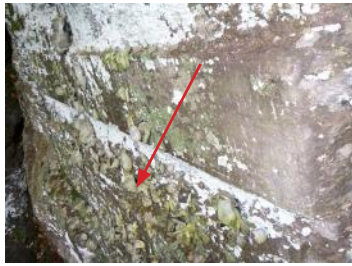
<p><b>Biological Soiling</b></p> <p>Locations at stone carvings of surface growth and/or discoloration indicative of biological colonization from microflora, including fungi, moss, lichen, algae, and bacteria.</p>	<p>A. Remove dense biological growth by hand and treat residual soiling with chemical product and pressurized water rinsing.</p> <p>B. Implement a biological growth inhibitor misting program.</p> <p>Note: Further testing is required to determine feasibility of removal with a chemical product.</p>

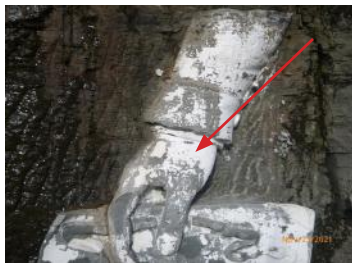
<p><b>Coating, Failed</b></p> <p>Previous coating intervention at stone carvings exhibiting loss, loose material, and/or cracks.</p>	<p>A. Remove previous finish and apply new coating, compatible with the existing stone properties and original aesthetic intent.</p> <p>Note: Further testing is required to determine feasibility of finishes removal via chemical product and an appropriate new coating.</p>

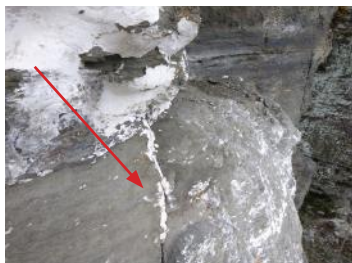
<p><b>Crack Repair, Failed</b></p> <p>Previous crack repairs at stone carvings exhibiting edge separation, loss, loose material, and/or cracks.</p>	<p>A. Remove previous repair and fill void with cementitious patching material to match the adjacent stone.</p>

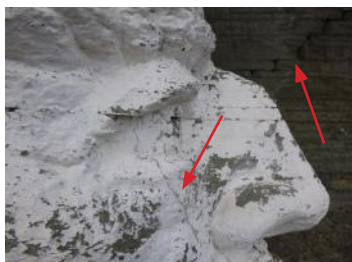
<p><b>Crack System</b></p> <p>Small to moderately sized fractures or fissures in the sculptures or adjacent stone.</p>	<p>A. Remove loose material, prepare crack, and fill with grout or cementitious patching material as appropriate to match the adjacent stone.</p>

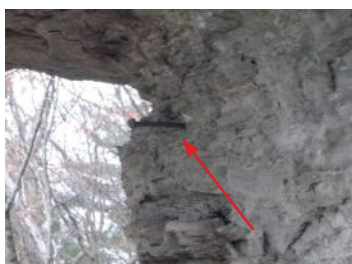
<p><b>Embedment, Ferrous</b></p> <p>Ferrous fasteners, fixtures, or nails embedded in the stone that are no longer in service.</p>	<p>A. Remove existing ferrous embedment and fill resulting hole with cementitious patching material matching the adjacent stone.</p>

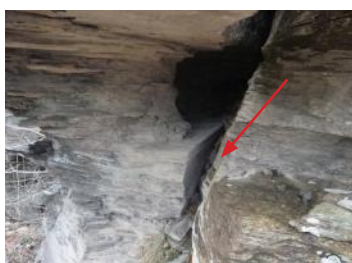
<p><b>Fissures, Large</b></p> <p>Large stone cracks, fissures, and/or voids resulting from geological and environmental forces.</p>	<p>A. ICR recommends coordination with a specialized project team, including a geologist and structural engineer, to determine outcropping stability and potential scope.</p>

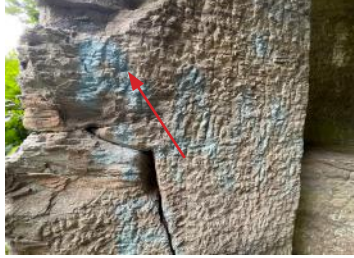
<p><b>Graffiti, Painted</b></p> <p>Locations of painted graffiti on stone surface.</p>	<p>A. Remove painted graffiti with chemical product and pressurized water rinsing.</p> <p>Note: Further testing is required to determine feasibility of removal with chemical products.</p>

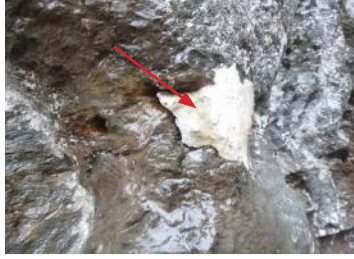
<p><b>Repair Patch, Failed</b></p> <p>Previous repairs at stone carvings exhibiting edge separation, loss, loose material, and/or cracks.</p>	<p>A. Remove previous repair and fill void with cementitious patching material to match the adjacent stone.</p>

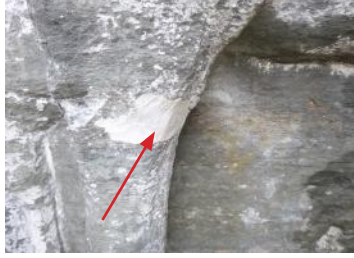
<p><b>Repair Patch, Sound</b></p> <p>Aesthetically incompatible but sound previous repair at stone carvings.</p>	<p>A. No further action.</p> <p>B. Remove previous repair and fill void with cementitious patching material to match the adjacent stone.</p>

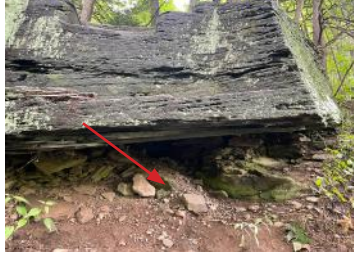
<p><b>Soil Erosion</b></p> <p>The loss of topsoil to wind, rain, or other environmental forces.</p>	<p>A. ICR recommends coordination with the specialized project team to determine scope.</p>

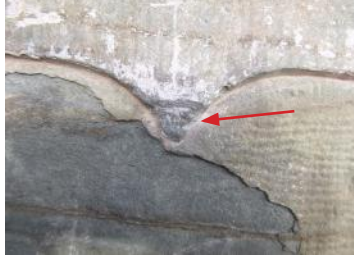
<p><b>Surface Loss, Chipped</b></p> <p>Small and shallow carved stone surface loss characterized by loss in form, profile, or ornament.</p>	<p>A. No further action.</p>

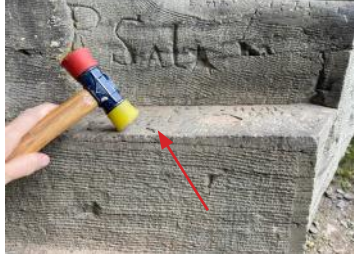
<p><b>Surface Loss, Delaminated</b></p> <p>Planar detachment and loss parallel to the carved stone surface, where sounding techniques indicate loose portions of stone.</p>	<p>A. No further action.</p> <p>B. Mechanically tool to remove loose material and finish to shed water.</p> <p>C. Stabilize delaminated portions of stone to minimize loss.</p> <p>Note: Further testing is required to determine feasibility of stabilization treatment.</p>

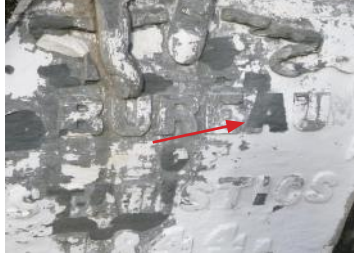
<p><b>Surface Loss, Eroded</b></p> <p>Carved stone surface deterioration and loss due to environmental forces characterized by loss in form, profile, or ornament.</p>	<p>A. No further action.</p>

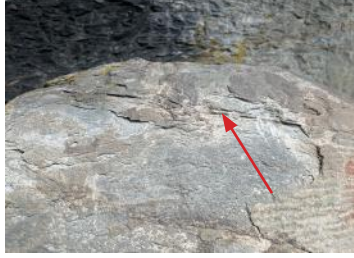
<p><b>Surface Loss, Exfoliated</b></p> <p>Surface deterioration and loss characterized by fine networks of planar detachment parallel to the carved stone surface.</p>	<p>A. No further action.</p> <p>B. Mechanically tool to remove loose material and finish to shed water.</p> <p>C. Stabilize exfoliated portions of stone to minimize loss.</p> <p>Note: Further testing is required to determine feasibility of stabilization treatment.</p>

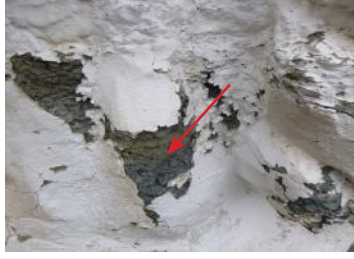
<p><b>Surface Loss, Friable</b></p> <p>Surface deterioration and loss characterized by the disaggregation of carved stone into loose particles.</p>	<p>A. No further action.</p> <p>B. Mechanically tool to remove loose material and finish to shed water.</p> <p>C. Stabilize friable portions of stone to minimize loss.</p> <p>Note: Further testing is required to determine feasibility of stabilization treatment.</p>

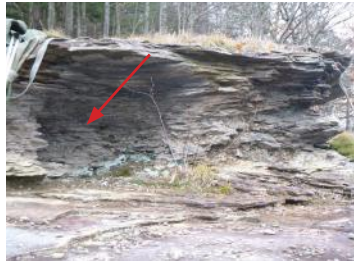
<p><b>Undermined Stone</b> Erosion of stone, limiting the support of material above.</p>	<p>A. ICR recommends coordination with a specialized project team, including a geologist and structural engineer, to determine outcropping stability and potential scope.</p>

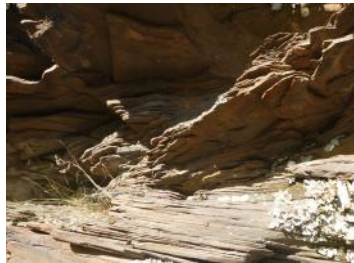
<p><b>Unsecured, Loose Bedding Plane</b> Loose separation of layers of stratified stone from its preceding or subsequent depositional plane layer.</p>	<p>A. ICR recommends coordination with a specialized project team, including a geologist and structural engineer, to determine outcropping stability and potential scope.</p>

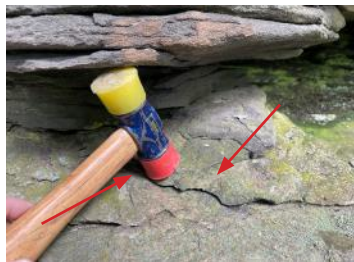
<p><b>Unsecured, Loose or Removed Stone</b> Locations where sounding techniques indicate detached portions of stone.</p>	<p>A. Mechanically remove loose material to a sound surface.</p>

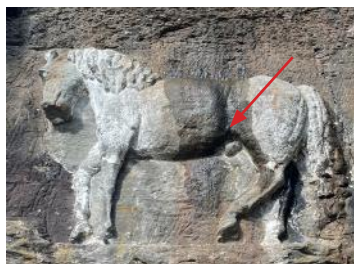
<p><b>Water Seepage</b> Water infiltration from runoff or groundwater migration onto carved stone surfaces causing deterioration and/or staining.</p>	<p>A. ICR recommends coordination with the specialized project team to determine scope.</p>

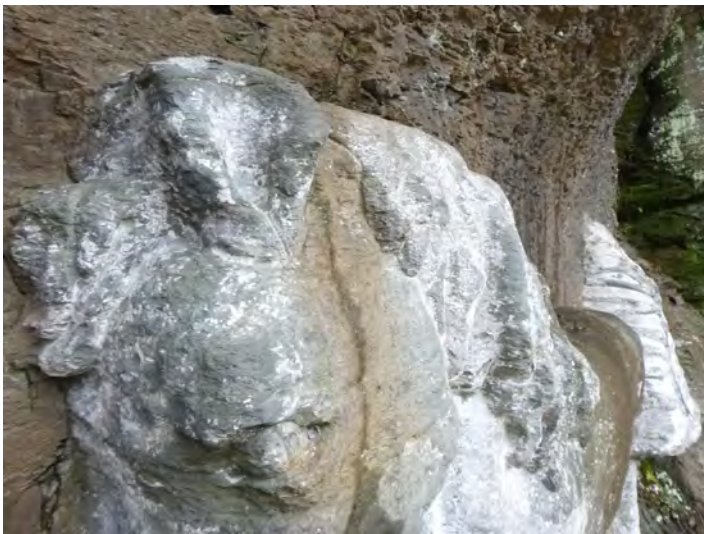
0-13 Stone\_Note Photo-water seepage 2021-3

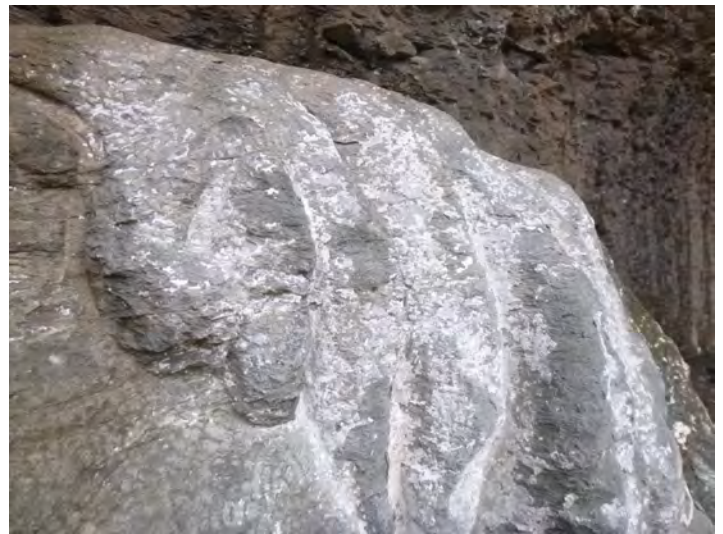
0-13 Stone\_SurfLoss Eroded 2021-1

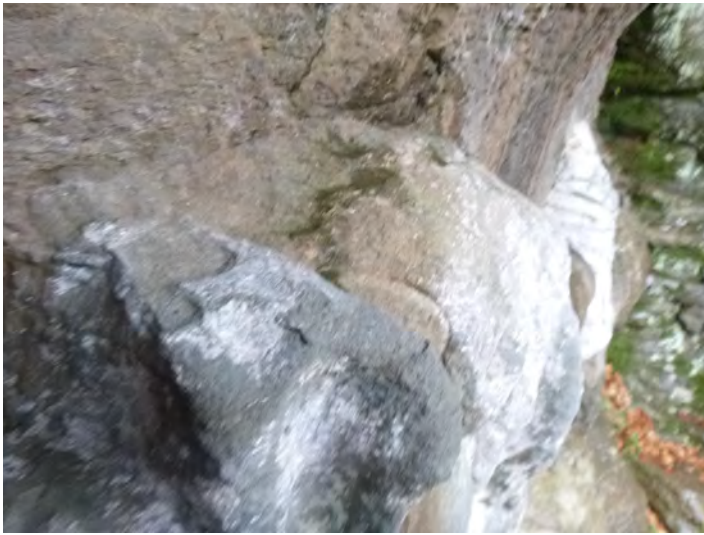
0-13 Stone\_SurfLoss Eroded 2021-2

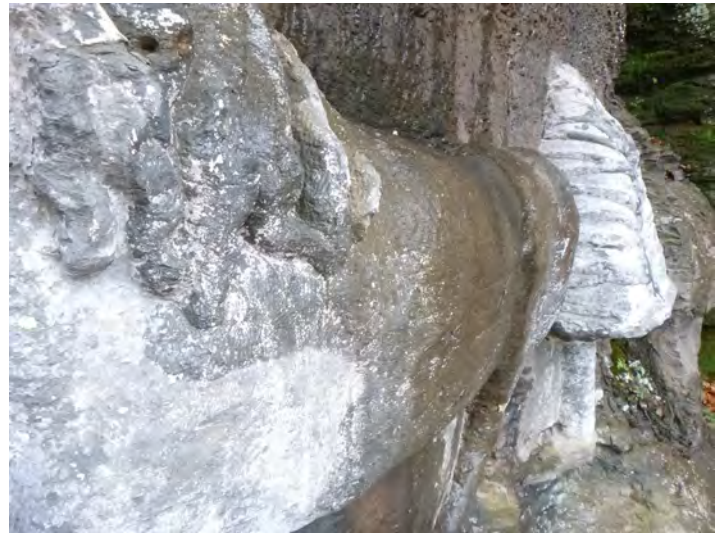
0-13 Stone\_SurfLoss Eroded 2021-3

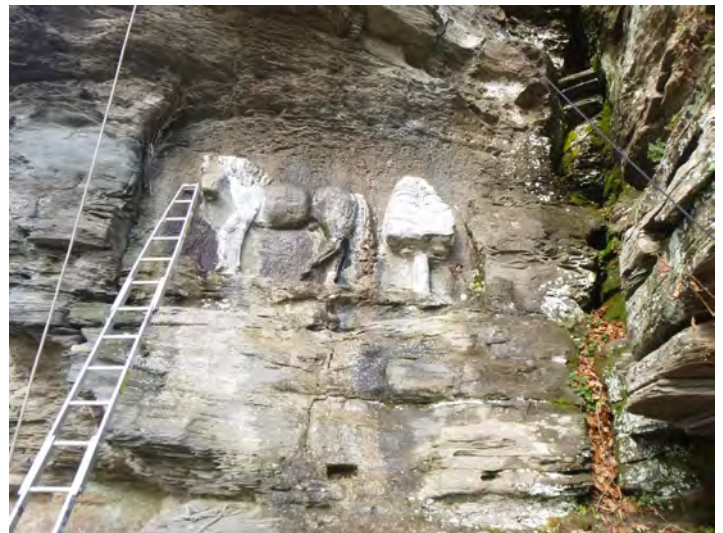
0-13 Stone\_SurfLoss Eroded 2021-5

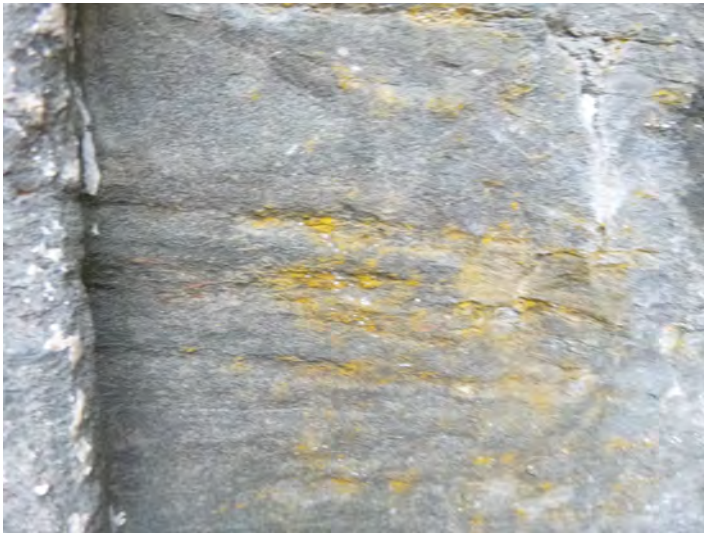
1-11 Stone\_SoilStain Biological 2021-1

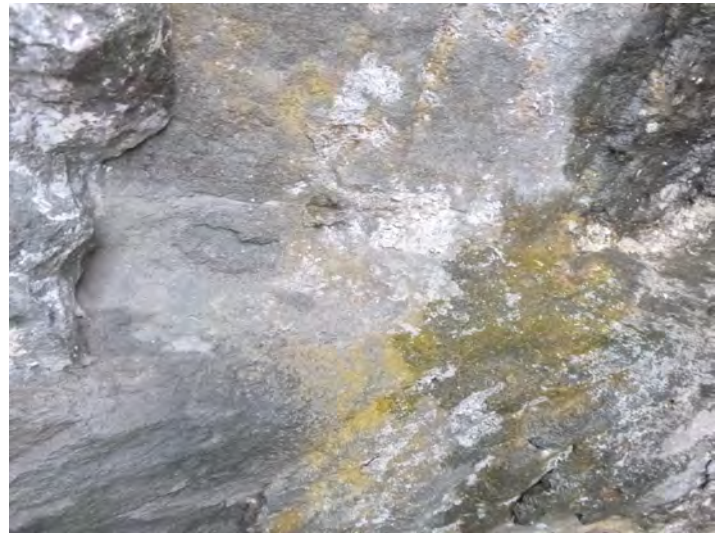
1-11 Stone\_SoilStain Biological 2021-2

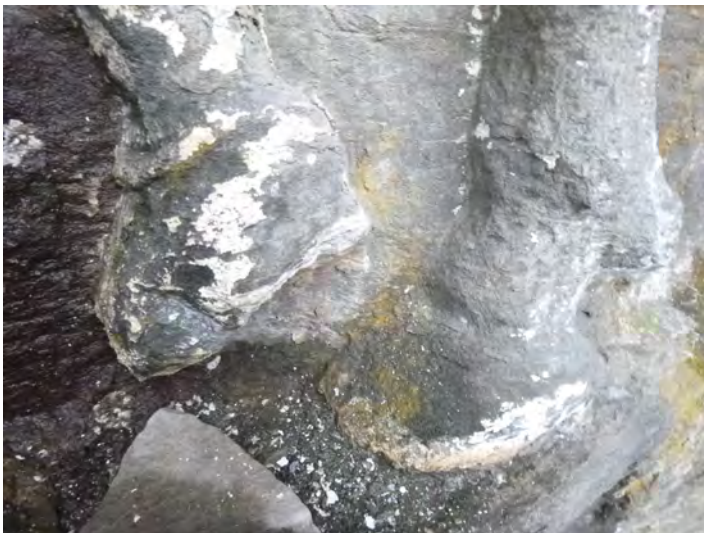
1-11 Stone\_SoilStain Biological 2021-3

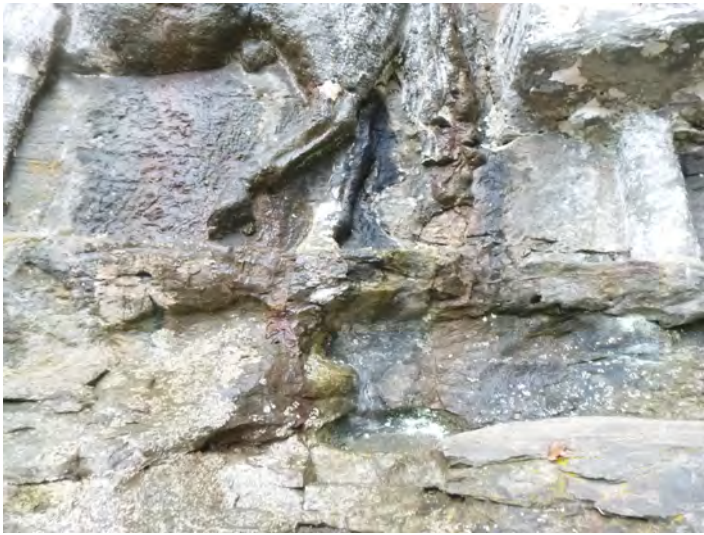
1-15 Stone\_Note Photo-water seepage 2021-4

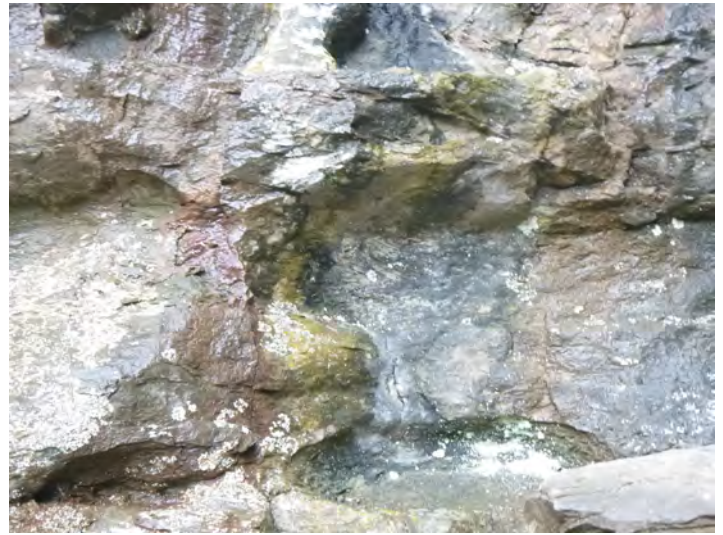
2-10 Stone\_SoilStain Biological 2021-1

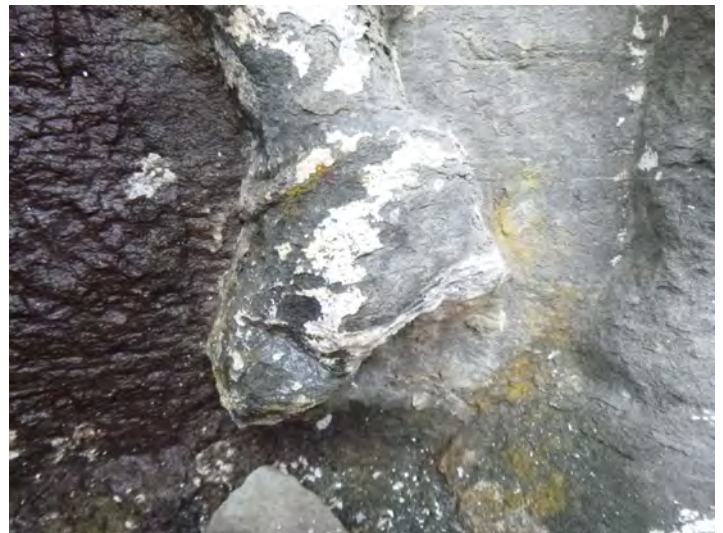
2-11 Stone\_Crack System units 2021-1

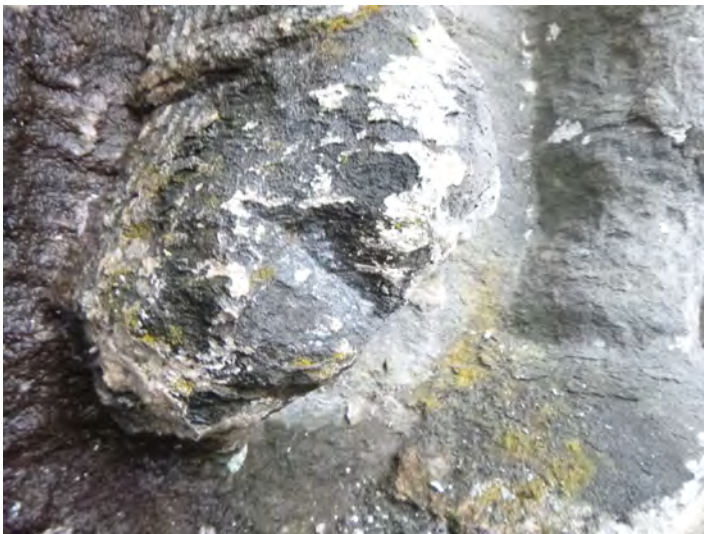
2-11 Stone\_Spall Missing 2021-1

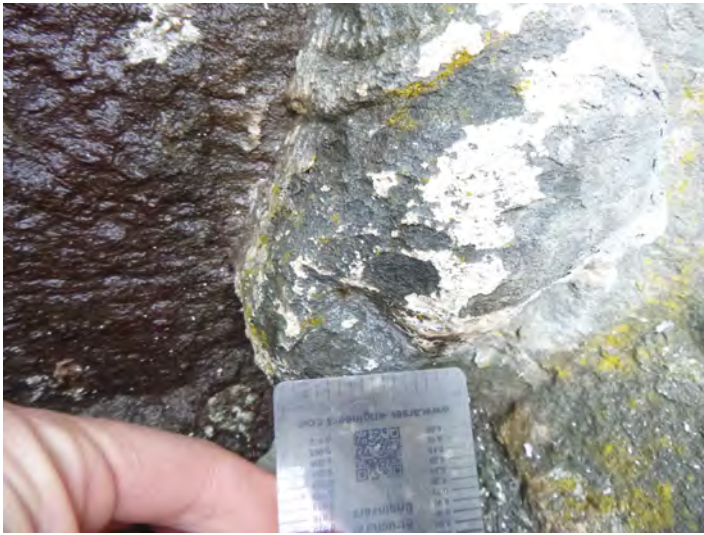
2-11 Stone\_Spall Missing 2021-3

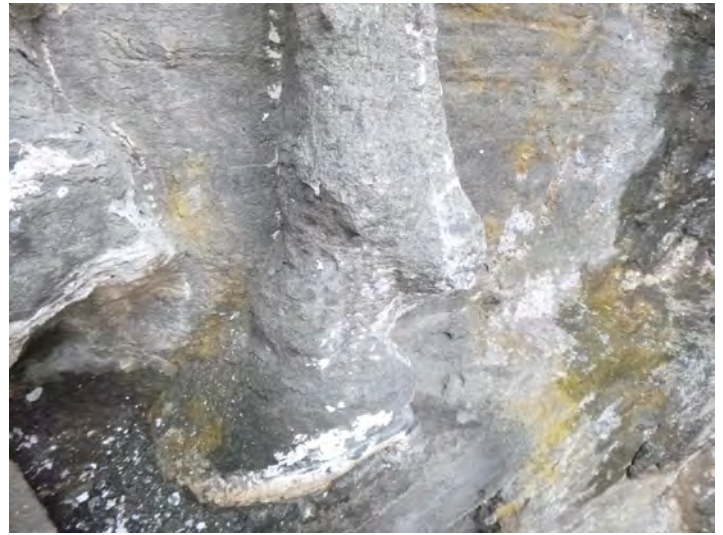
2-11 Stone\_Spall Missing 2021-4

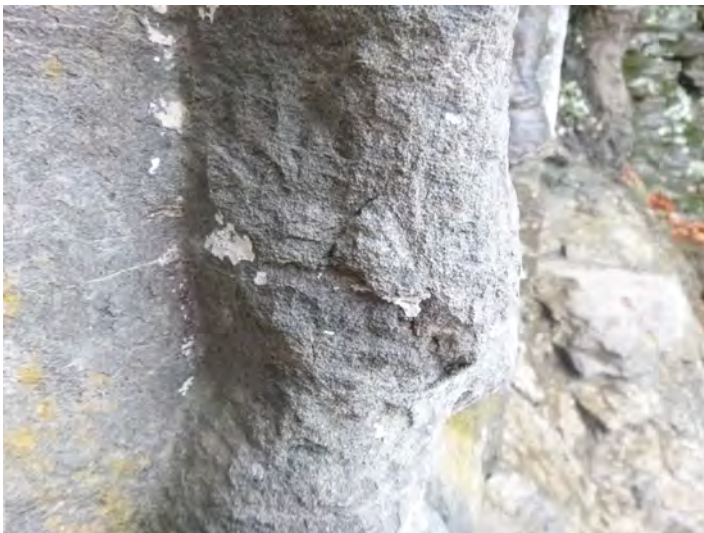
2-11 Stone\_SurfLoss Exfoliated 2021-1

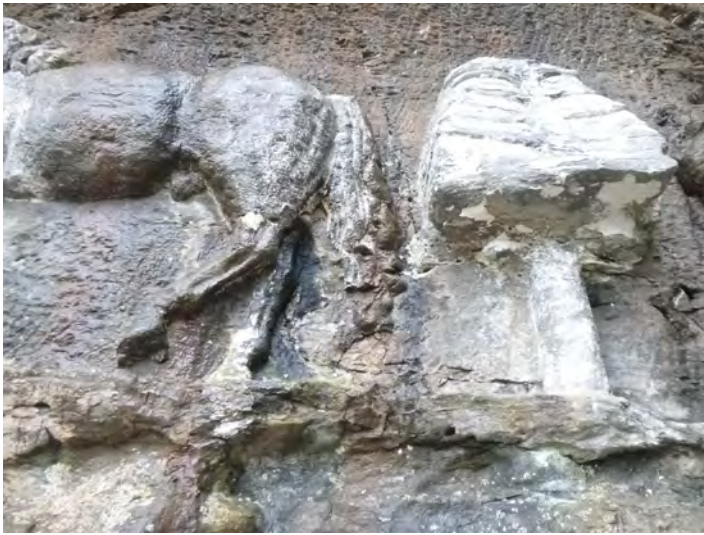
2-12 Stone\_Note Photo-water seepage 2021-2

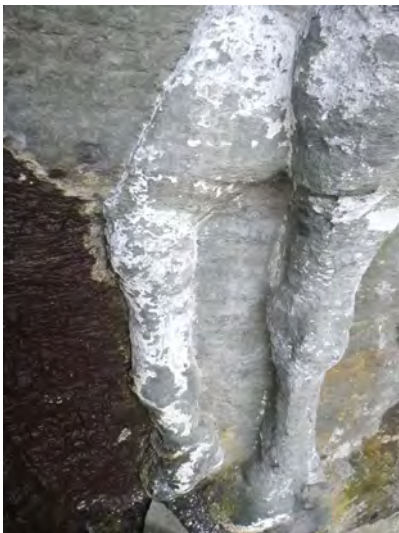
2-12 Stone\_Spall Missing 2021-2

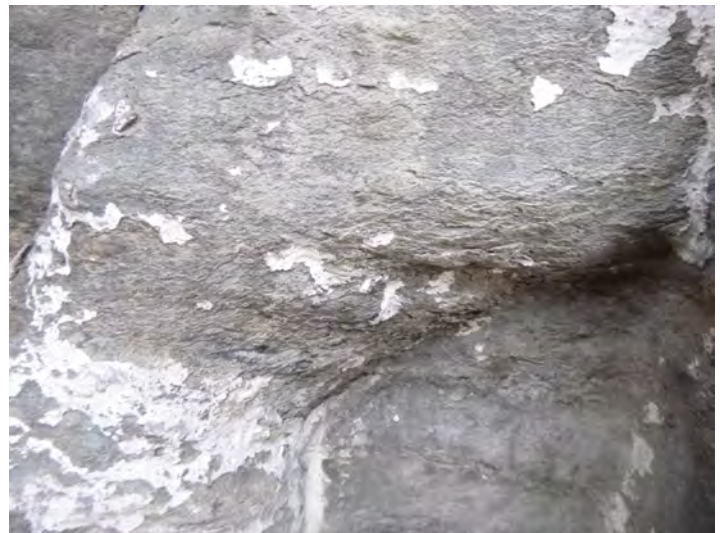
2-12 Stone\_SurfLoss Exfoliated 2021-1

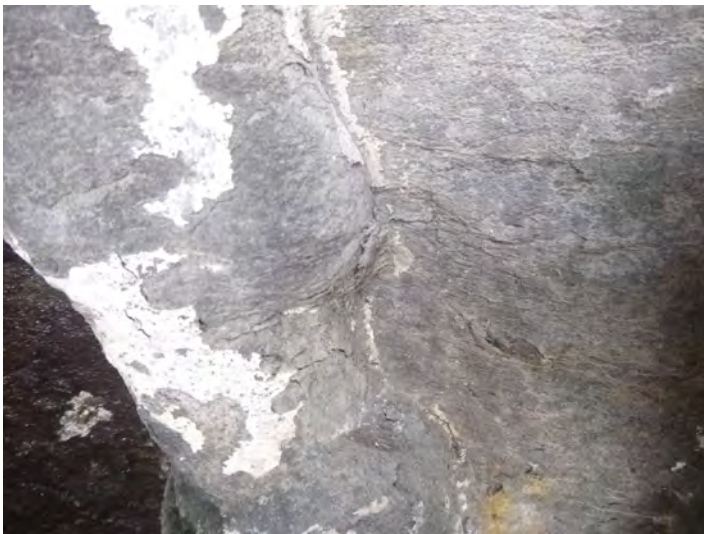
2-12 Stone\_SurfLoss Exfoliated 2021-2

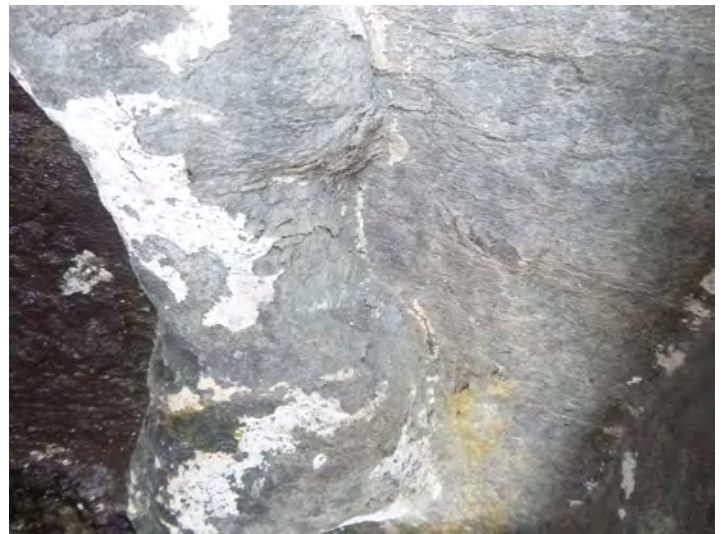
2-12 Stone\_SurfLoss Exfoliated 2021-3

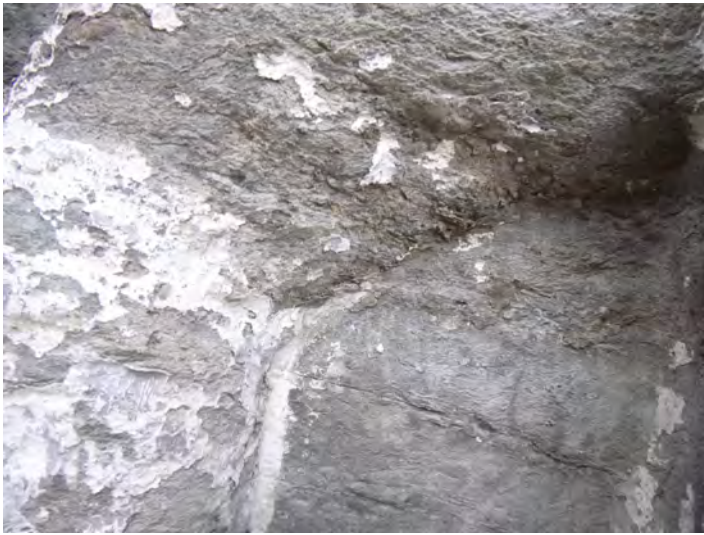
2-12 Stone\_SurfLoss Exfoliated 2021-4

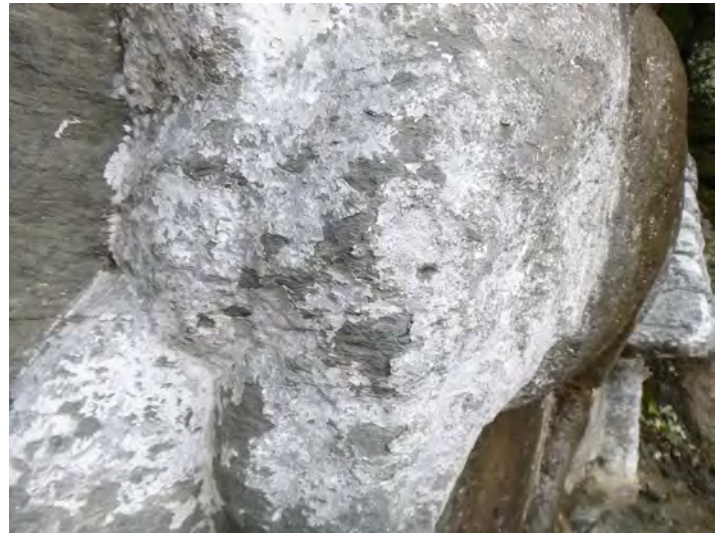
2-12 Stone\_SurfLoss Exfoliated 2021-5

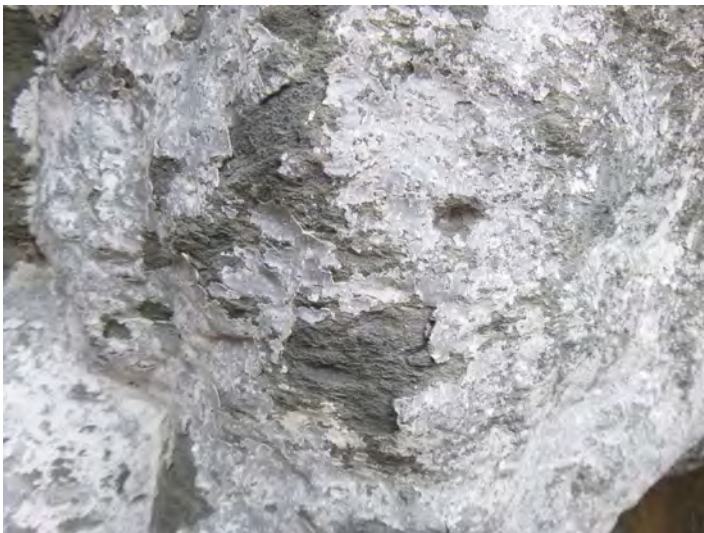
2-13 Stone\_SurfLoss Exfoliated 2021-1

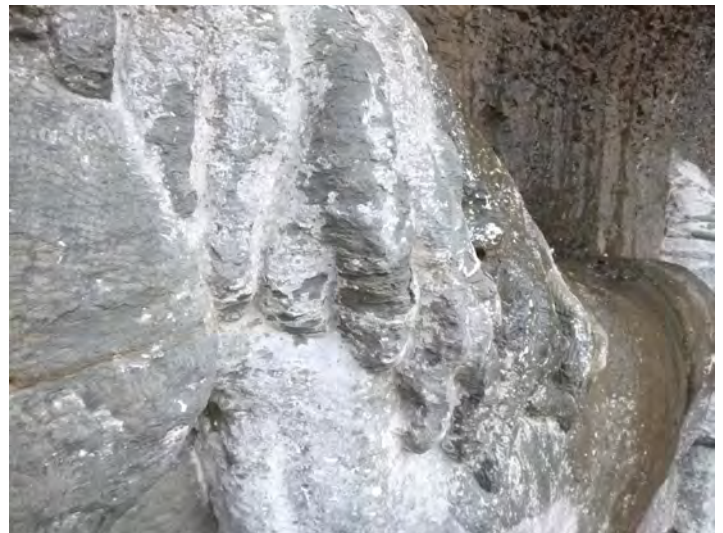
2-13 Stone\_SurfLoss Exfoliated 2021-2

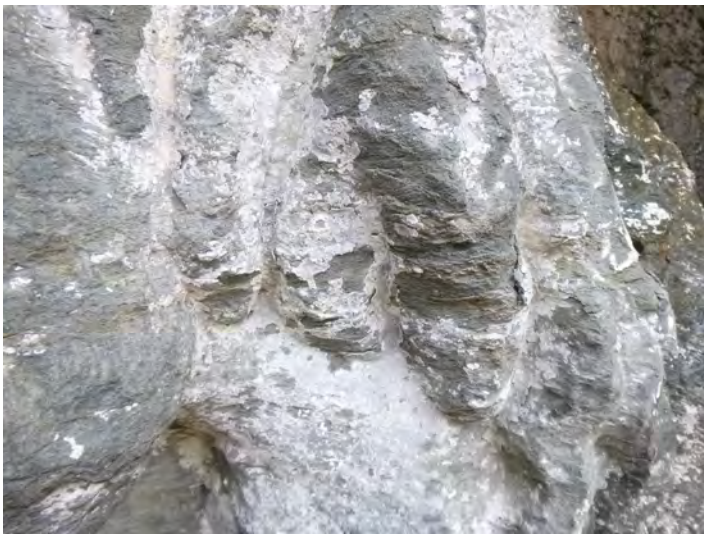
2-14 Stone\_SurfLoss Exfoliated 2021-1

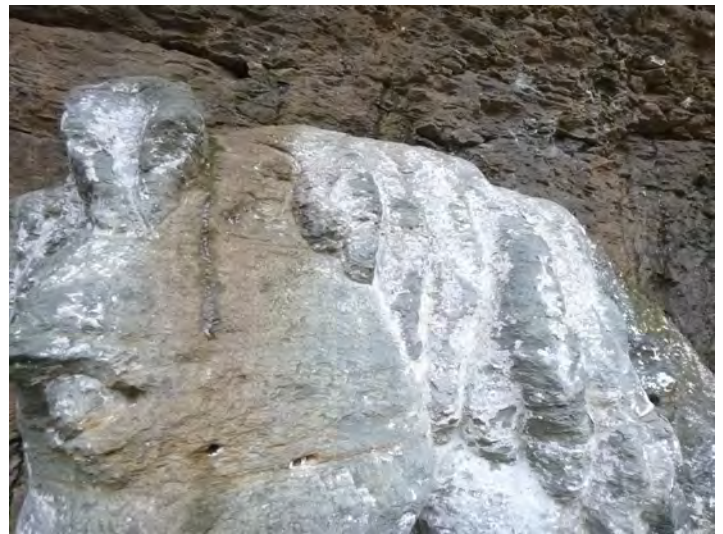
2-14 Stone\_SurfLoss Exfoliated 2021-2

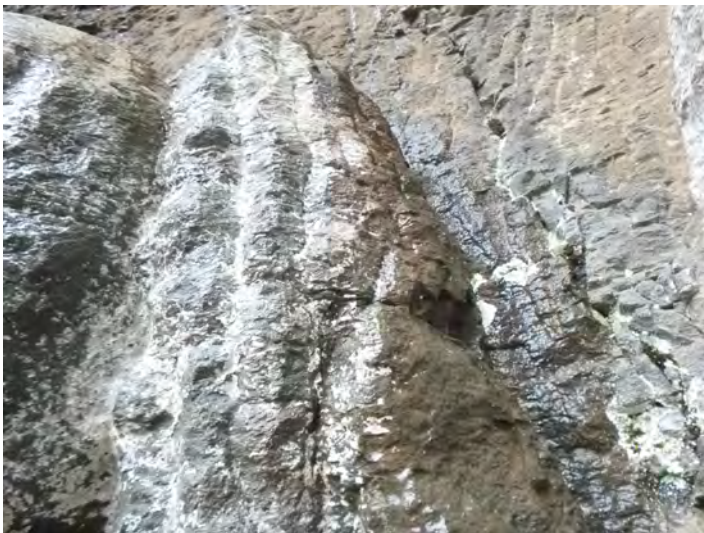
3-13 Stone\_Note Photo-water seepage 2021-3

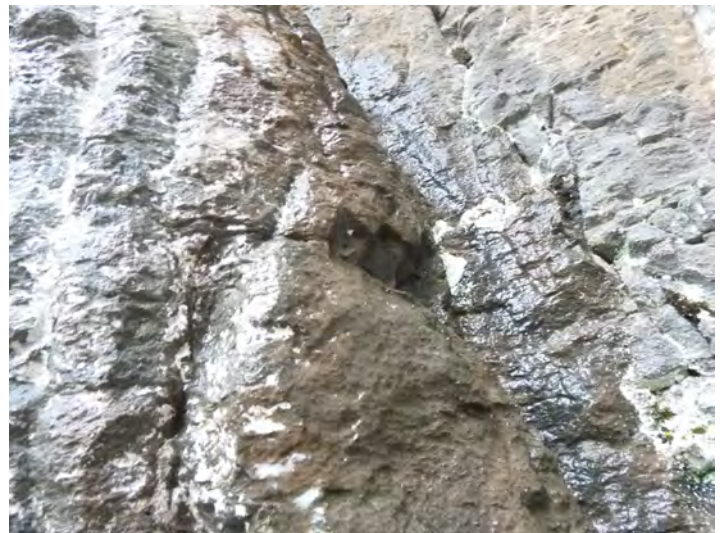
3-13 Stone\_Spall Missing 2021-1

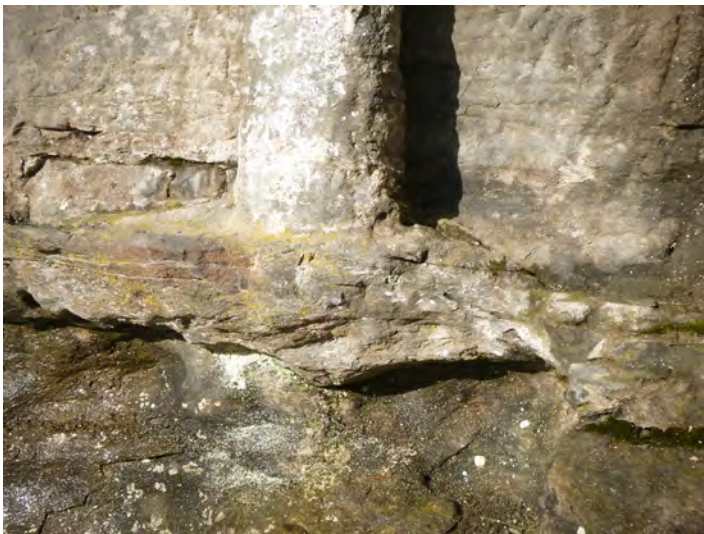
3-13 Stone\_Spall Missing 2021-2

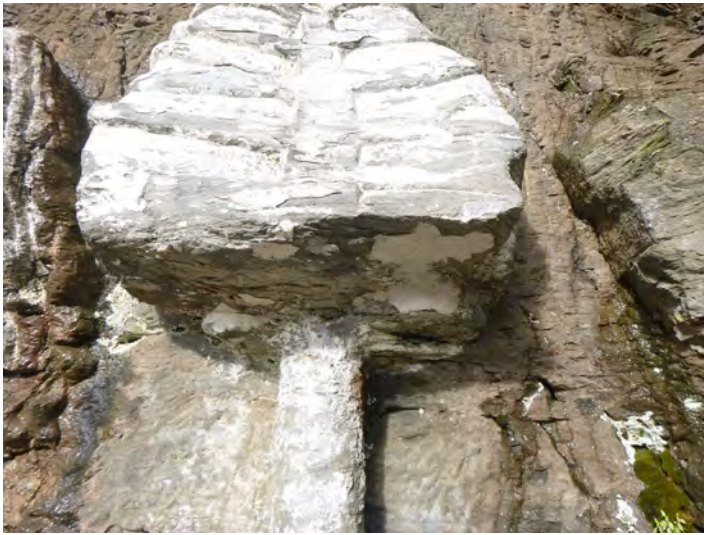
4-11 Stone\_Crack System units 2021-1

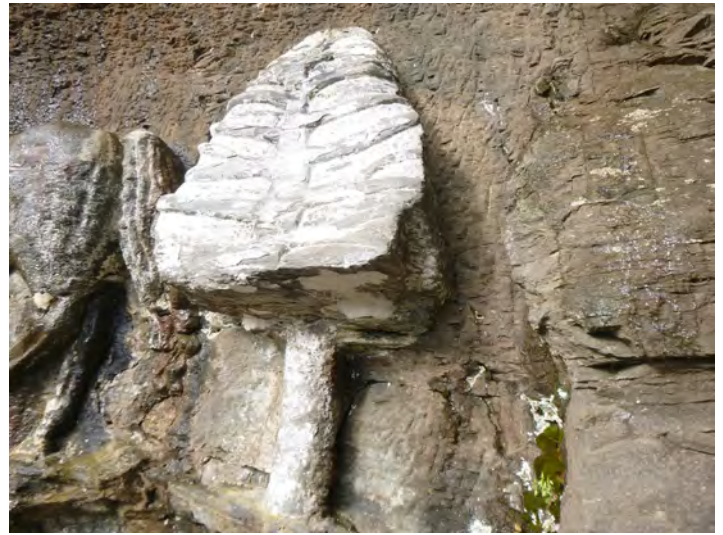
4-13 Stone\_Coating Coating Failed 2021-6

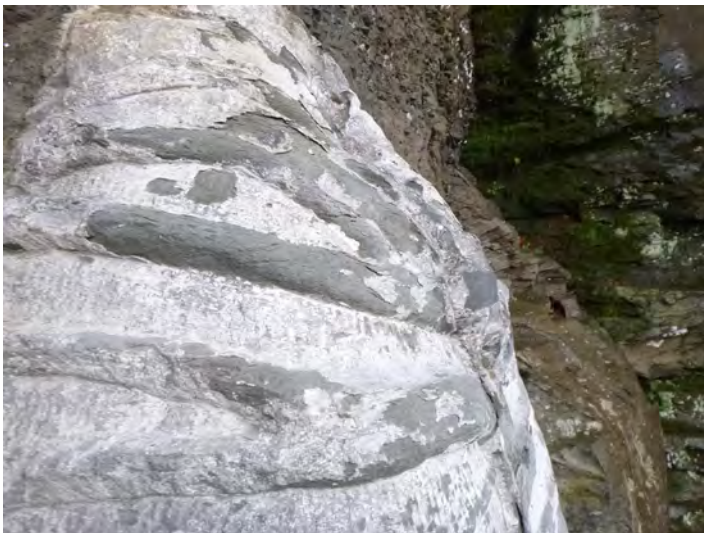
4-13 Stone\_SurfLoss Eroded 2021-1

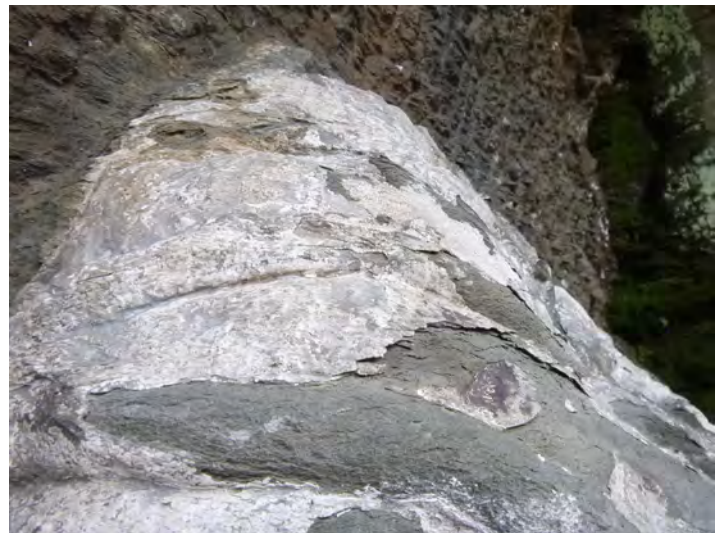
4-13 Stone\_SurfLoss Exfoliated 2021-1

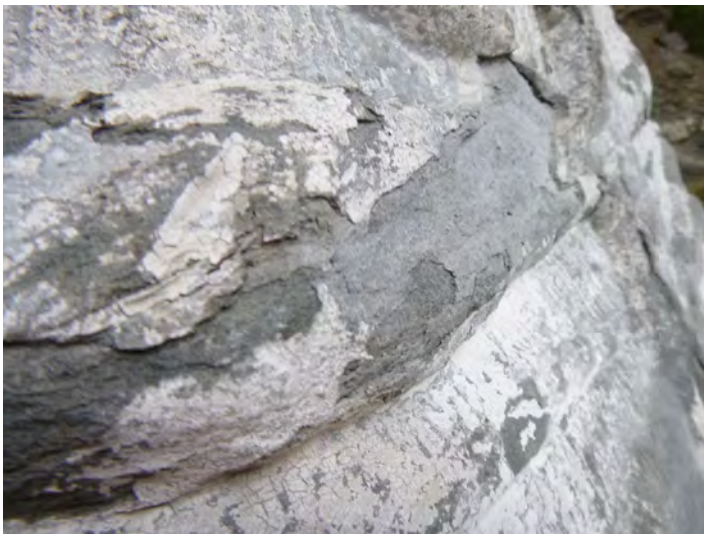
4-13 Stone\_SurfLoss Exfoliated 2021-2

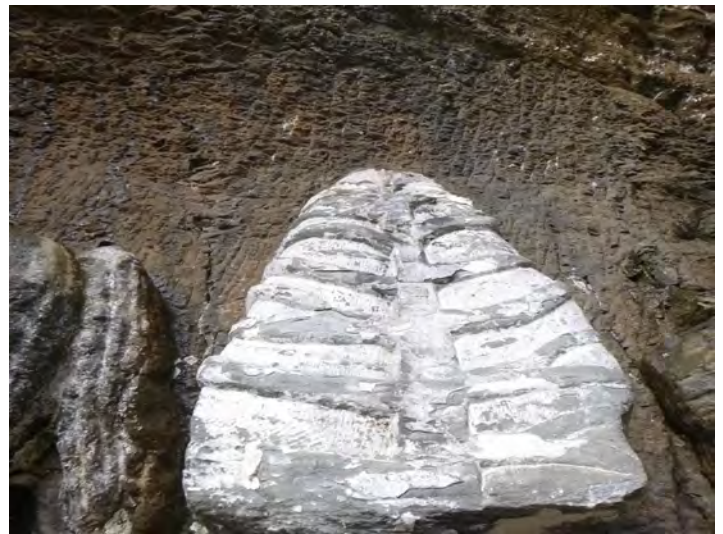
4-13 Stone\_SurfLoss Exfoliated 2021-3

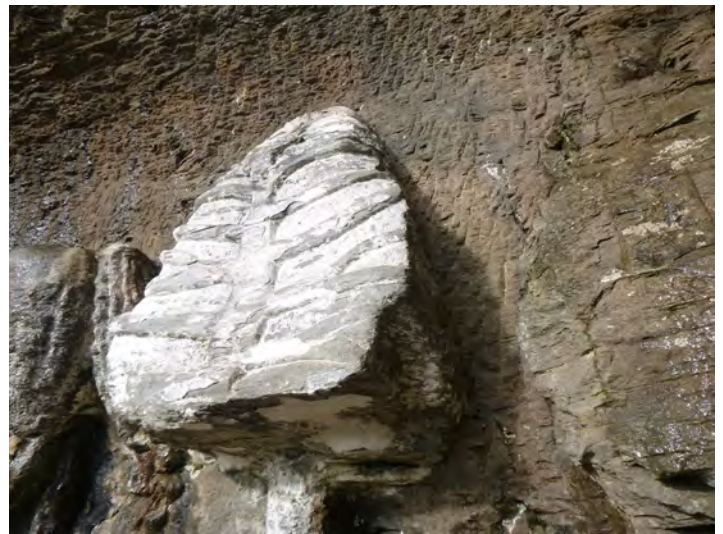
5-11 Stone\_Note Photo-water seepage 2021-2
