## **PRATT ROCK PARK**

Phase 1: Initial Needs Assessment  
Pratt Rock Park, Prattsville, New York

prepared for:  
Pratt Park Committee  
Prattsville, New York

April 18, 2022

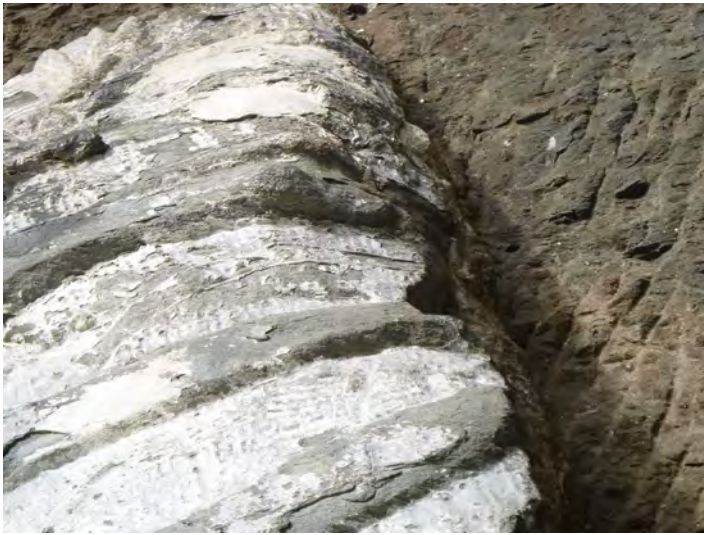
5-14 Stone\_Spall Missing 2021-1

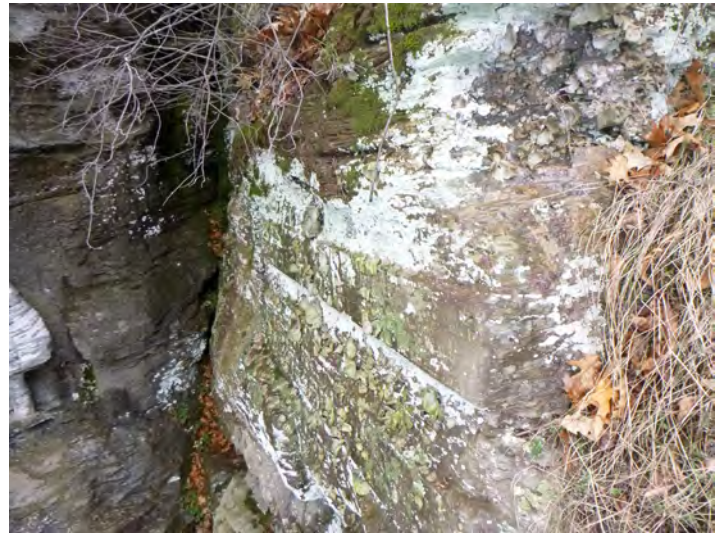
5-14 Stone\_Spall Missing 2021-2

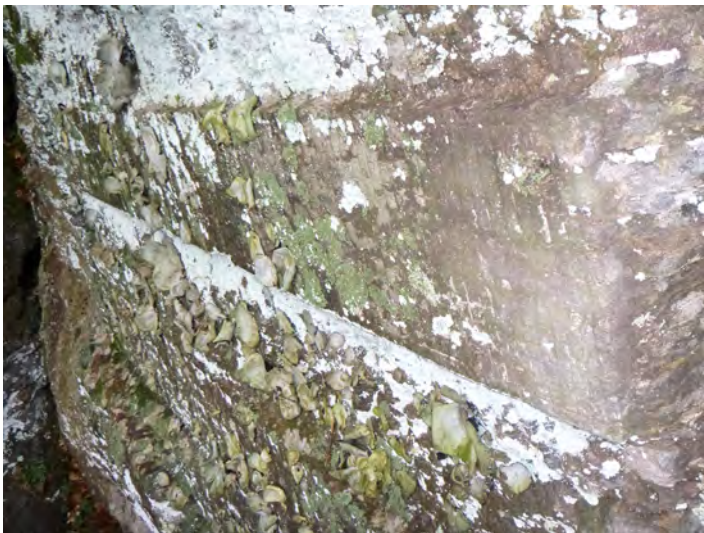
6-19 Stone\_SoilStain Biological 2021-1

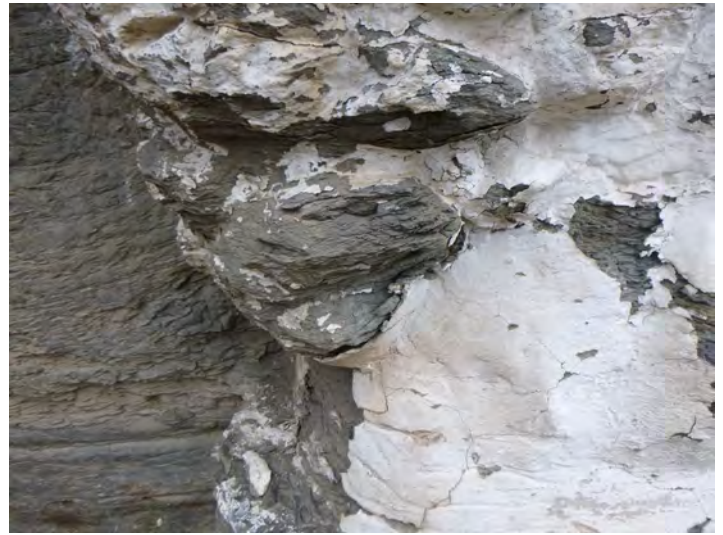
12-18 Stone\_Coating Coating Failed 2021-4

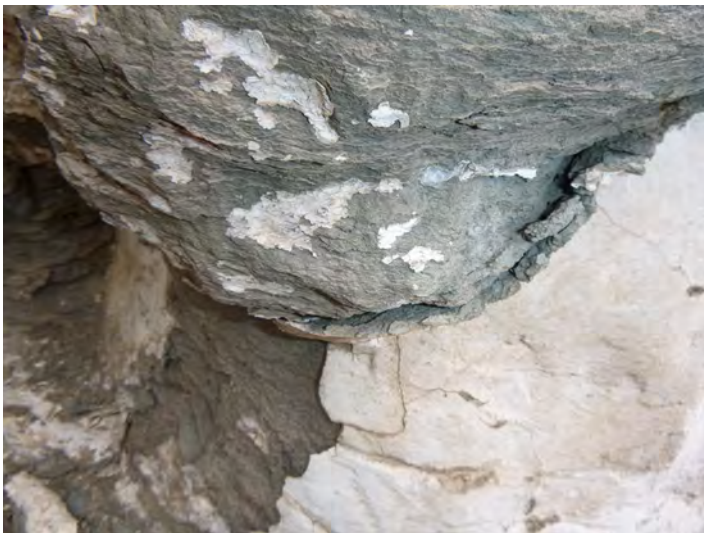
12-21 Stone\_SurfLoss Friable 2021-1

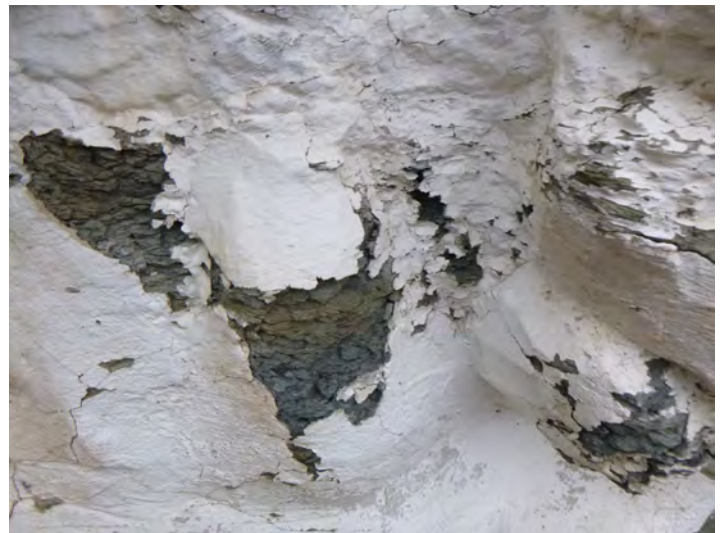
12-21 Stone\_SurfLoss Friable 2021-2

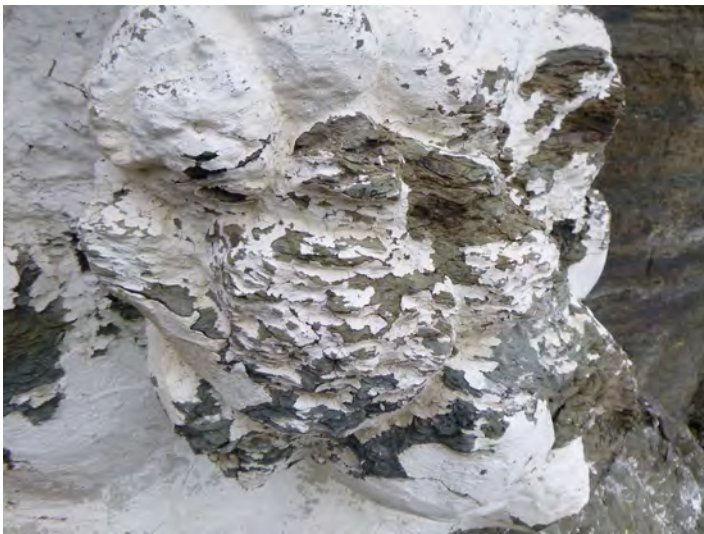
12-21 Stone\_SurfLoss Friable 2021-3

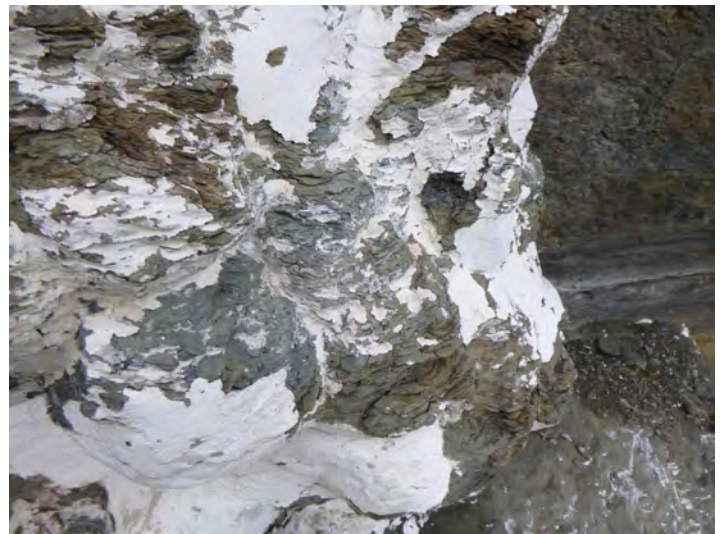
12-21 Stone\_SurfLoss Friable 2021-4

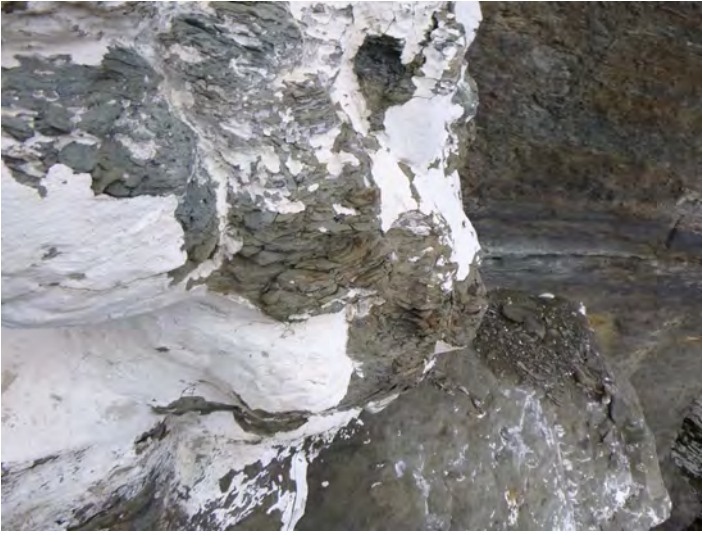
12-21 Stone\_SurfLoss Friable 2021-5

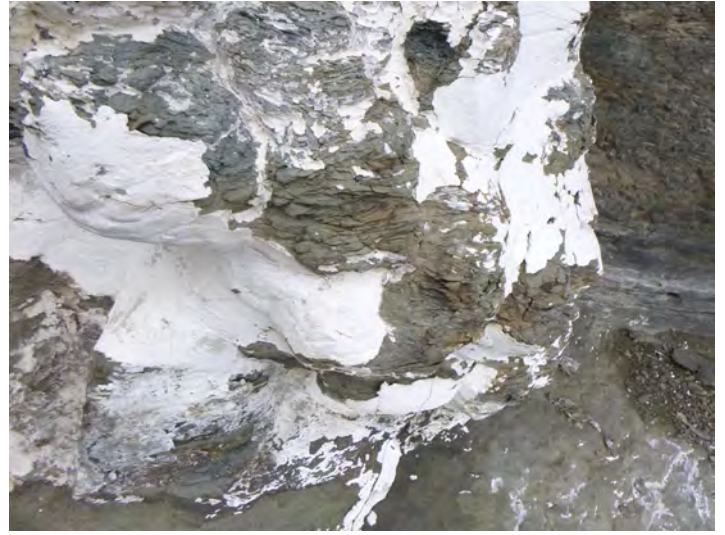
12-21 Stone\_SurfLoss Friable 2021-6

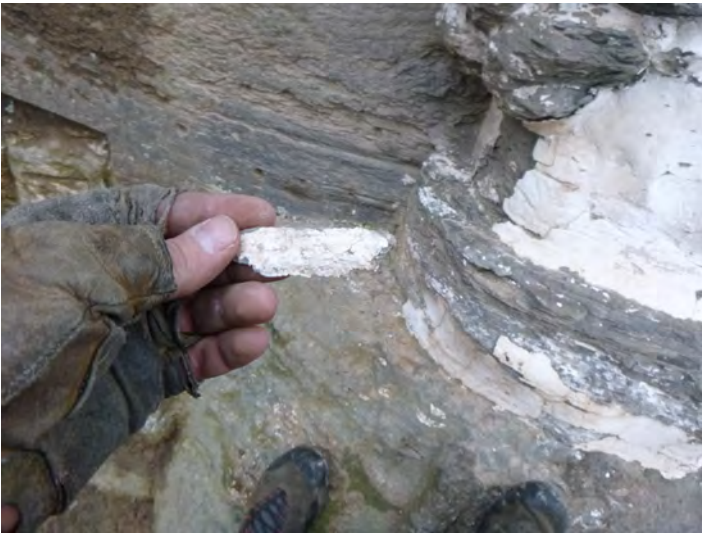
12-21 Stone\_SurfLoss Friable 2021-7

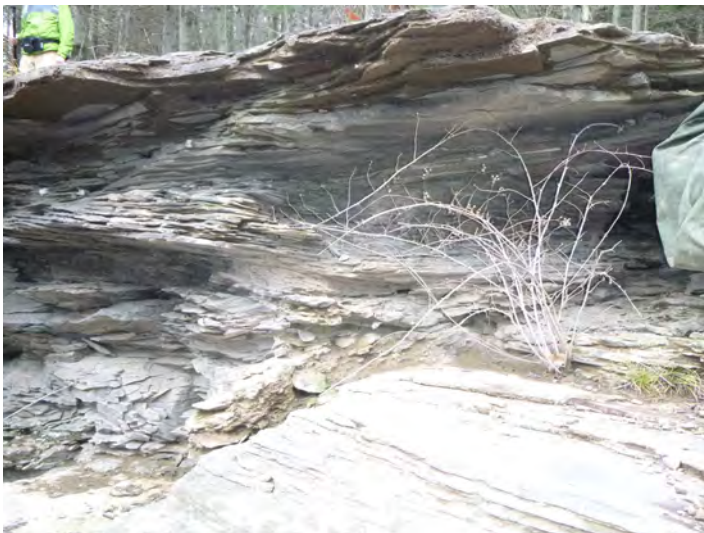
13-23 Stone\_Crack Single unit 2021-1

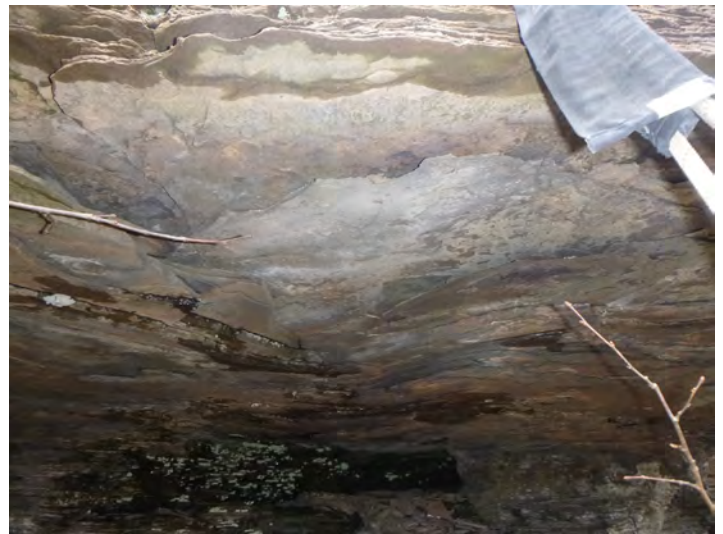
15-19 Stone\_Crack Single unit 2021-1

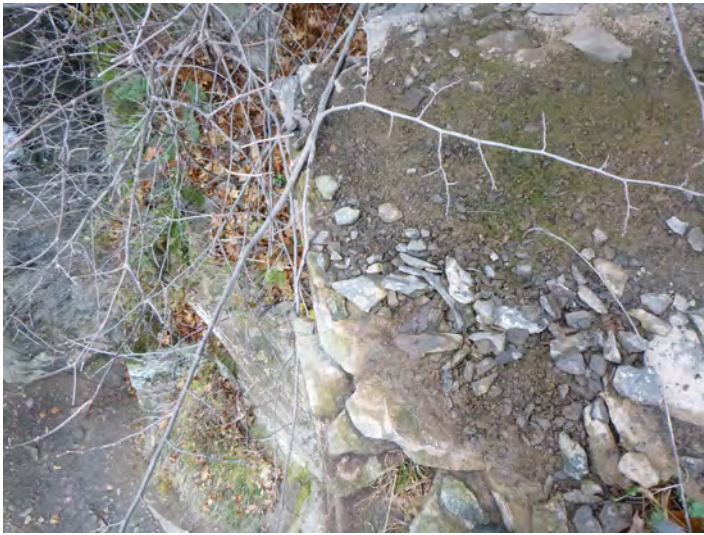
15-35 Stone\_Unsecured LooseBeddingPlane 2021-1

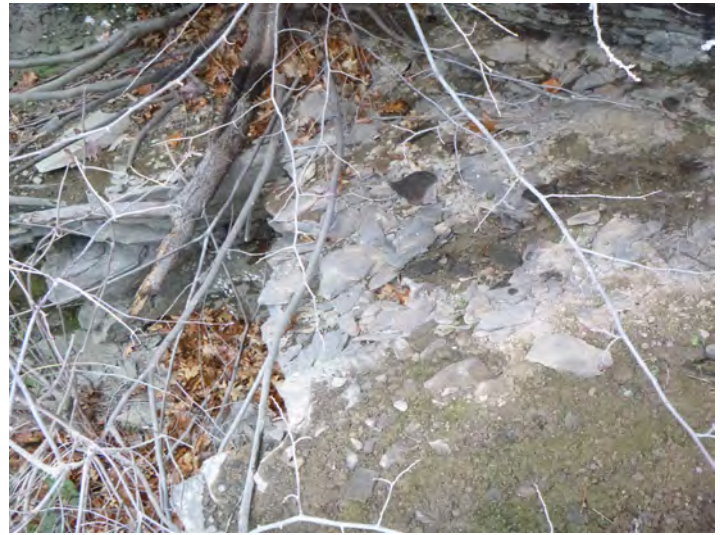
15-35 Stone\_Unsecured LooseBeddingPlane 2021-2

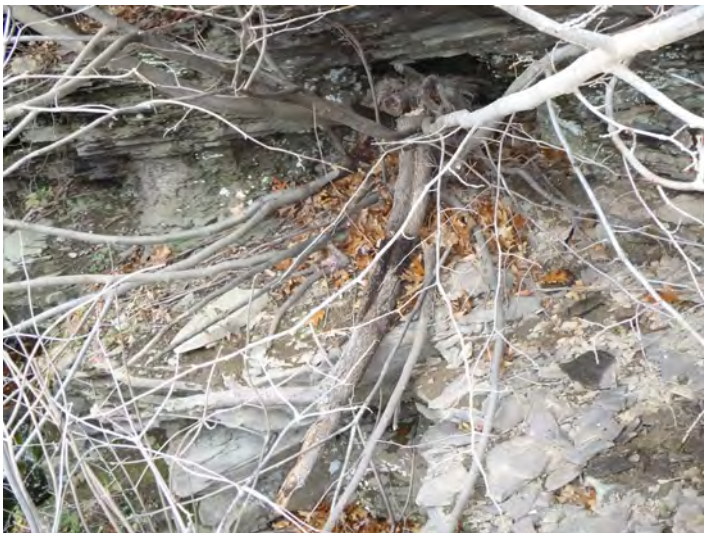
15-35 Stone\_Unsecured LooseBeddingPlane 2021-3

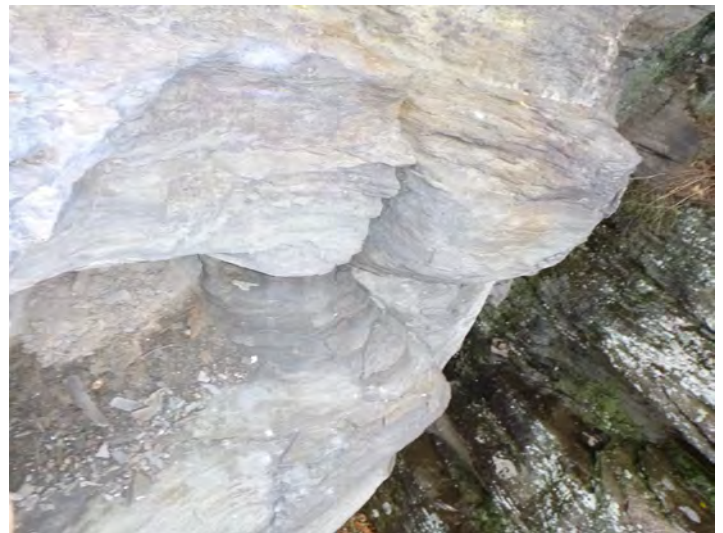
15-35 Stone\_Unsecured LooseBeddingPlane 2021-4

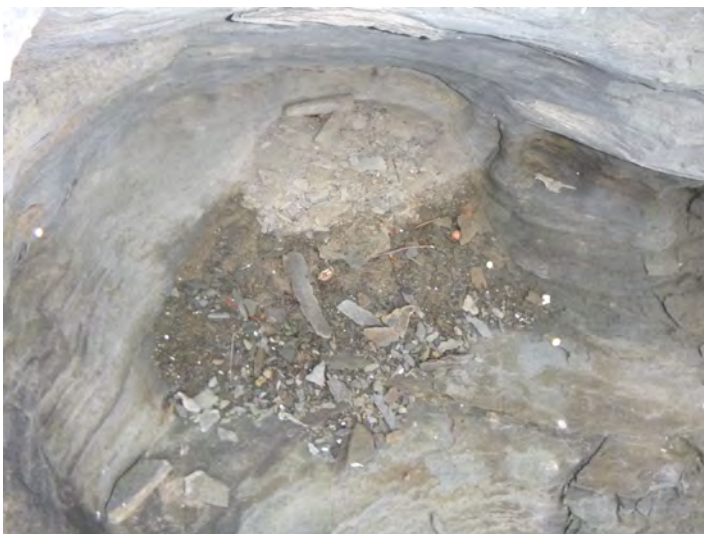
16-18 Stone\_Spall Missing 2021-1

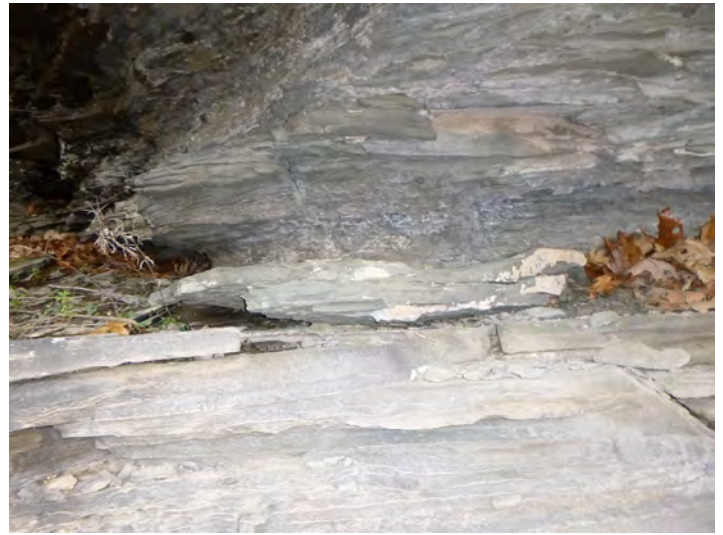
16-23 Stone\_Crack Single unit 2021-2

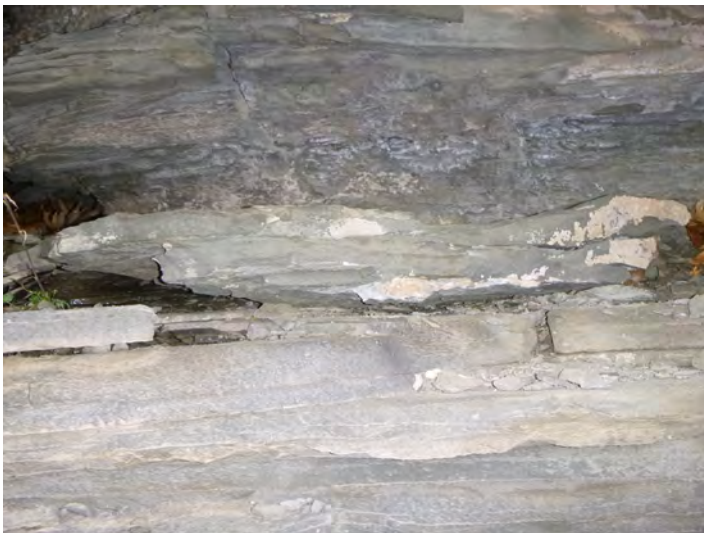
16-24 Stone\_Unsecured Removed 2021-1

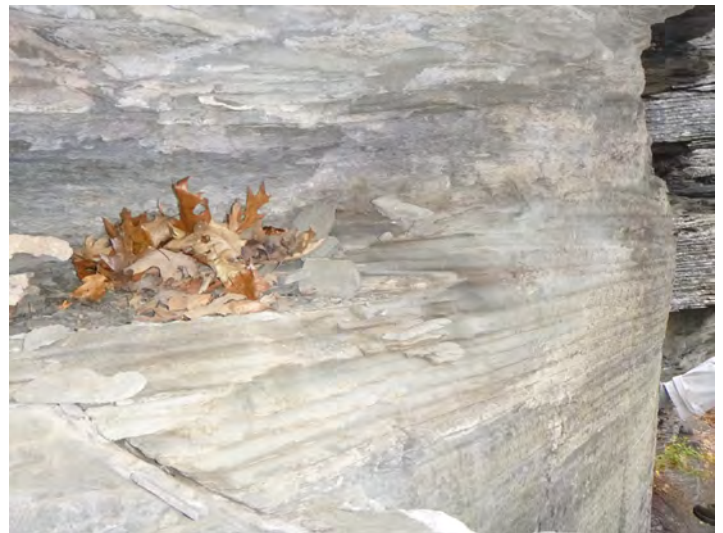
16-24 Stone\_Unsecured Removed 2021-2

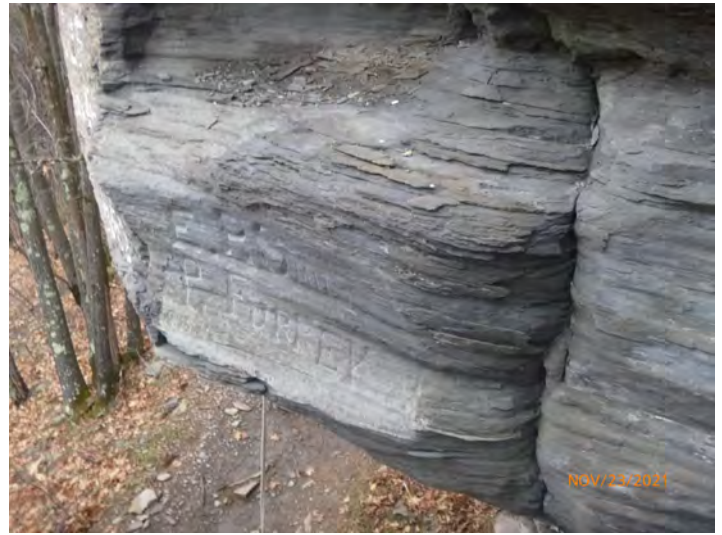
17-17 Stone\_Crack Single unit 2021-2

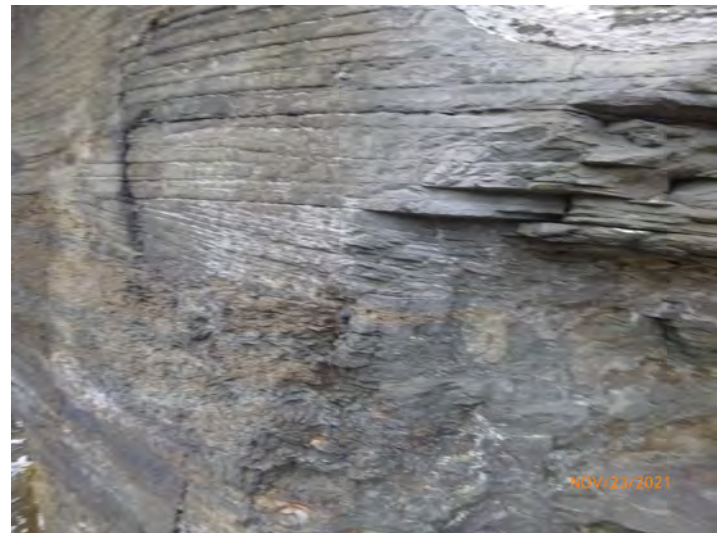
19-22 Stone\_Crack Single unit 2021-6

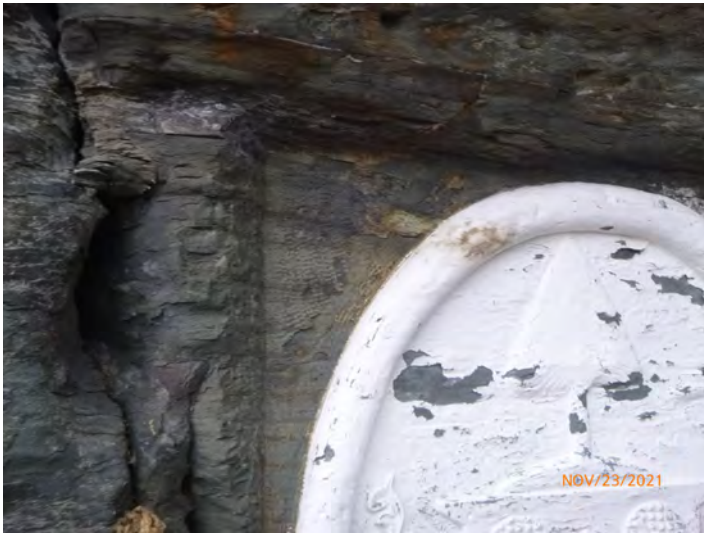
19-27 Stone\_Embedment Ferrous Embedment 2021-2

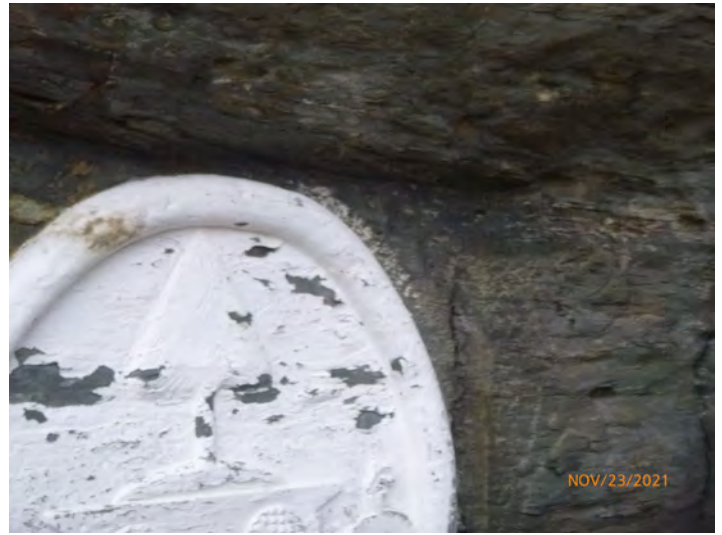
21-17 Stone\_SurfLoss Exfoliated 2021-1

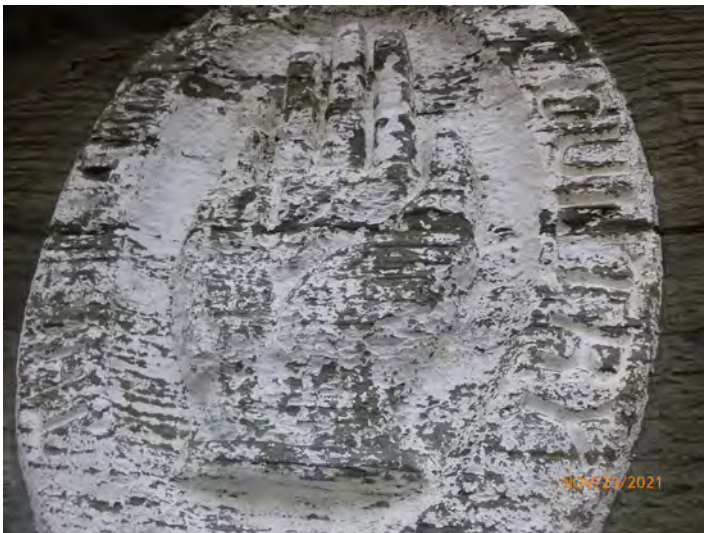
21-22 Stone\_Coating Coating Failed 2021-3

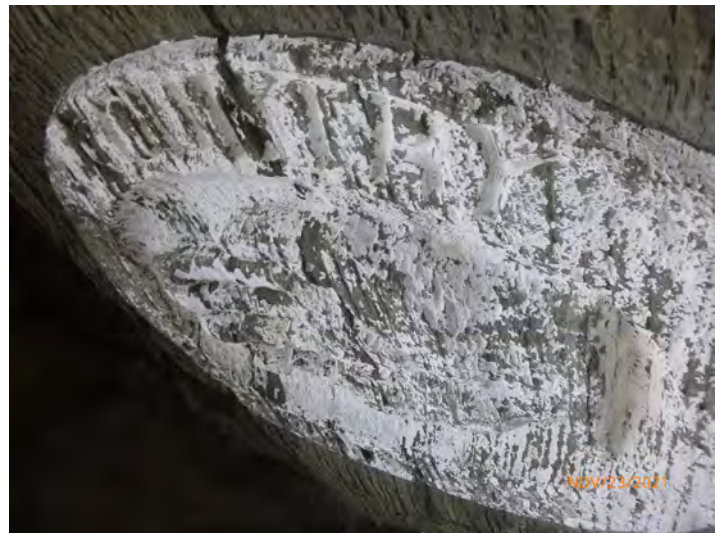
21-22 Stone\_SurfLoss Eroded 2021-1

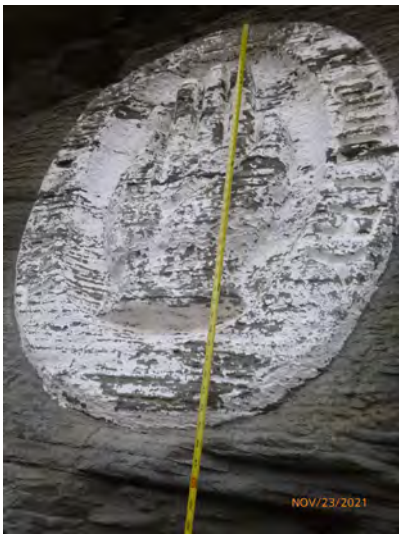
21-22 Stone\_SurfLoss Eroded 2021-2

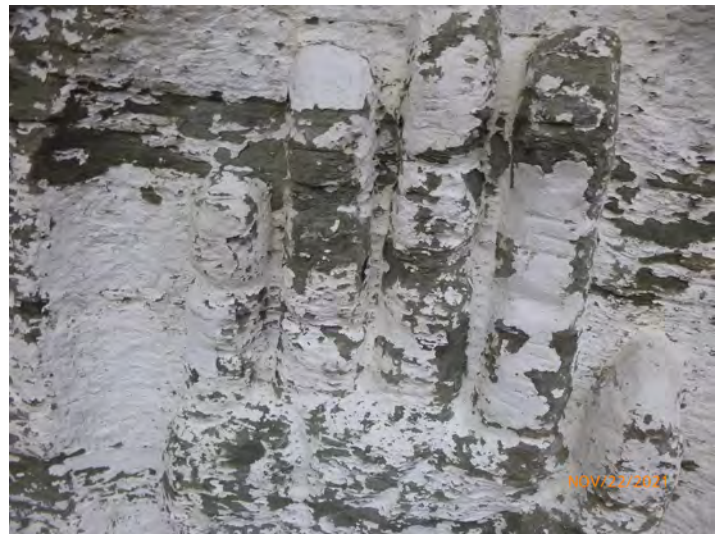
21-22 Stone\_SurfLoss Eroded 2021-3

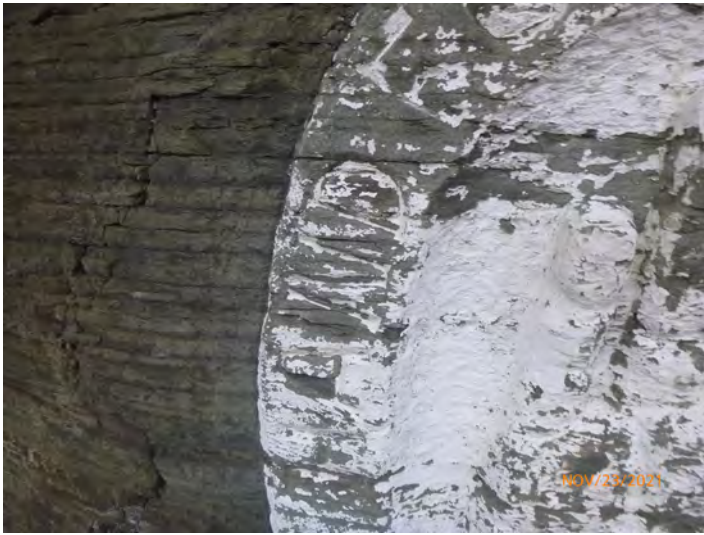
21-24 Stone\_SurfLoss Exfoliated 2021-1

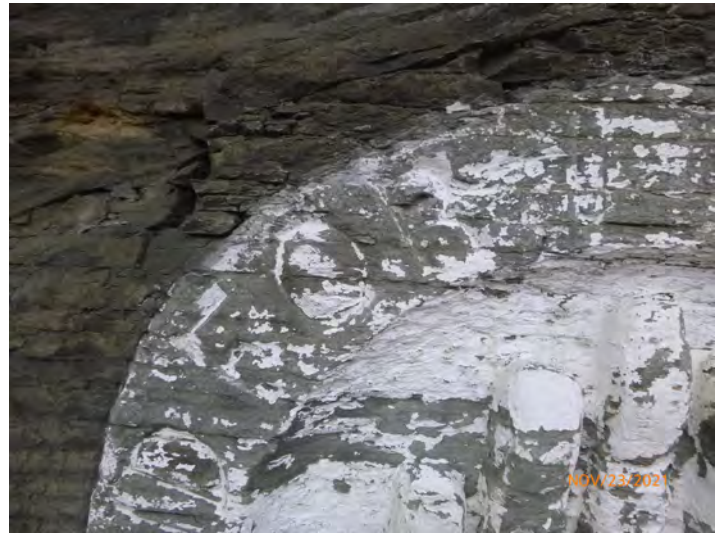
21-25 Stone\_SurfLoss Exfoliated 2021-1

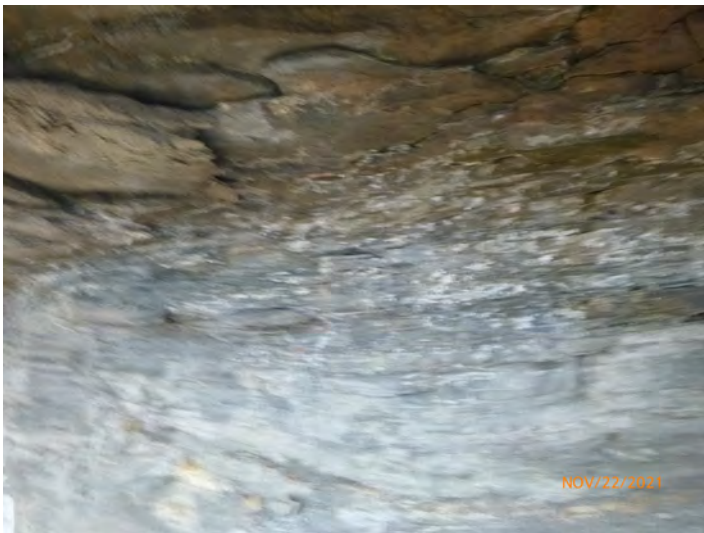
21-25 Stone\_SurfLoss Exfoliated 2021-2

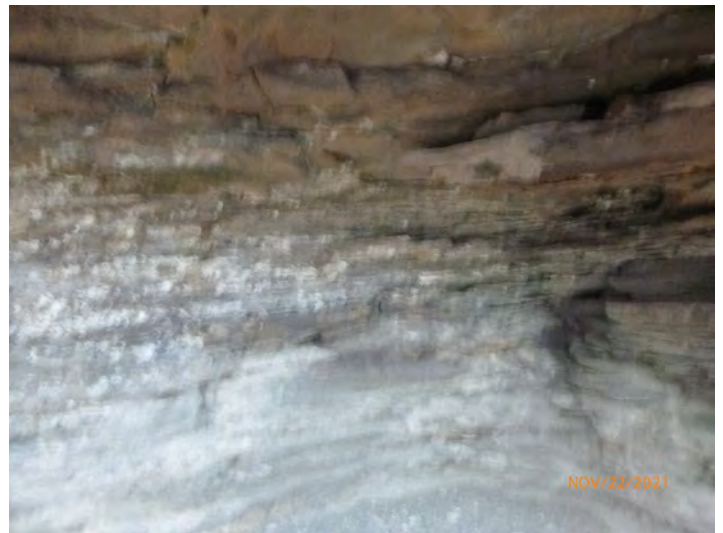
21-26 Stone\_SoilStain Biological 2021-1

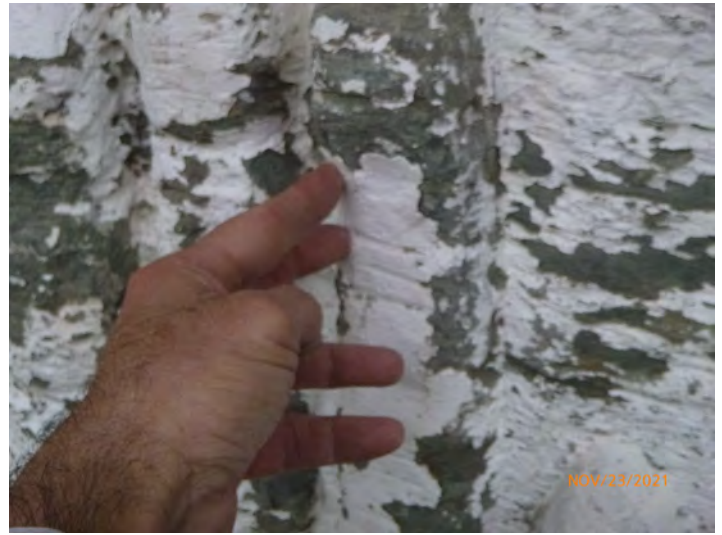
22-16 Stone\_Coating Coating Failed 2021-3

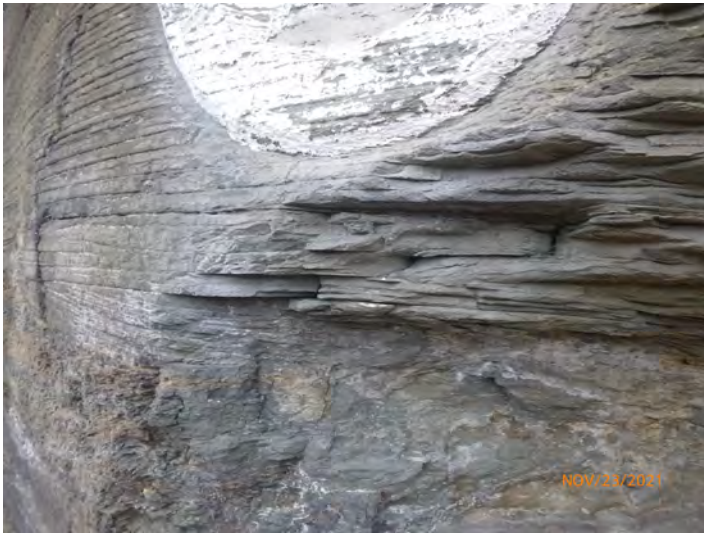
22-34 Stone\_Note Photo-fissure above carving 2021-4

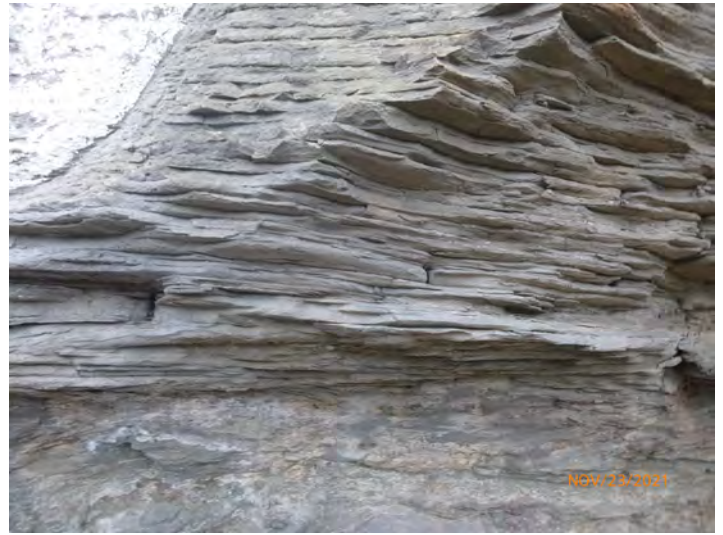
23-22 Stone\_Unsecured LooseBeddingPlane 2021-1

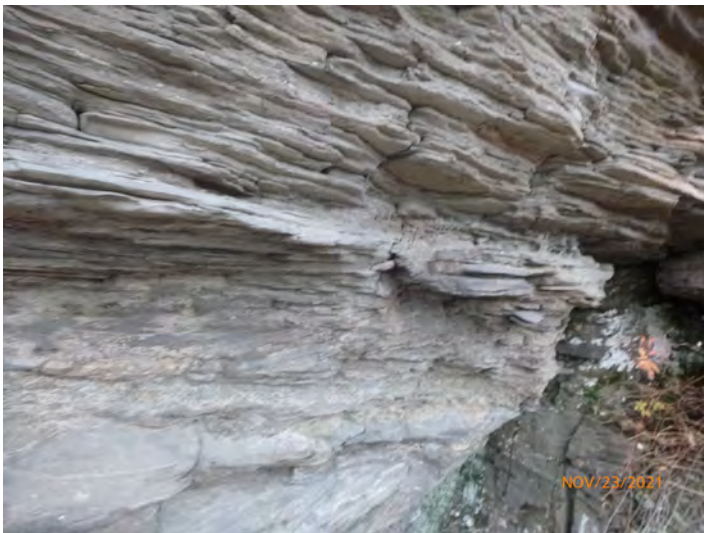
23-22 Stone\_Unsecured LooseBeddingPlane 2021-2

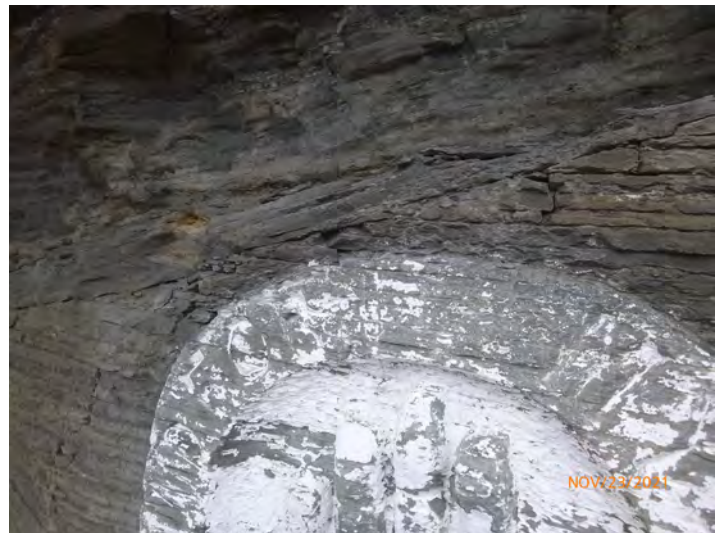
23-25 Stone\_SurfLoss Delaminated 2021-1

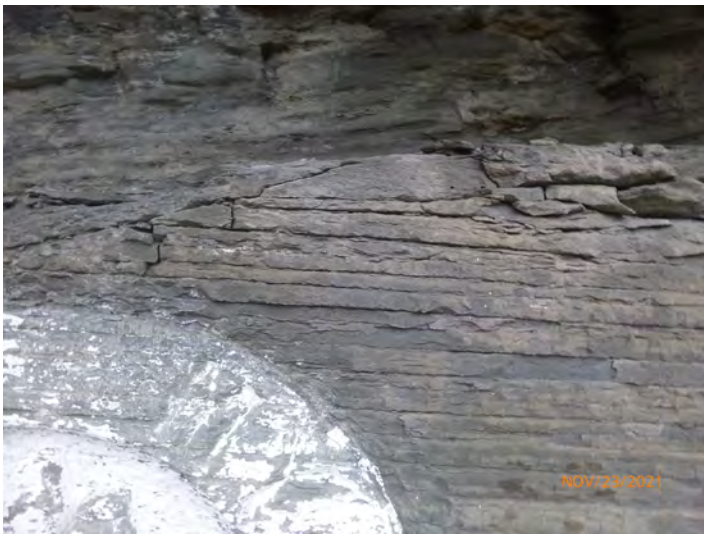
23-25 Stone\_SurfLoss Delaminated 2021-2

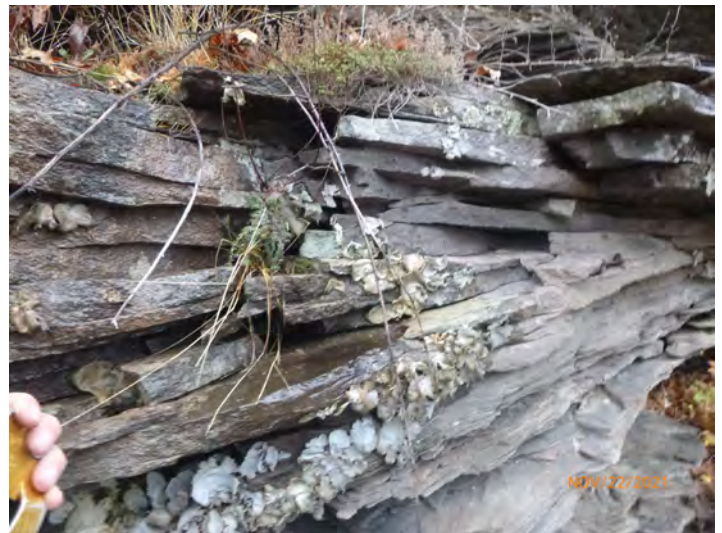
24-28 Stone\_Unsecured LooseBeddingPlane 2021-1

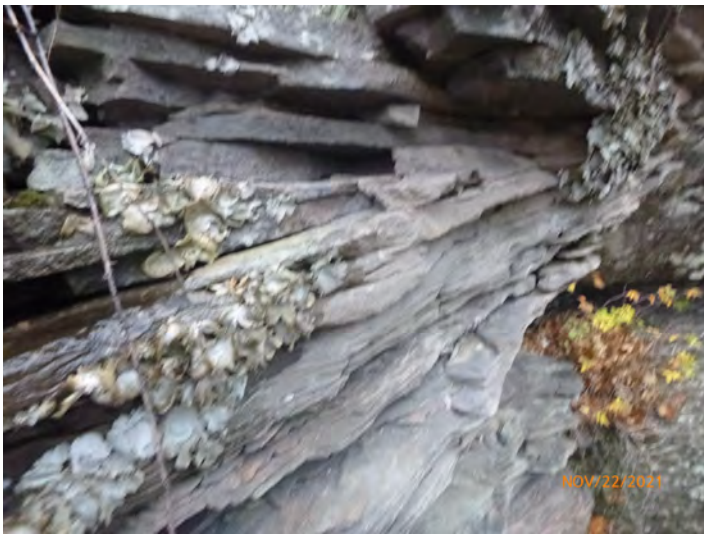
24-28 Stone\_Unsecured LooseBeddingPlane 2021-2

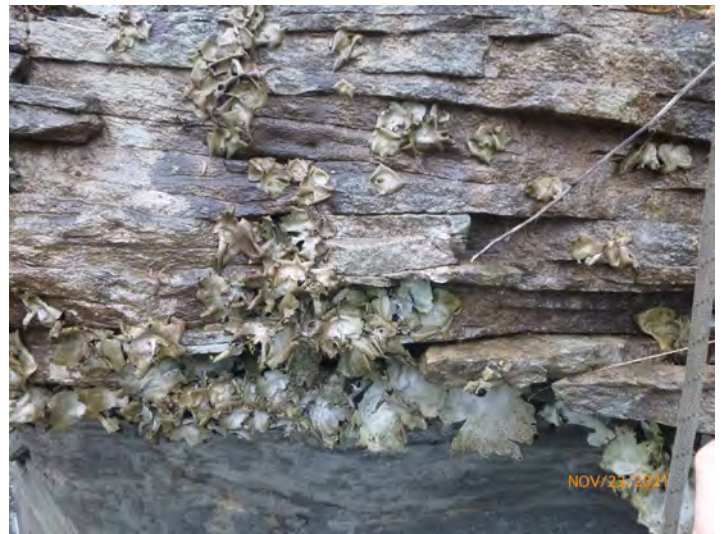
24-28 Stone\_Unsecured LooseBeddingPlane 2021-3

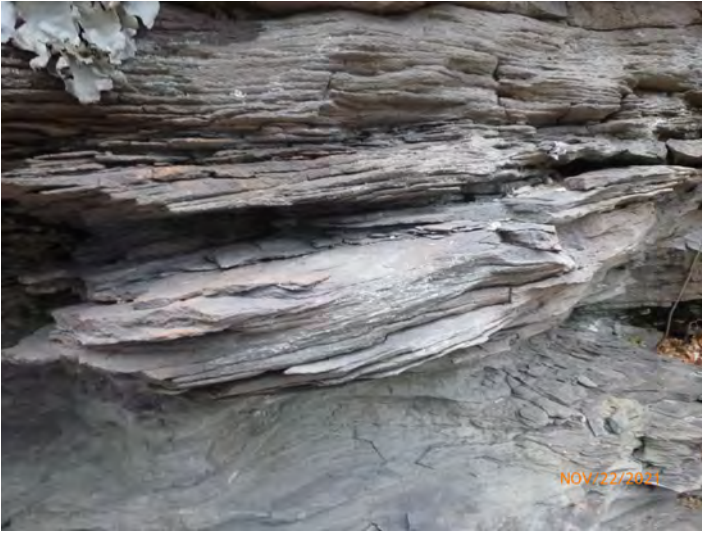
24-28 Stone\_Unsecured LooseBeddingPlane 2021-4

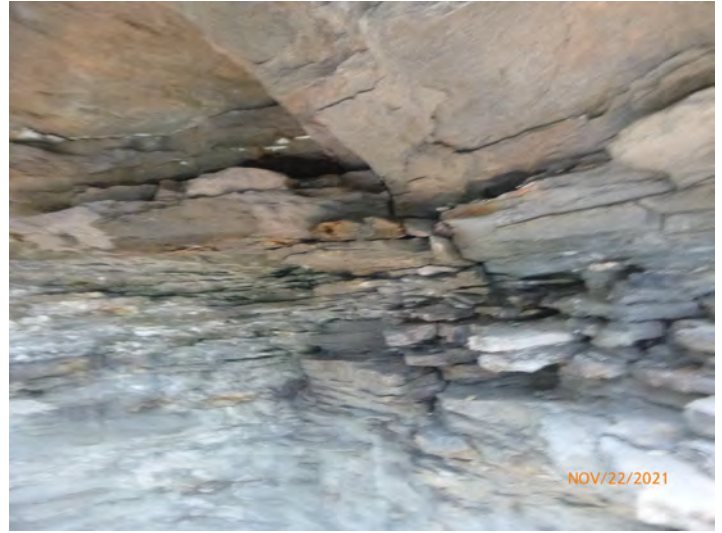
24-28 Stone\_Unsecured LooseBeddingPlane 2021-5

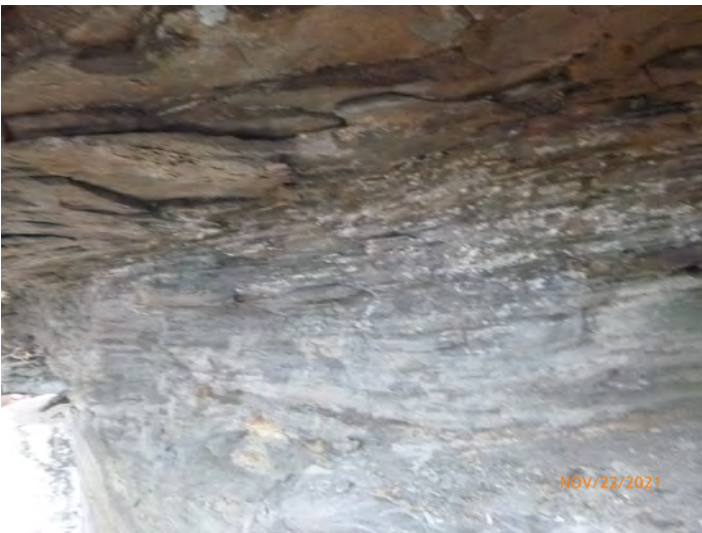
24-28 Stone\_Unsecured LooseBeddingPlane 2021-6

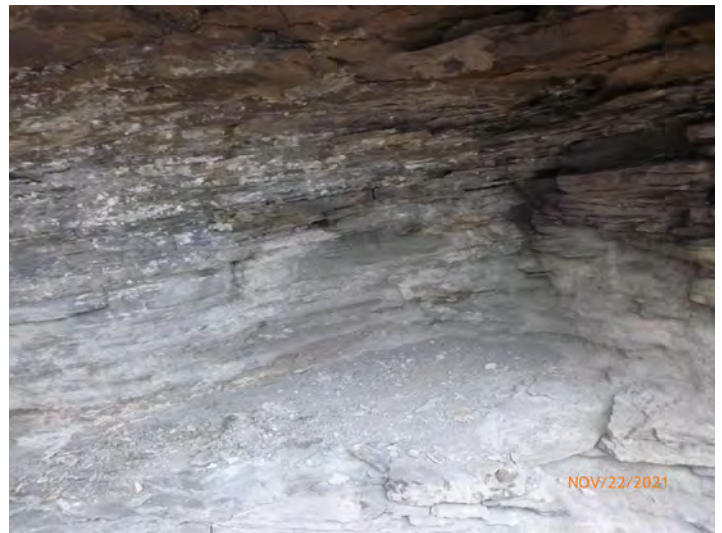
24-28 Stone\_Unsecured LooseBeddingPlane 2021-7

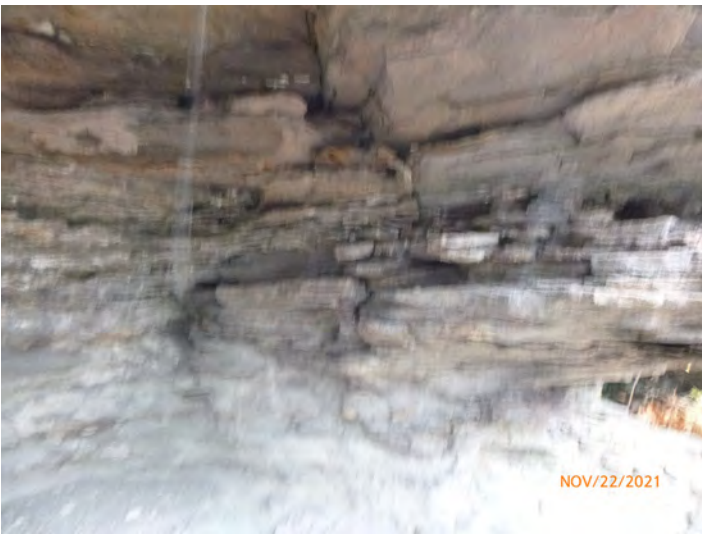
24-28 Stone\_Unsecured LooseBeddingPlane 2021-8

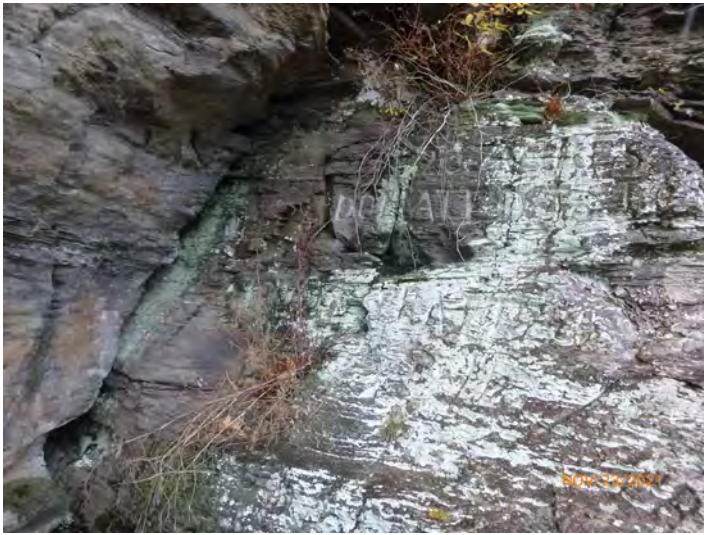
25-16 Stone\_Note Photo-carved lettering 2021-1

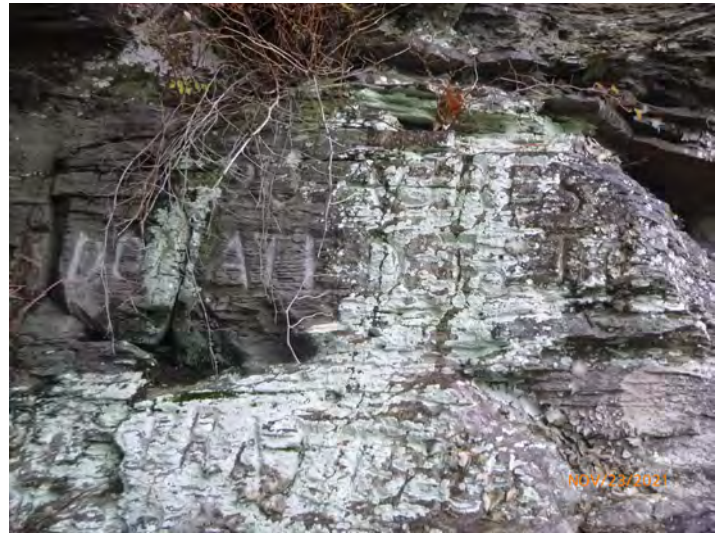
25-16 Stone\_Note Photo-carved lettering 2021-2

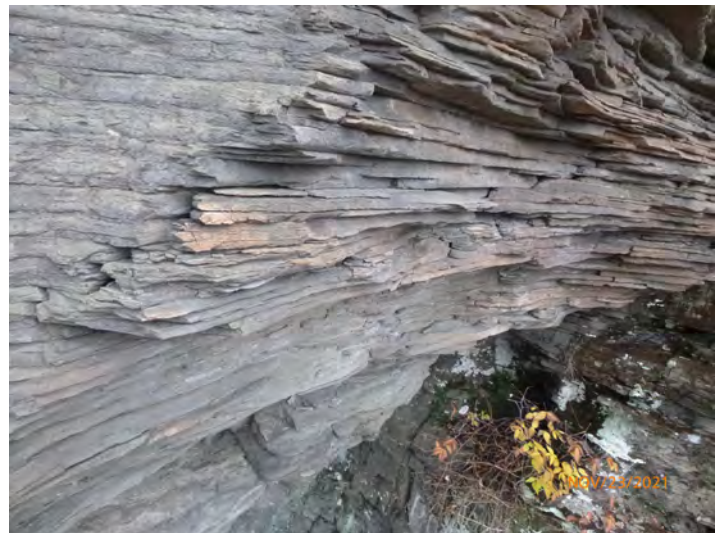
27-23 Stone\_Unsecured LooseBeddingPlane 2021-2

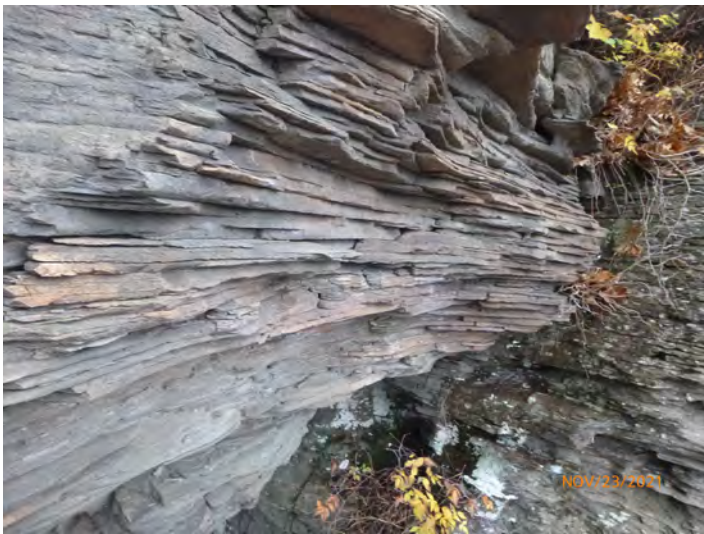
27-23 Stone\_Unsecured LooseBeddingPlane 2021-3

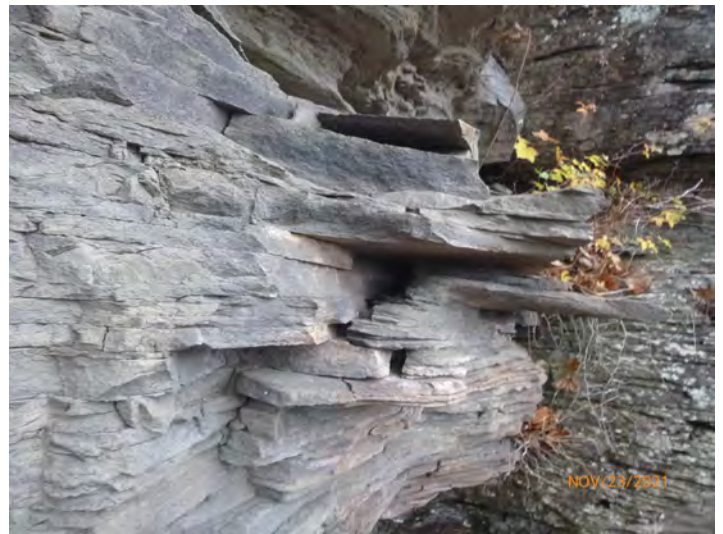
27-23 Stone\_Unsecured LooseBeddingPlane 2021-4

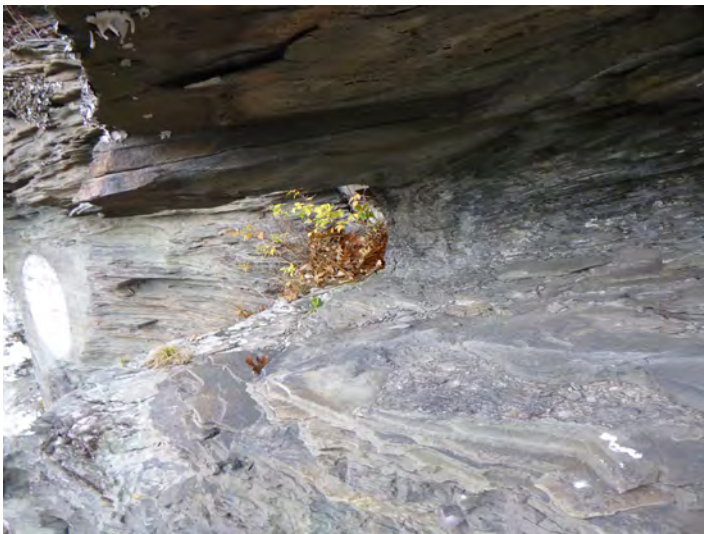
41-27 Stone\_Coating Coating Failed 2021-6

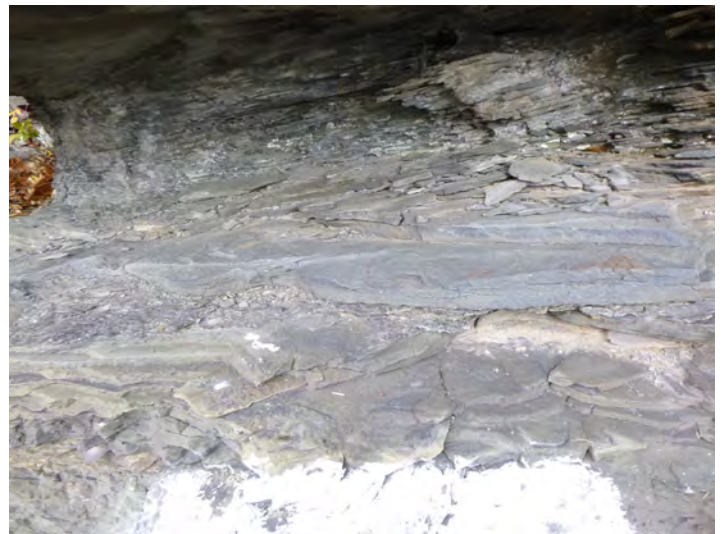
41-28 Stone\_Note Photo-general 2021-1

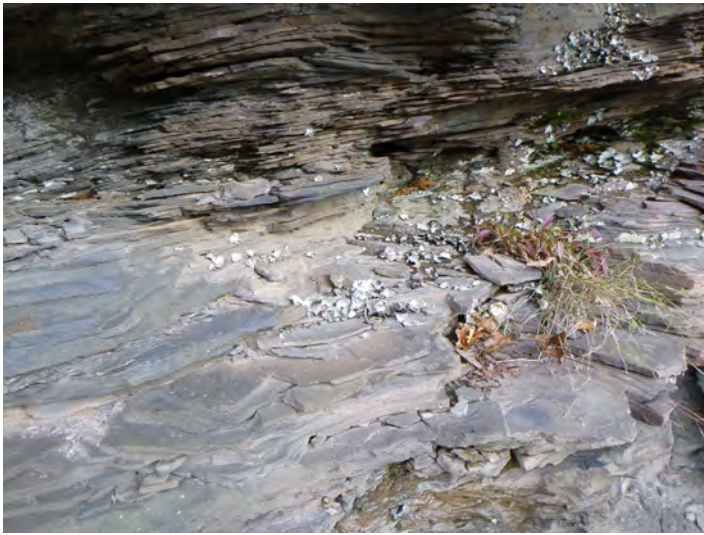
41-28 Stone\_Note Photo-general 2021-2

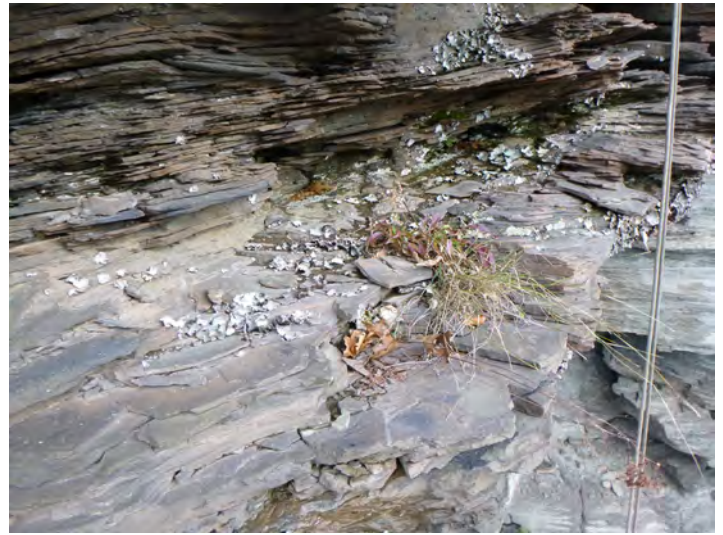
41-28 Stone\_Note Photo-general 2021-3

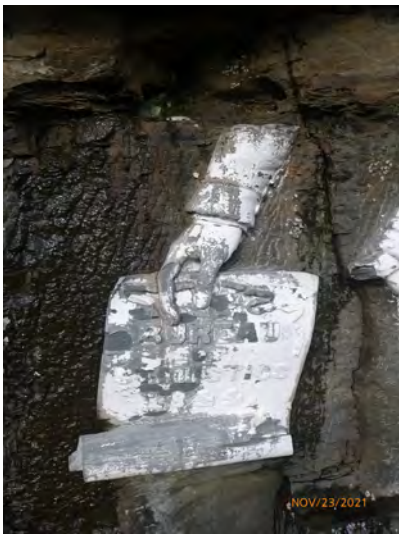
42-22 Stone\_Crack Single unit 2021-2

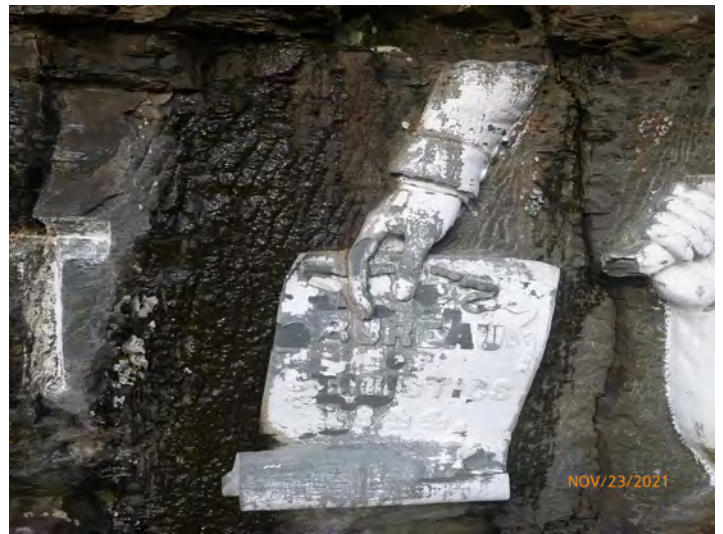
43-11 Stone\_Note Photo-overall 2021-1

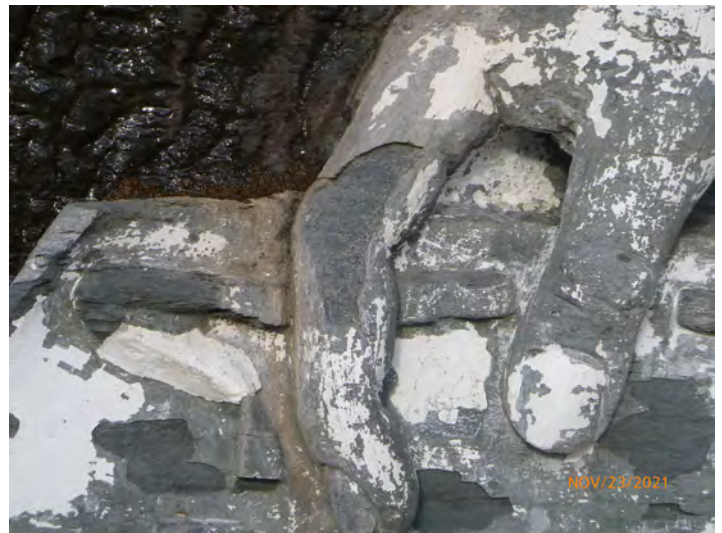
44-12 Stone\_Note Photo-water seepage 2021-3

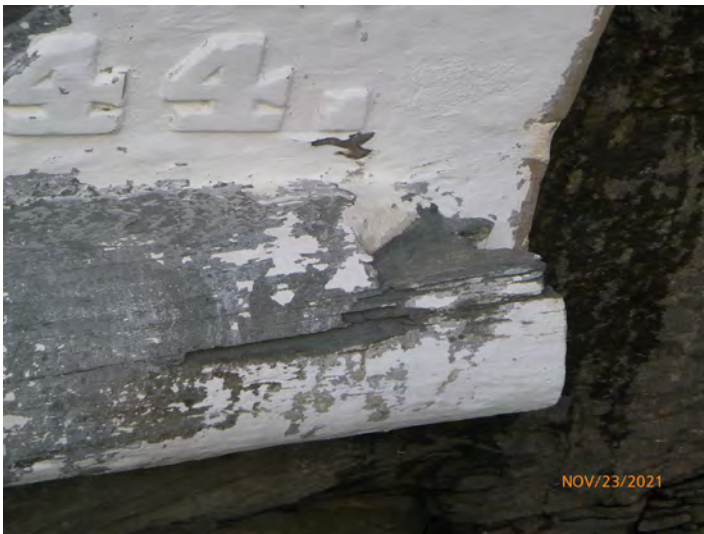
45-11 Stone\_SurfLoss Exfoliated 2021-1
