## **PRATT ROCK PARK**

Phase 1: Initial Needs Assessment  
Pratt Rock Park, Prattsville, New York

prepared for:  
Pratt Park Committee  
Prattsville, New York

April 18, 2022

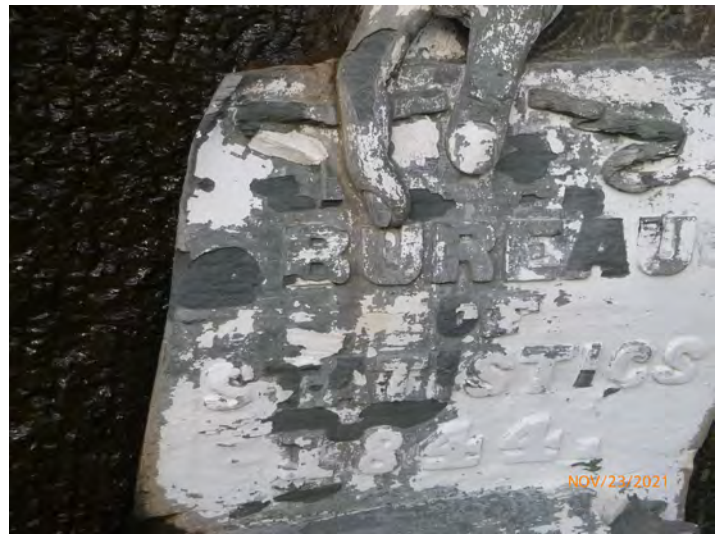
46-9 Stone\_SurfLoss Exfoliated 2021-1

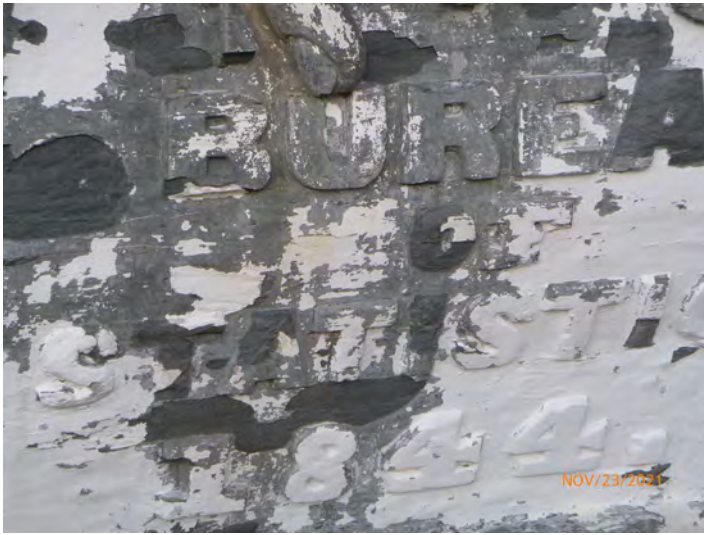
46-11 Stone\_SurfLoss Exfoliated 2021-1

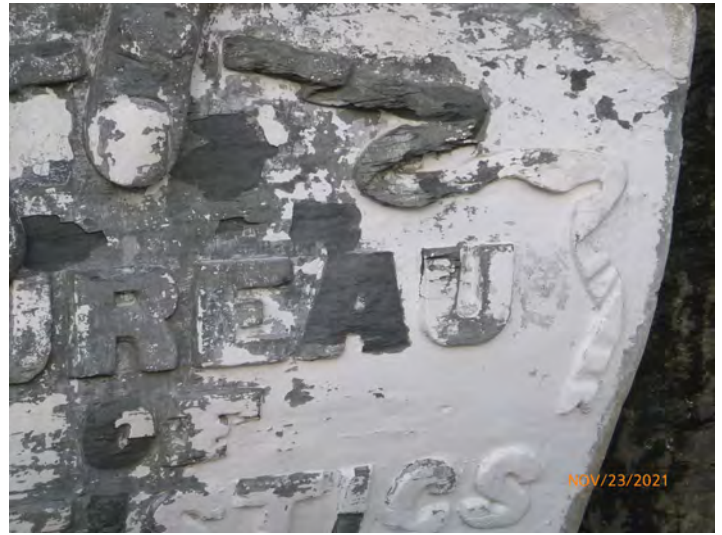
46-11 Stone\_SurfLoss Exfoliated 2021-2

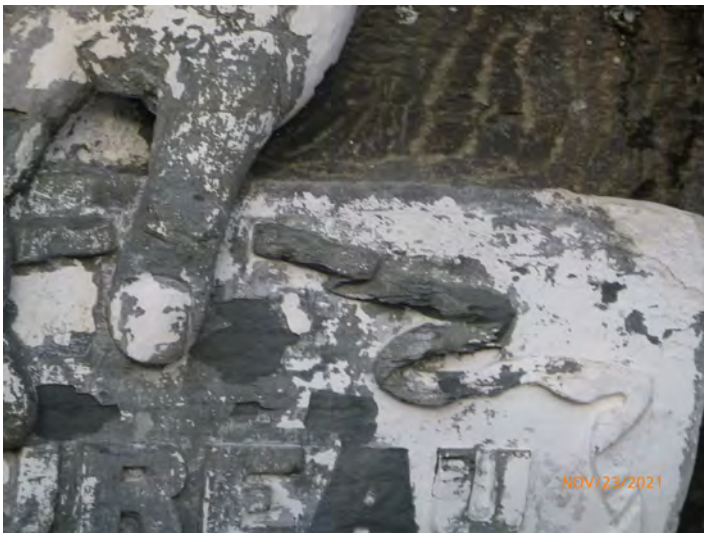
46-11 Stone\_SurfLoss Exfoliated 2021-3

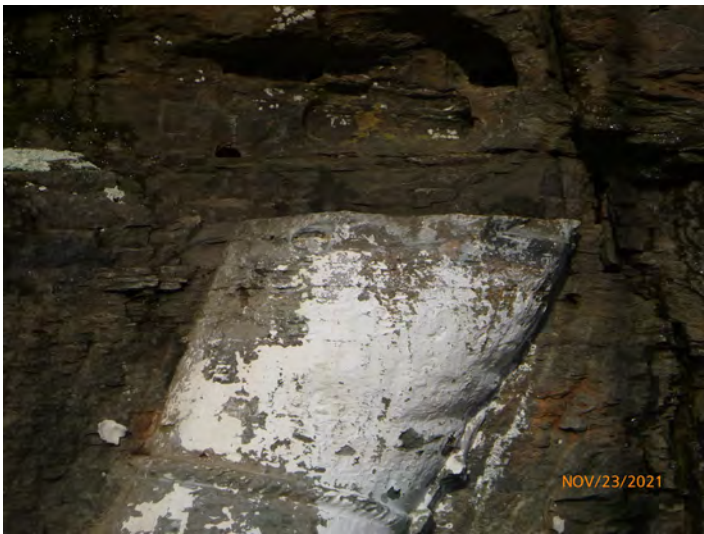
47-12 Stone\_Repair Patch Failed 2021-1

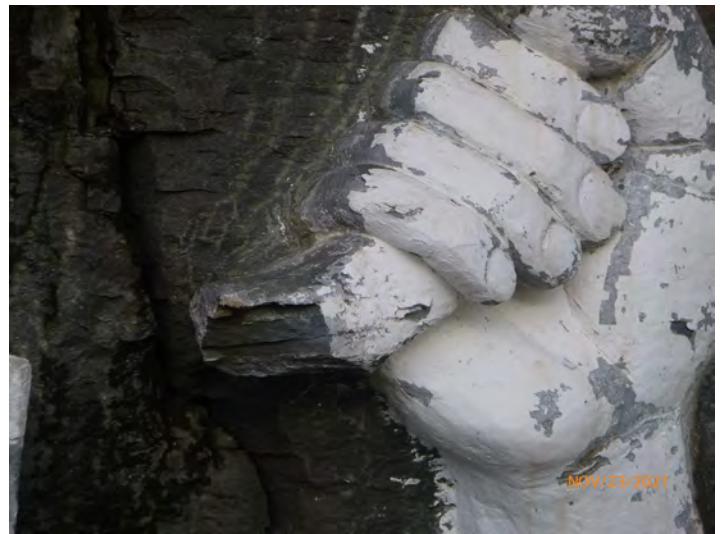
47-13 Stone\_Spall Missing 2021-1

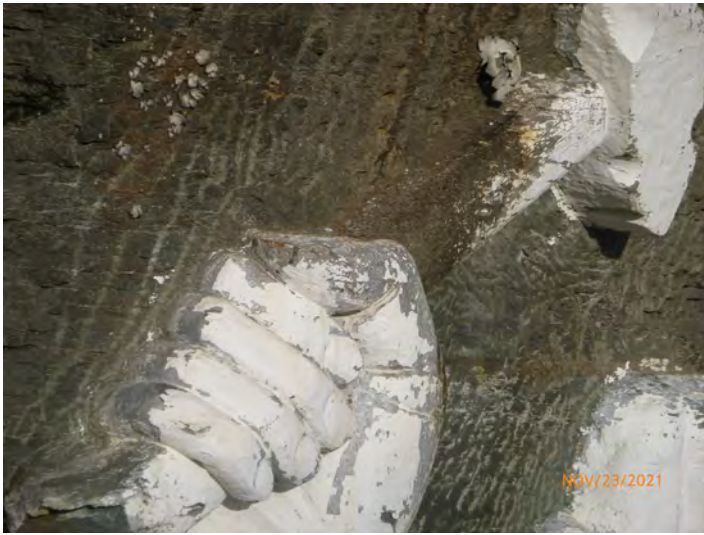
48-11 Stone\_Spall Missing 2021-1

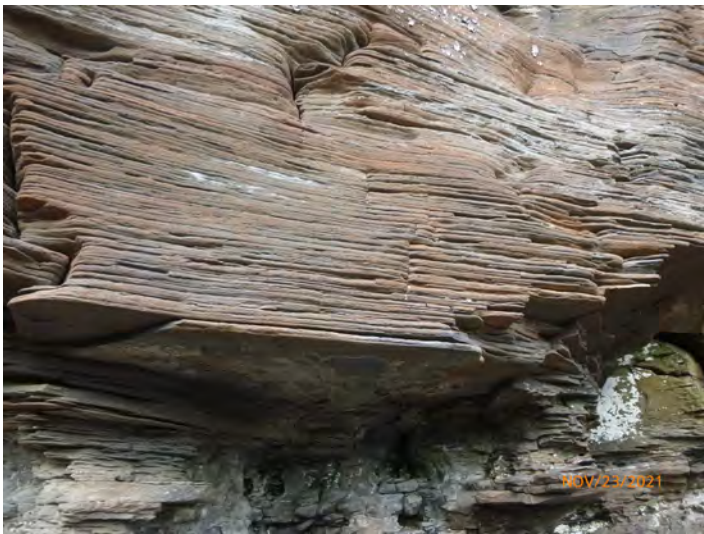
48-13 Stone\_Note Photo-water seepage 2021-3

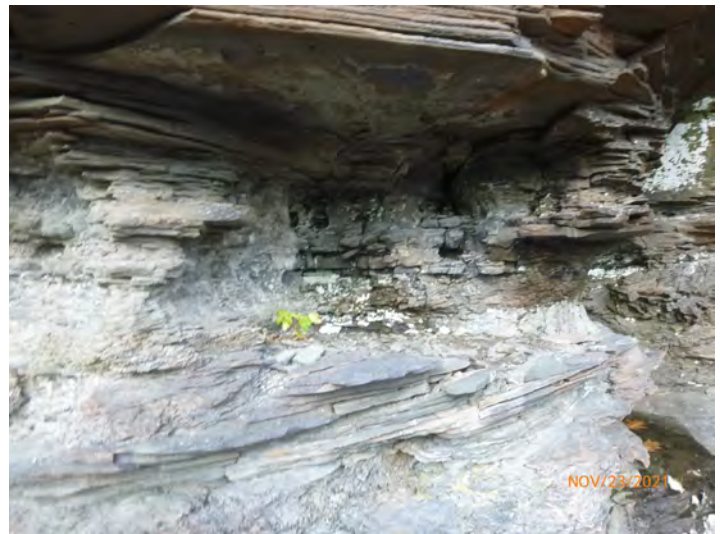
48-13 Stone\_Unsecured LooseBeddingPlane 2021-1

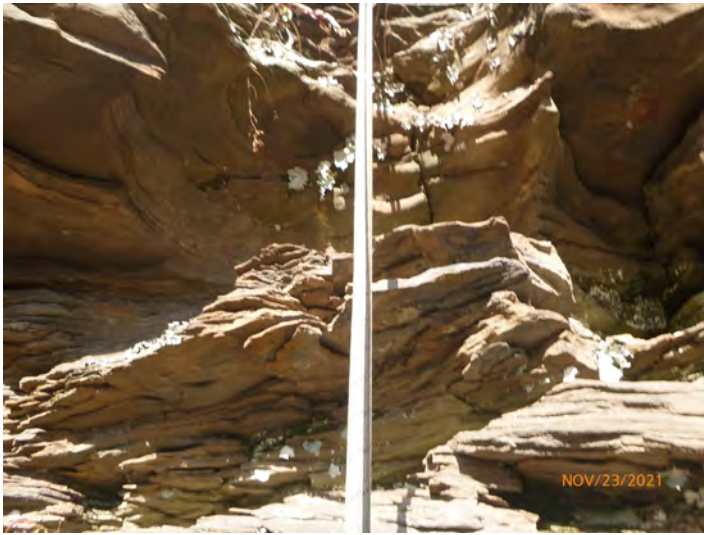
48-13 Stone\_Unsecured LooseBeddingPlane 2021-2

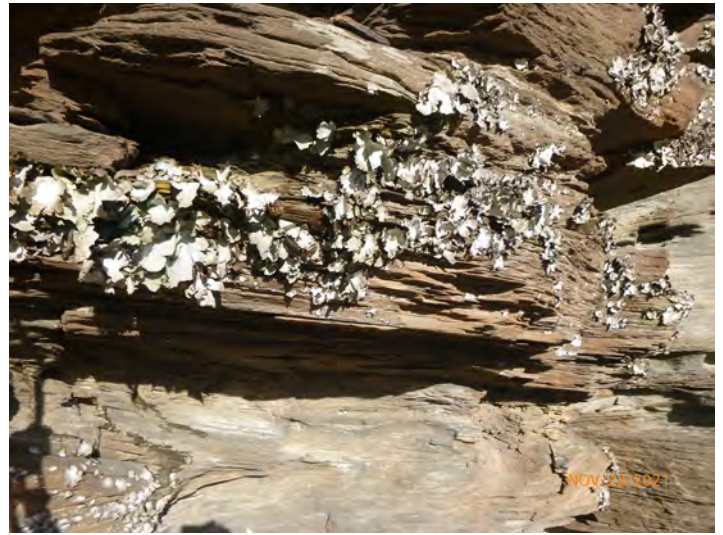
48-14 Stone\_Note Photo-general 2021-1

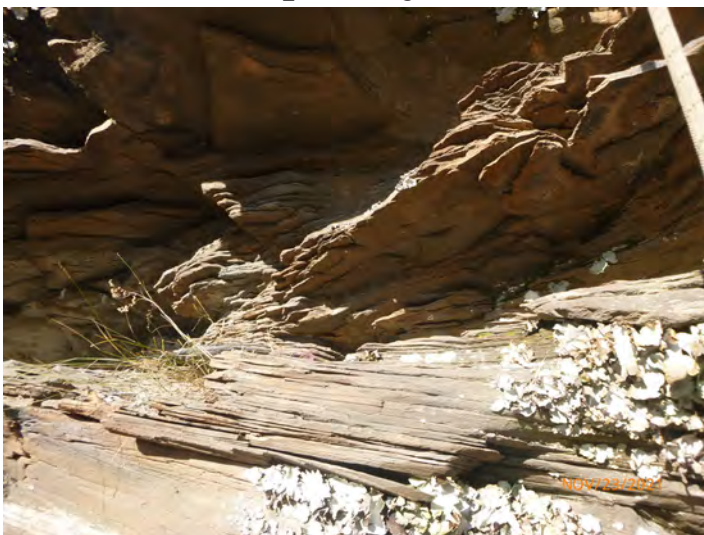
48-14 Stone\_Note Photo-general 2021-2

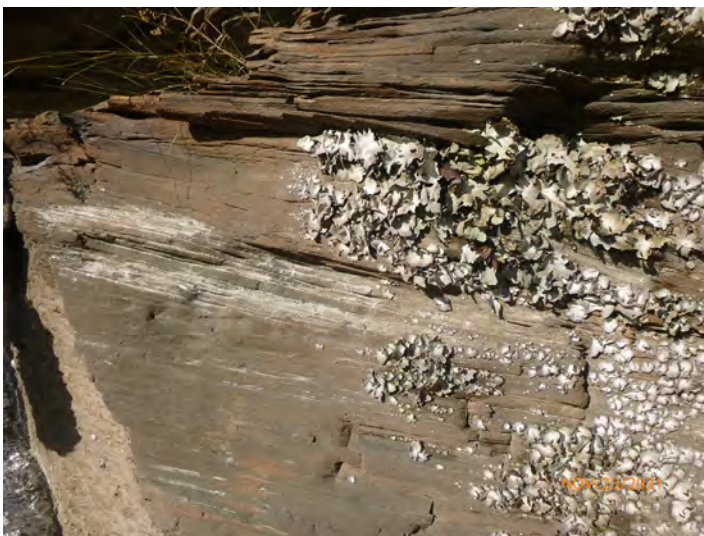
48-14 Stone\_Note Photo-general 2021-4

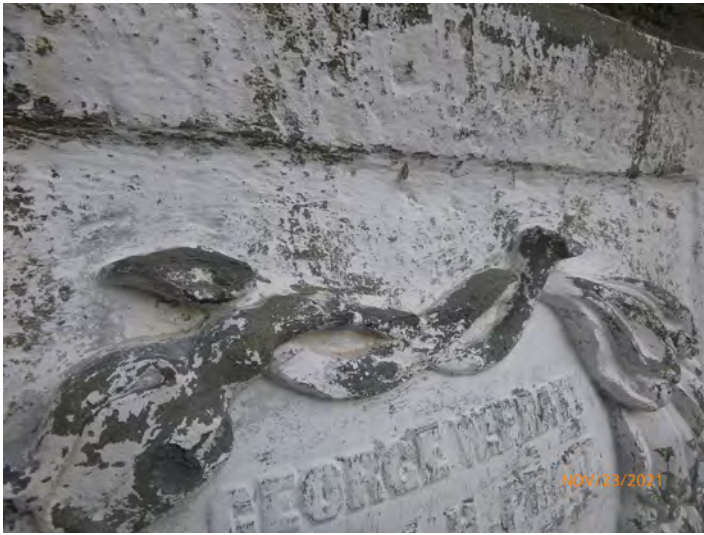
56-15 Stone\_SurfLoss Exfoliated 2021-1

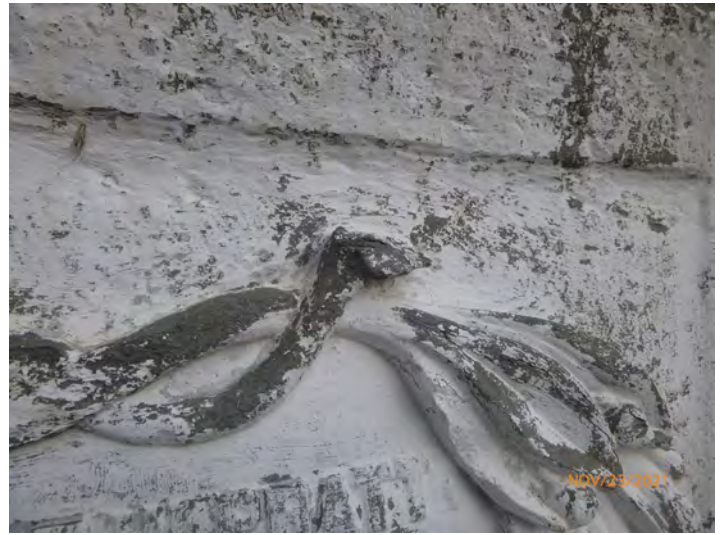
56-15 Stone\_SurfLoss Exfoliated 2021-2

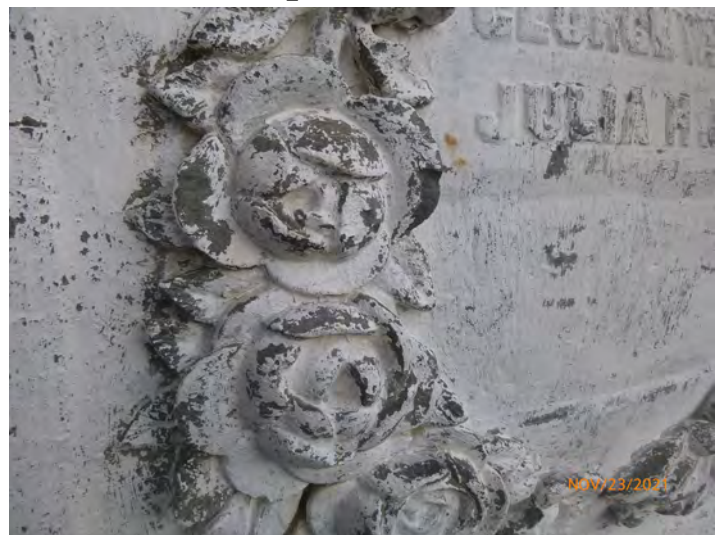
57-13 Stone\_SurfLoss Exfoliated 2021-1

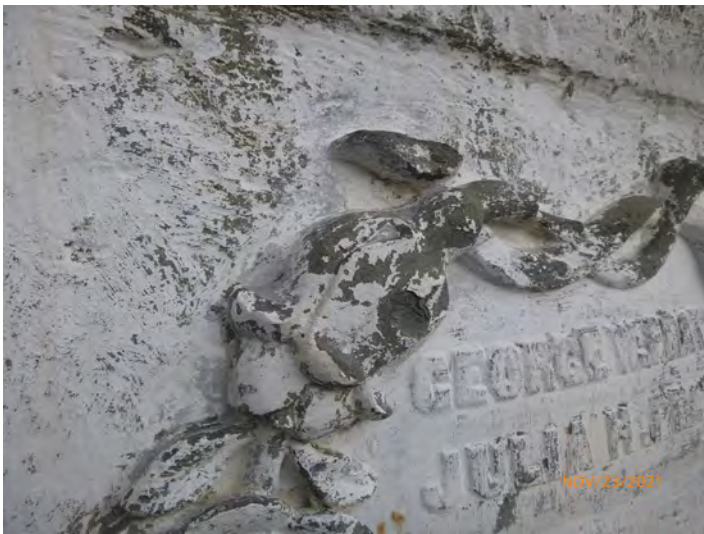
57-13 Stone\_SurfLoss Exfoliated 2021-2

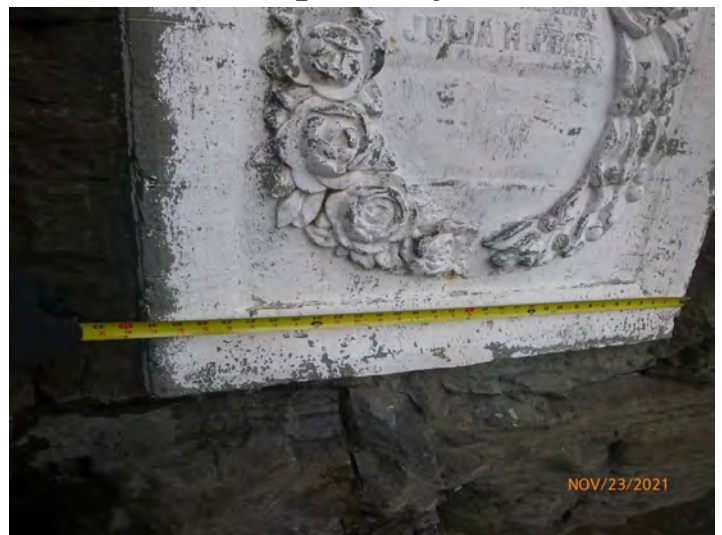
58-11 Stone\_Note Photo-27.5 inches high by 31 inches wide 2021-2

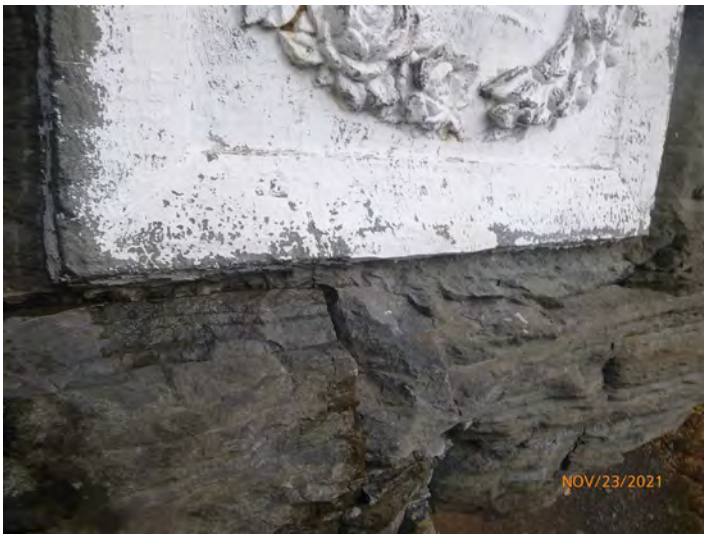
58-11 Stone\_SurfLoss Eroded 2021-1

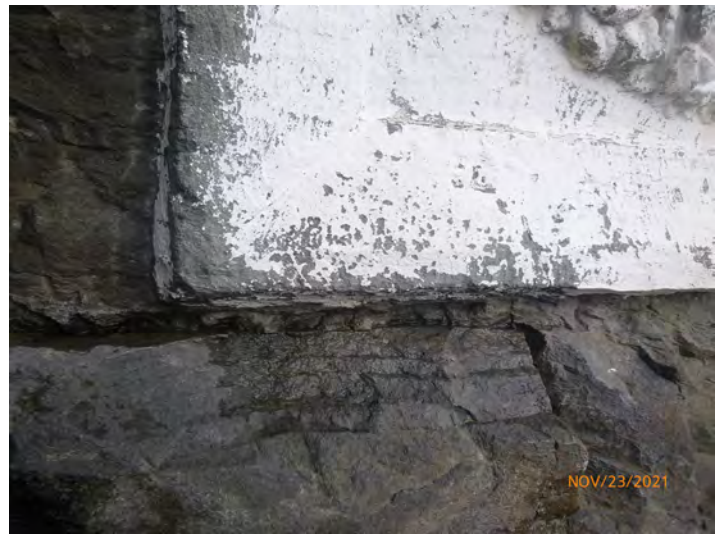
58-11 Stone\_SurfLoss Eroded 2021-2

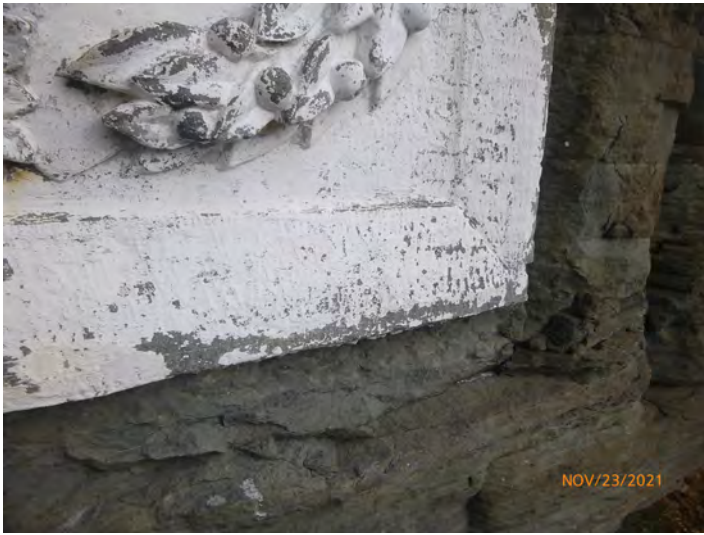
58-11 Stone\_SurfLoss Eroded 2021-3

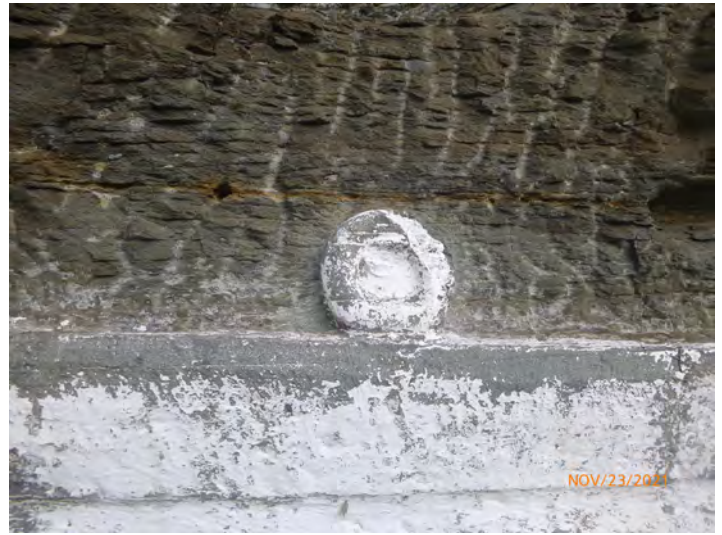
58-16 Stone\_Spall Missing 2021-1

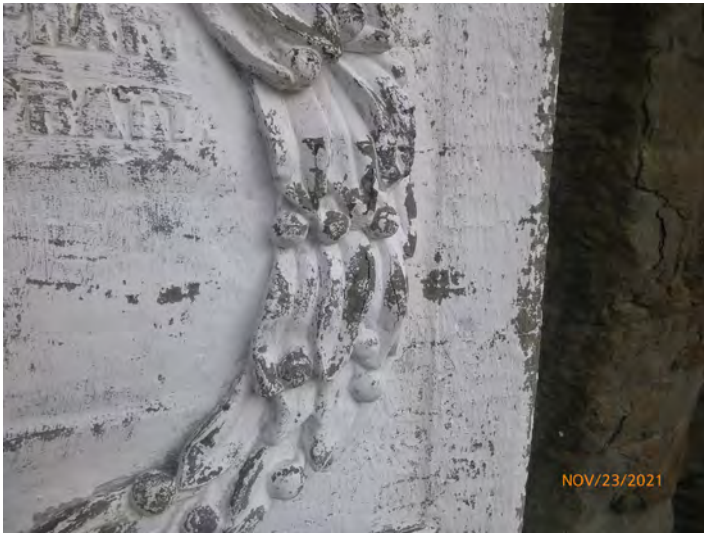
60-14 Stone\_SurfLoss Exfoliated 2021-1

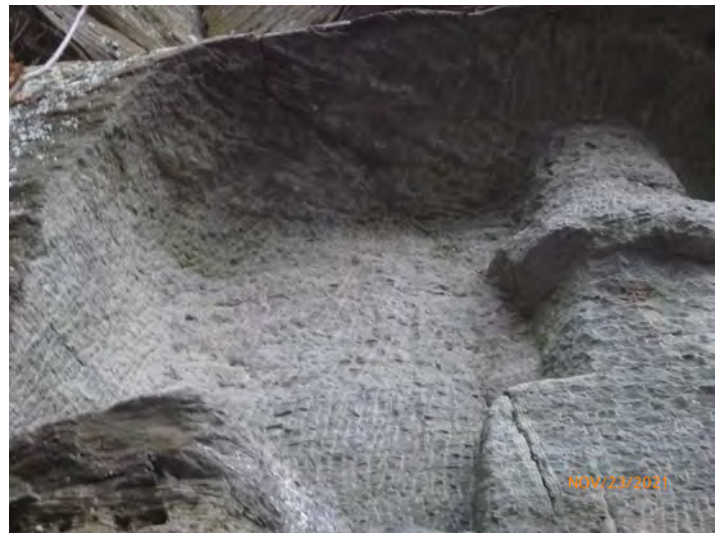
74-15 Stone\_Note Photo-carving 2021-2

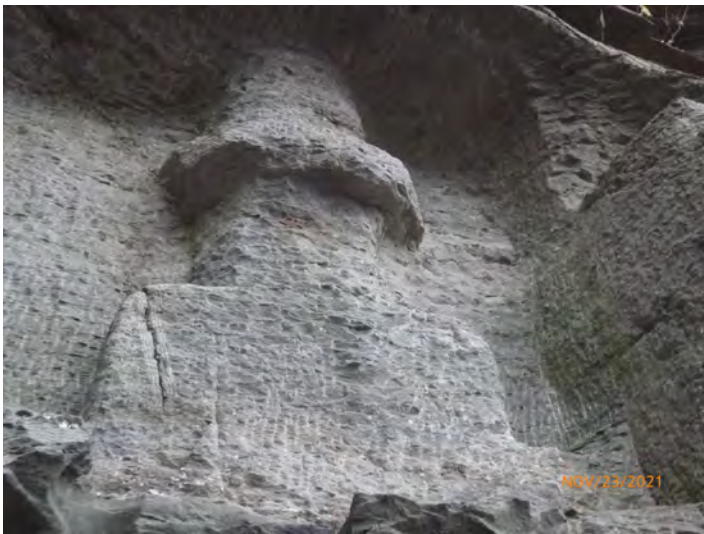
74-15 Stone\_Note Photo-carving 2021-3

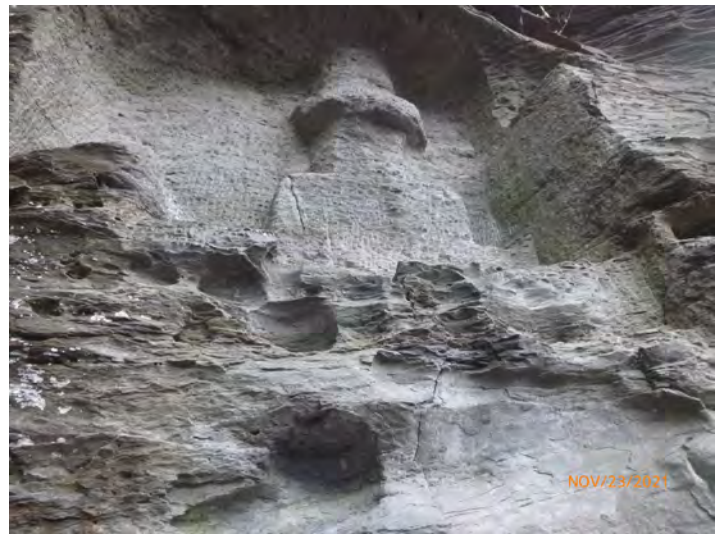
74-15 Stone\_Note Photo-carving 2021-4

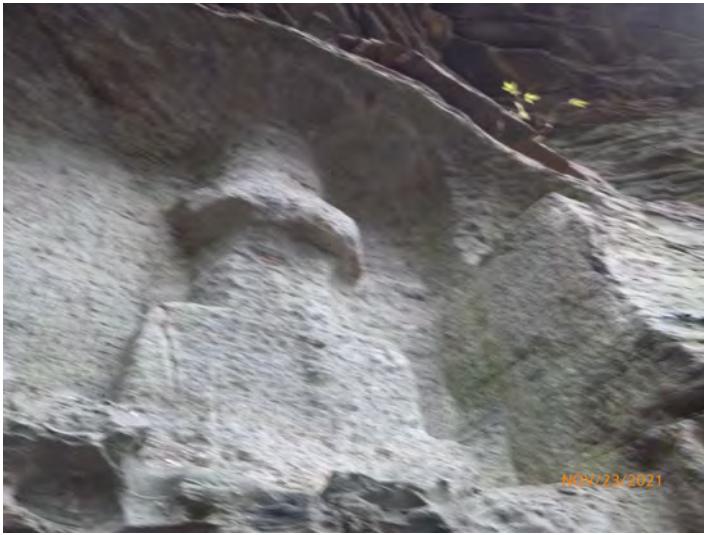
74-15 Stone\_Note Photo-carving 2021-5

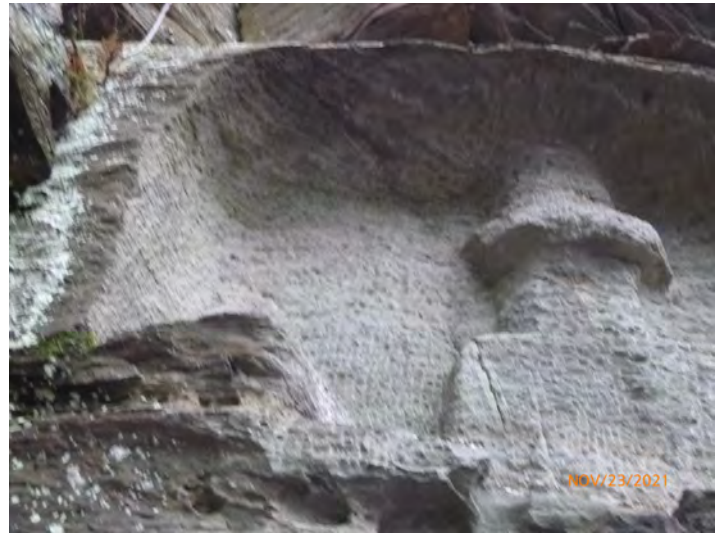
74-15 Stone\_Note Photo-carving 2021-6

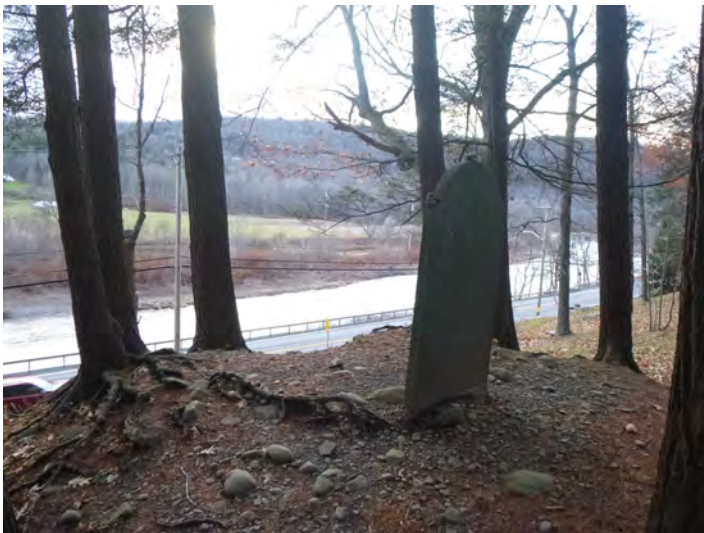
74-15 Stone\_Note Photo-carving 2021-7

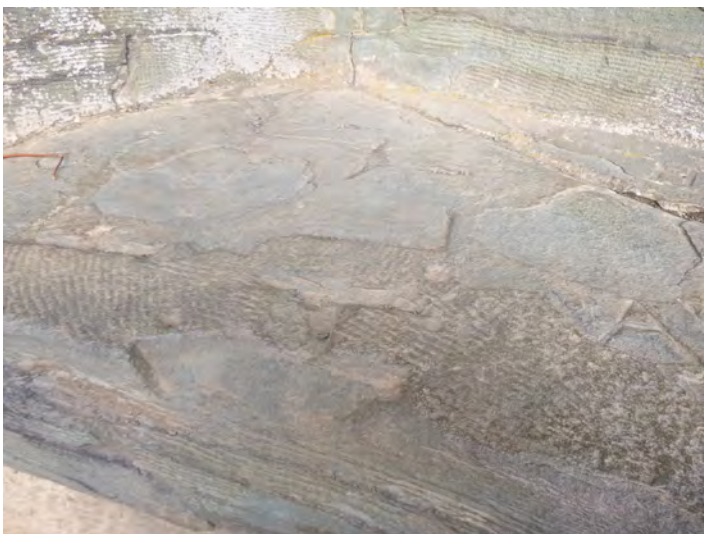
137-14 Stone\_Crack System units 2021-1

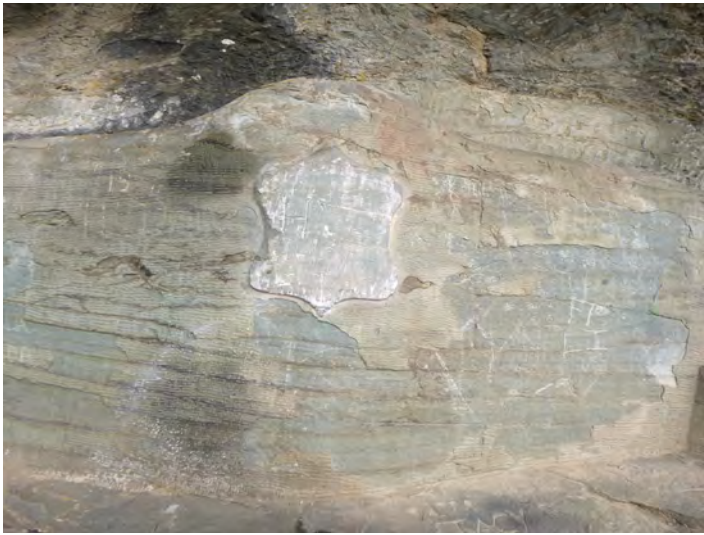
137-15 Stone\_SoilStain Biological 2021-1

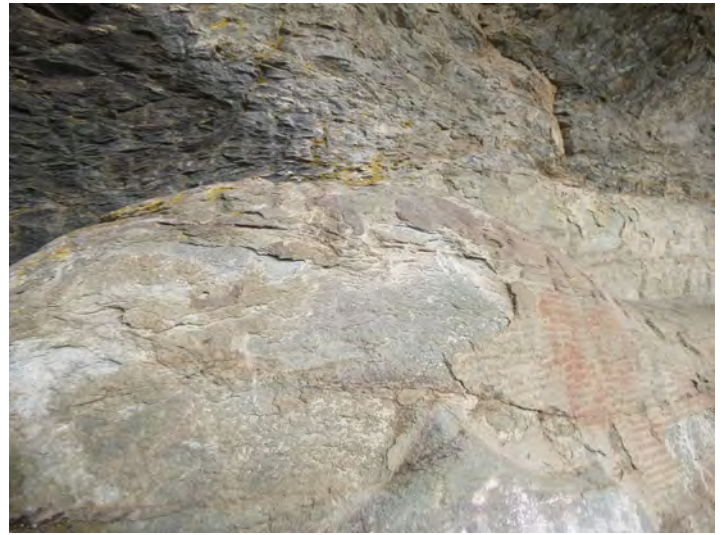
138-14 Stone\_SurfLoss Exfoliated 2021-1

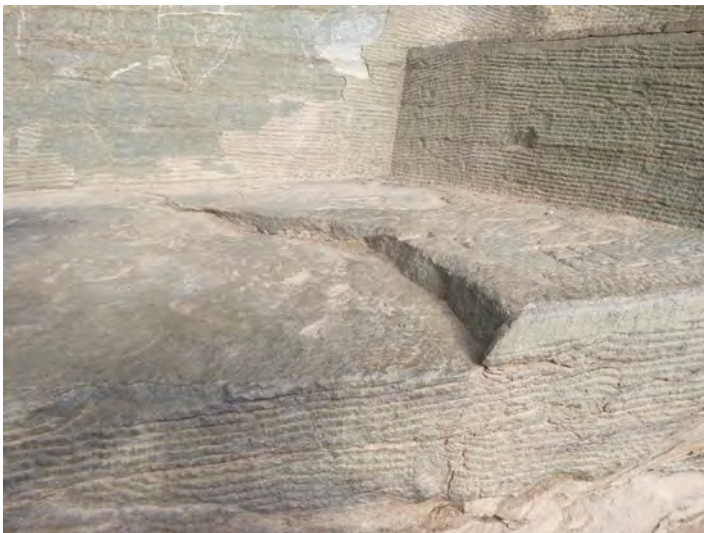
138-14 Stone\_SurfLoss Exfoliated 2021-2

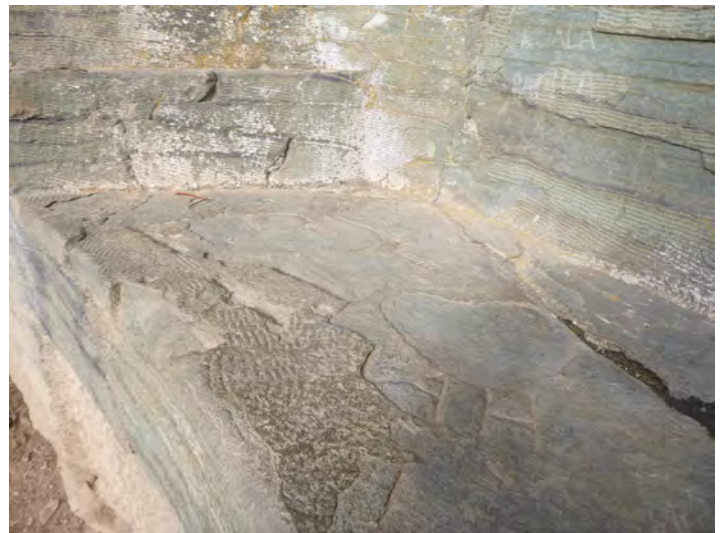
138-14 Stone\_SurfLoss Exfoliated 2021-3

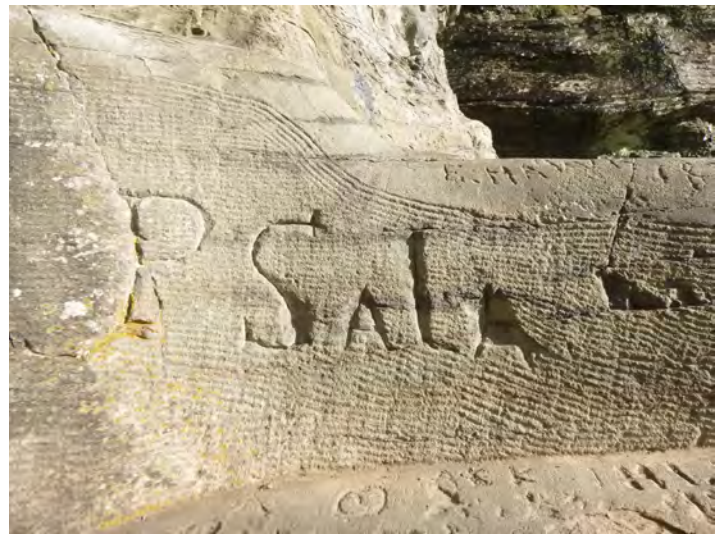
138-15 Stone\_Coating Coating Failed 2021-1

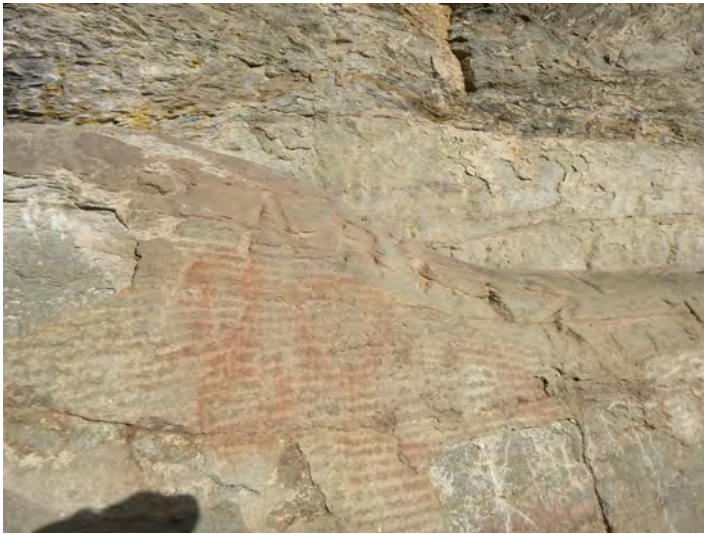
138-15 Stone\_Note Photo-carved graffiti 2021-1

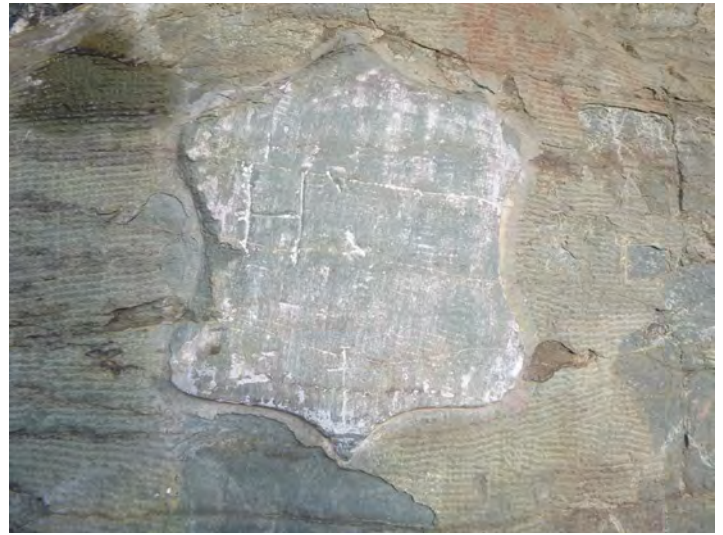
138-15 Stone\_Note Photo-carved graffiti 2021-2

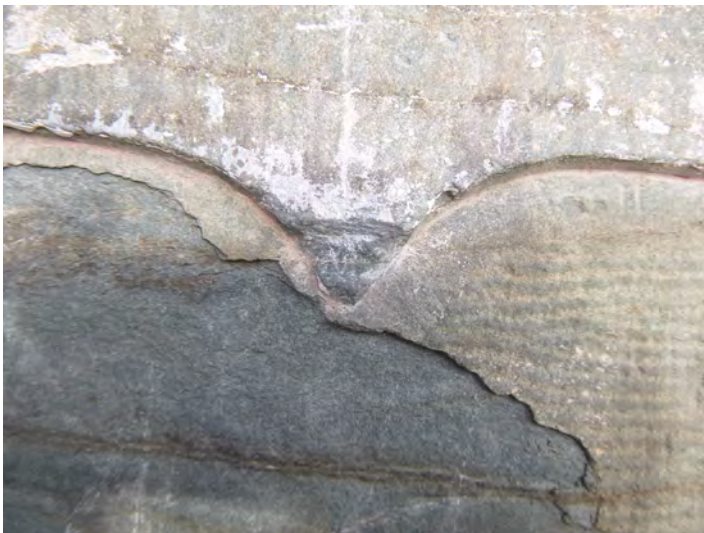
138-15 Stone\_SurfLoss Chipped 2021-1

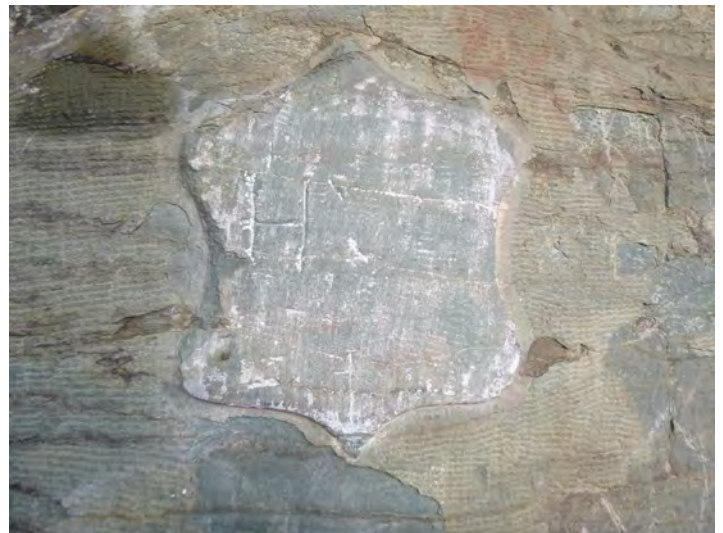
138-15 Stone\_SurfLoss Chipped 2021-2

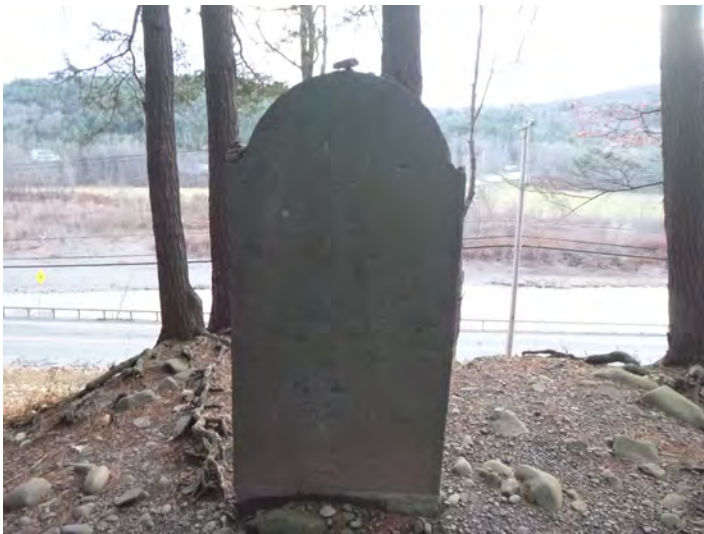
138-15 Stone\_SurfLoss Exfoliated 2021-1

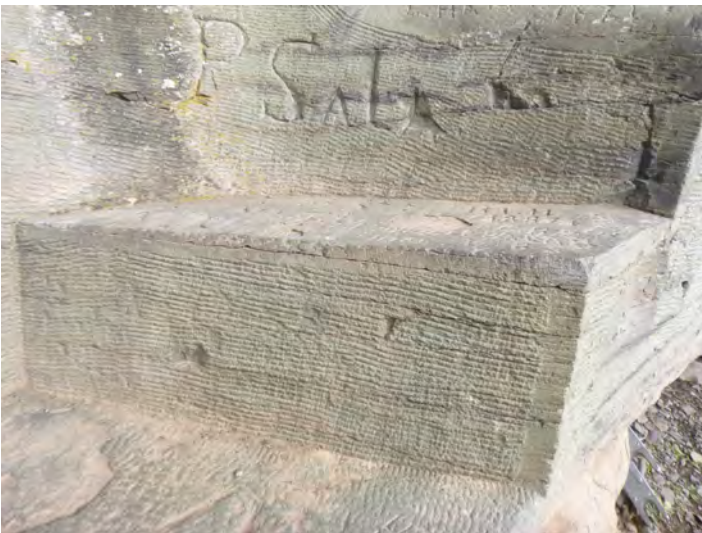
139-14 Stone\_Crack System units 2021-3

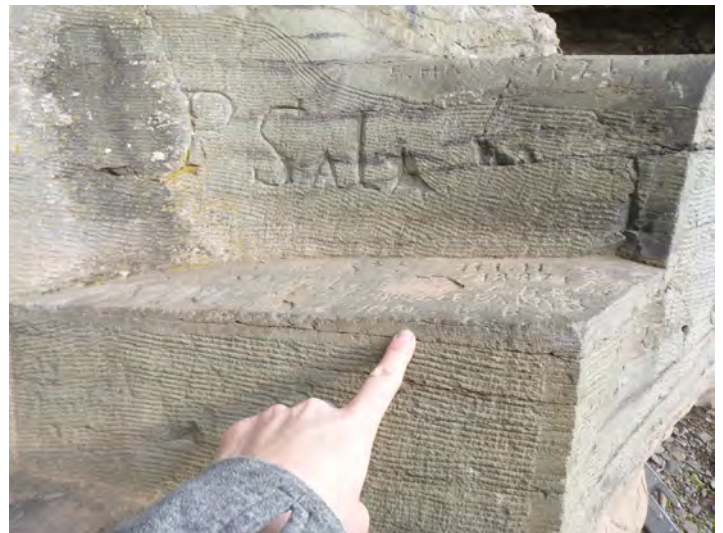
139-14 Stone\_SurfLoss Delaminated 2021-1

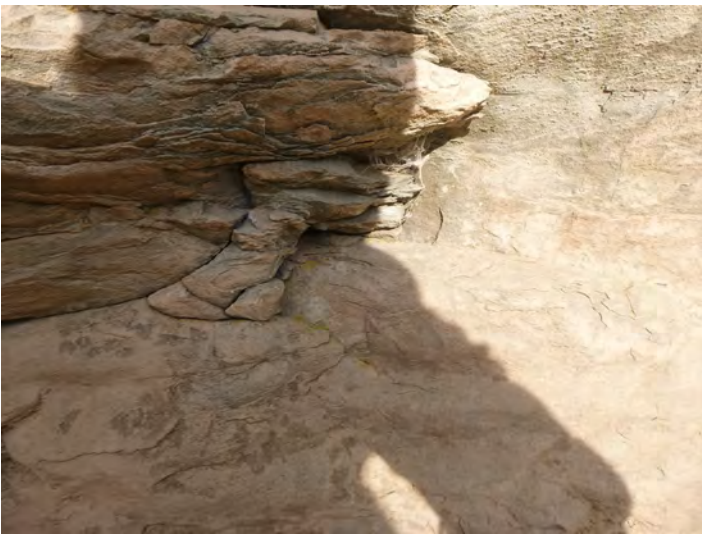
139-14 Stone\_SurfLoss Delaminated 2021-2

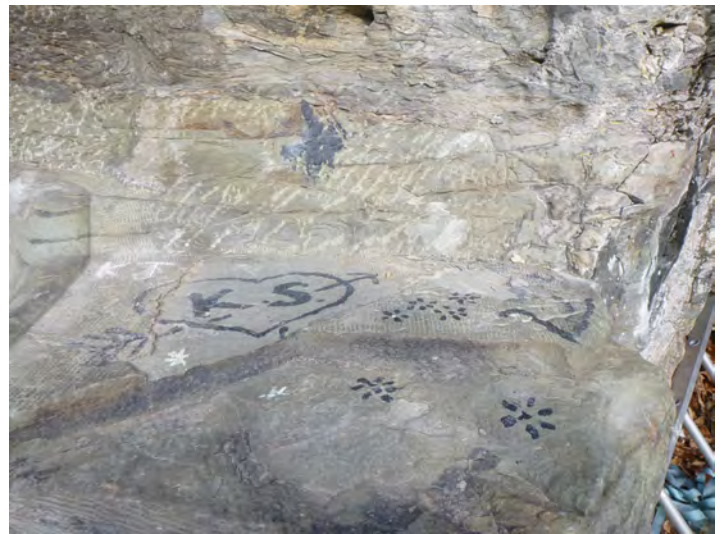
139-14 Stone\_Unsecured Loose 2021-1

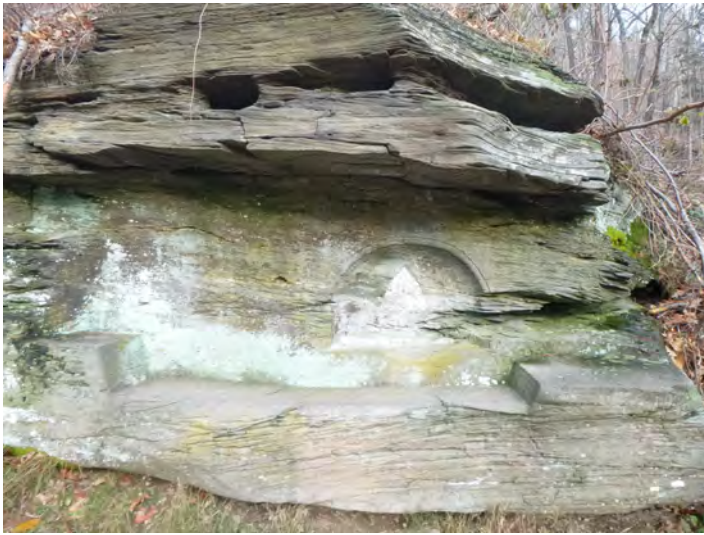
139-15 Stone\_Note Photo-painted graffiti 2021-1

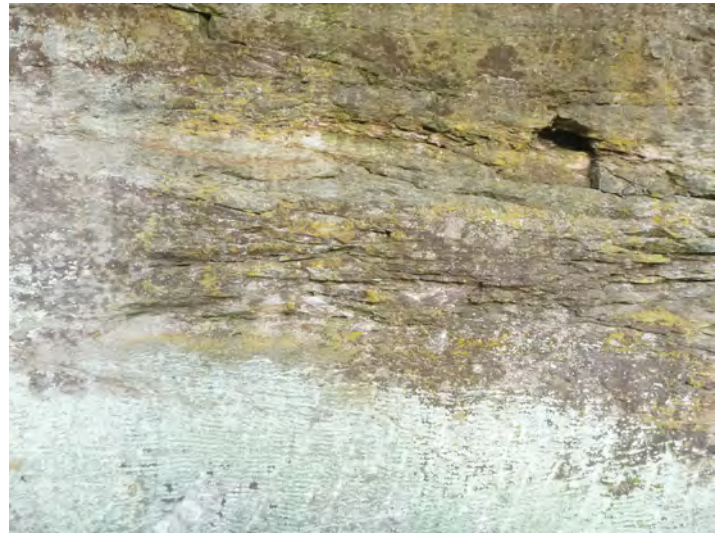
145-20 Stone\_Note Photo-overall 2021-1

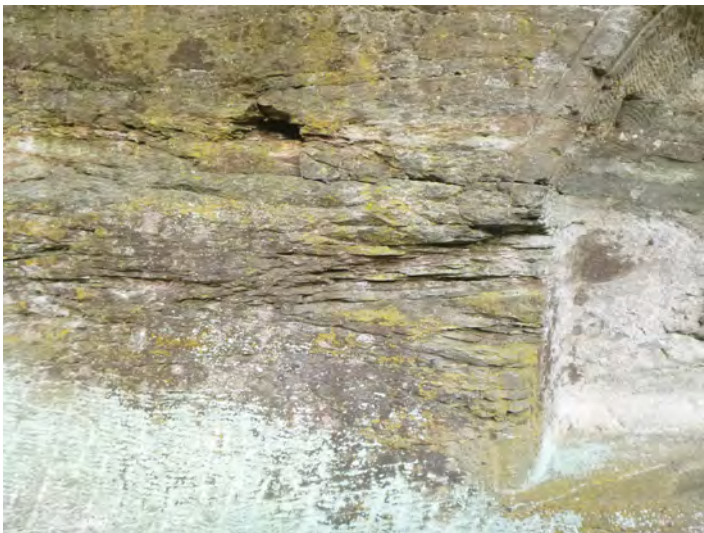
145-20 Stone\_Note Photo-overall 2021-2

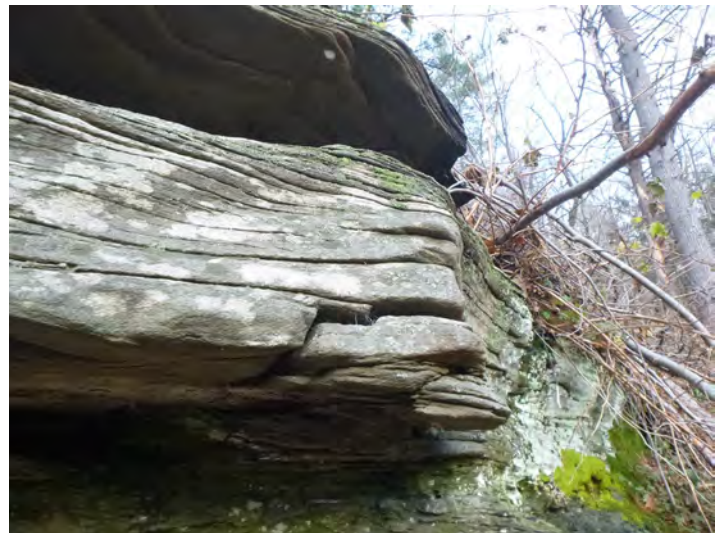
145-20 Stone\_Note Photo-overall 2021-3

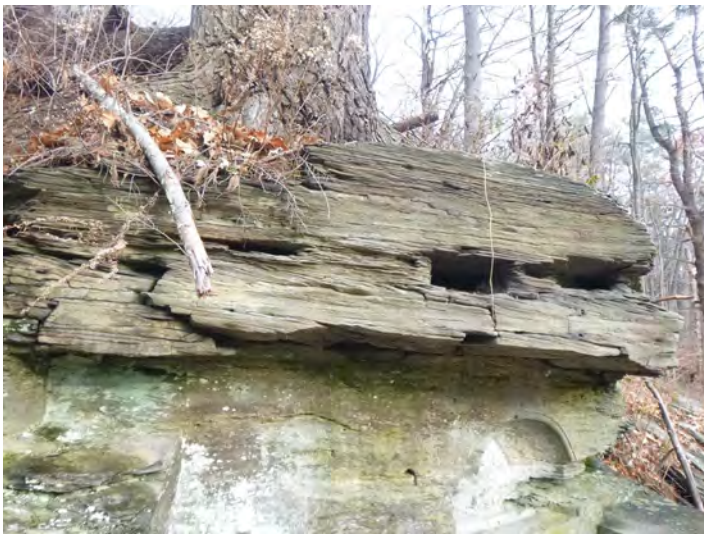
145-20 Stone\_Note Photo-overall 2021-4

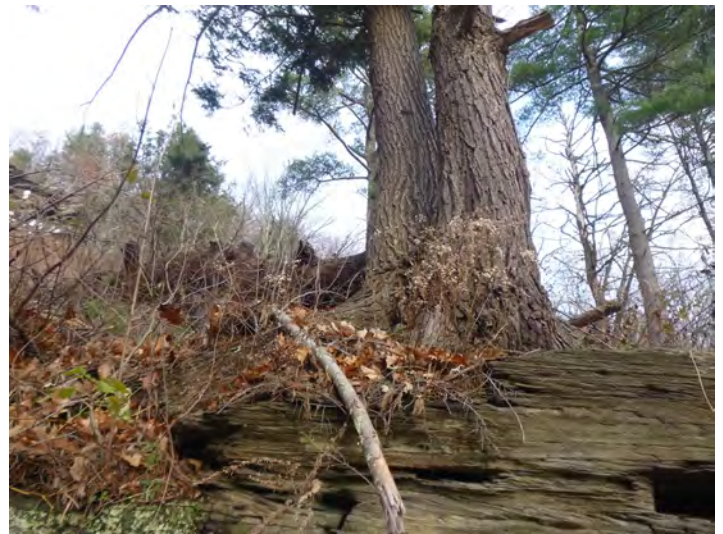
145-22 Stone\_Note Photo-general 2021-1

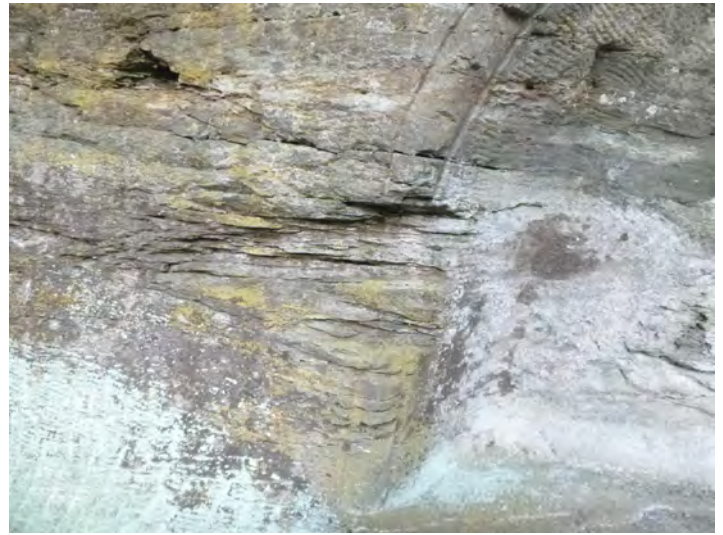
146-20 Stone\_Crack System units 2021-1

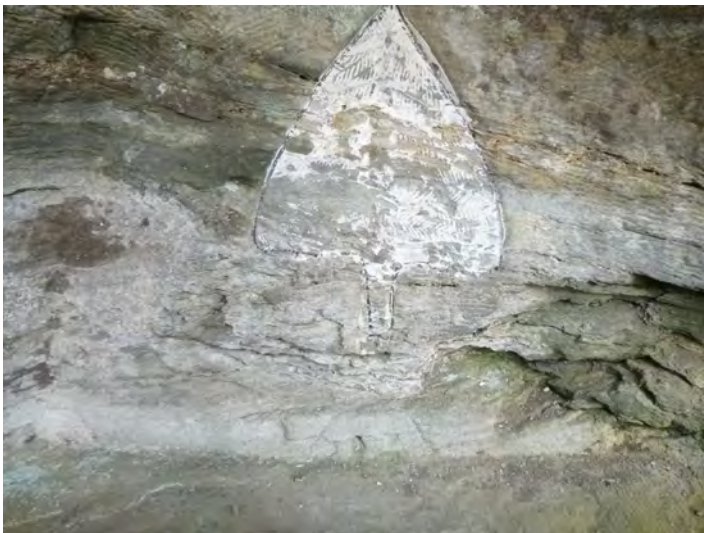
146-20 Stone\_Spall Missing 2021-1

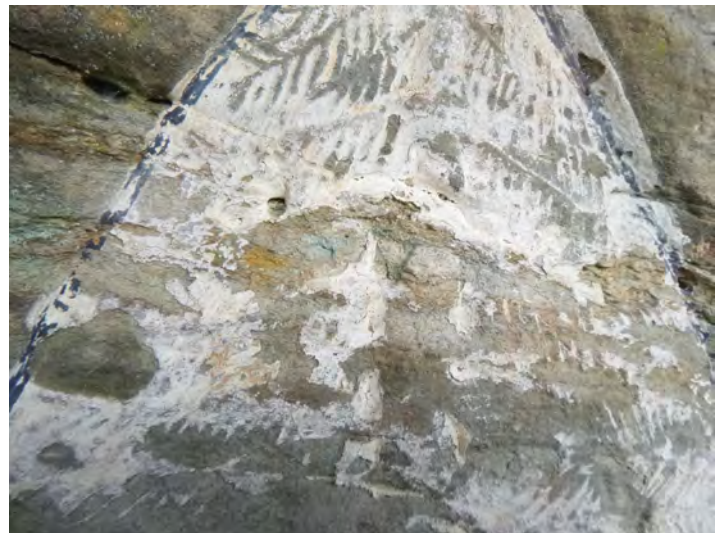
146-20 Stone\_SurfLoss Exfoliated 2021-1

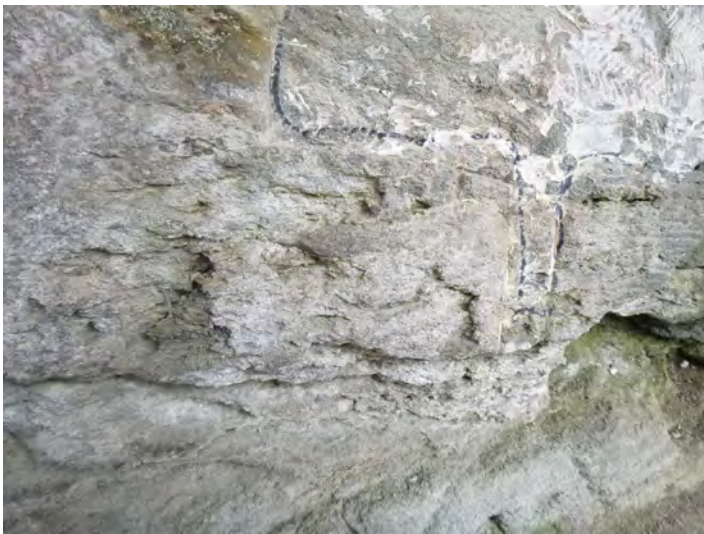
146-20 Stone\_SurfLoss Exfoliated 2021-2

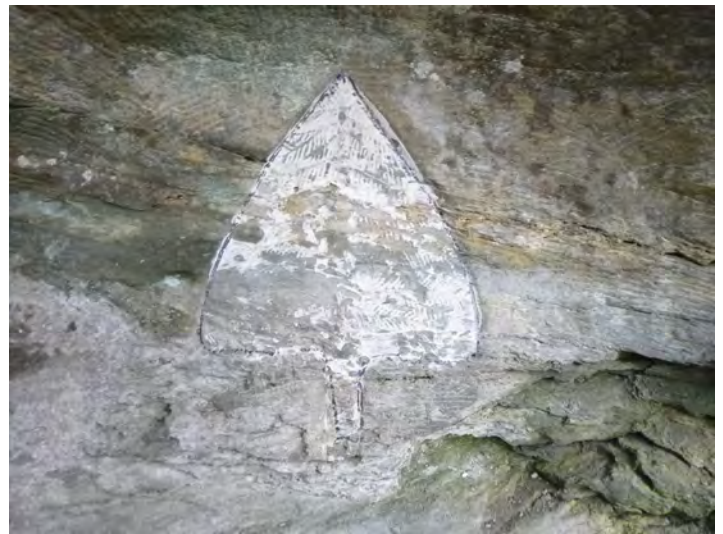
146-20 Stone\_SurfLoss Exfoliated 2021-3

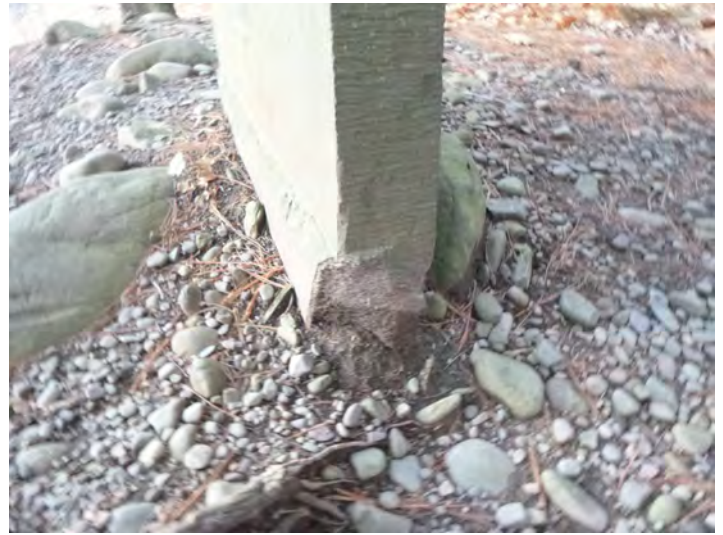
146-24 Stone\_Spall Missing 2021-1

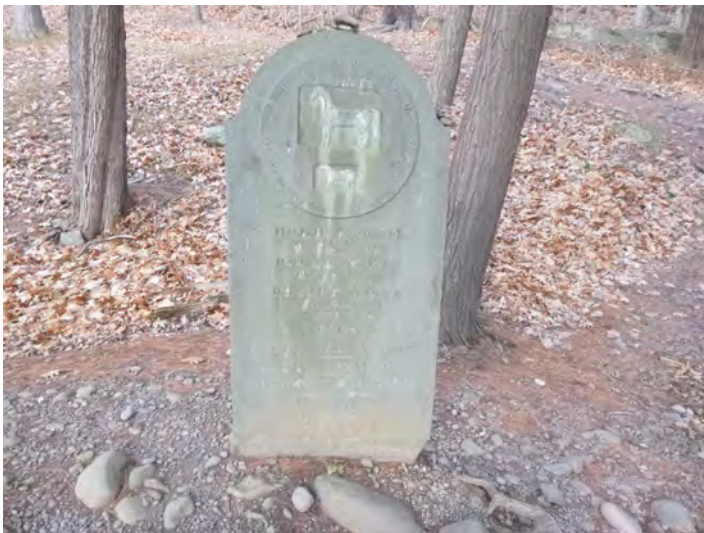
146-24 Stone\_Spall Missing 2021-2

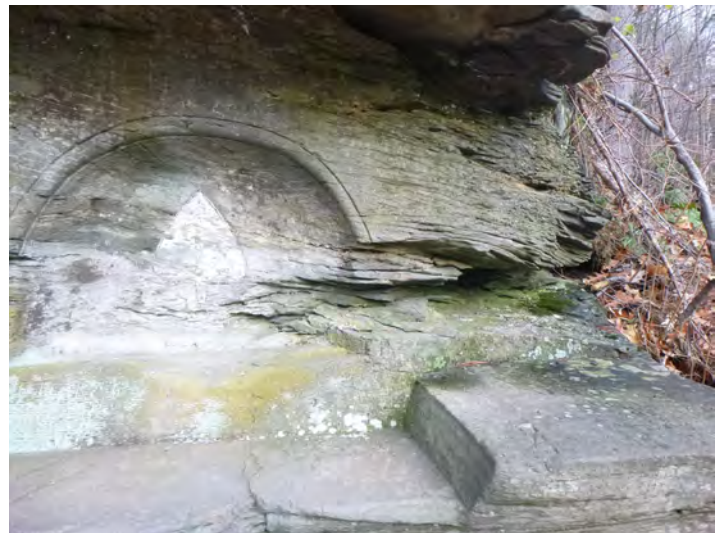
146-26 Stone\_SoilStain Biological 2021-1

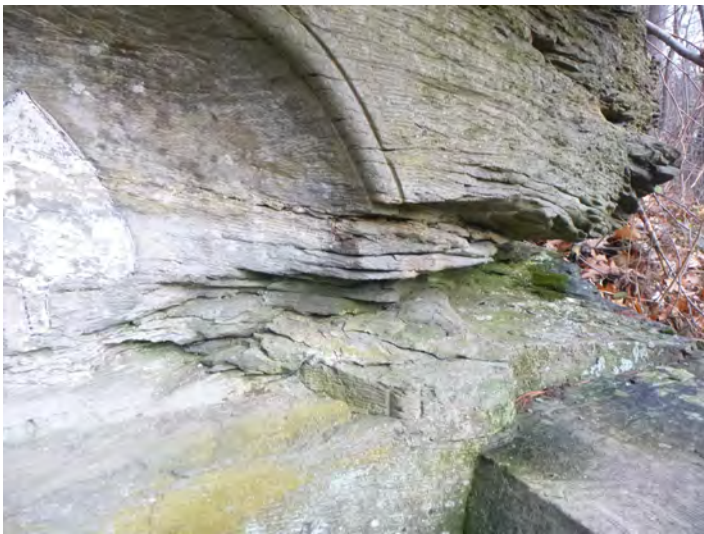
147-20 Stone\_Spall Missing 2021-1
