## **PRATT ROCK PARK**

Phase 1: Initial Needs Assessment  
Pratt Rock Park, Prattsville, New York

prepared for:  
Pratt Park Committee  
Prattsville, New York

April 18, 2022

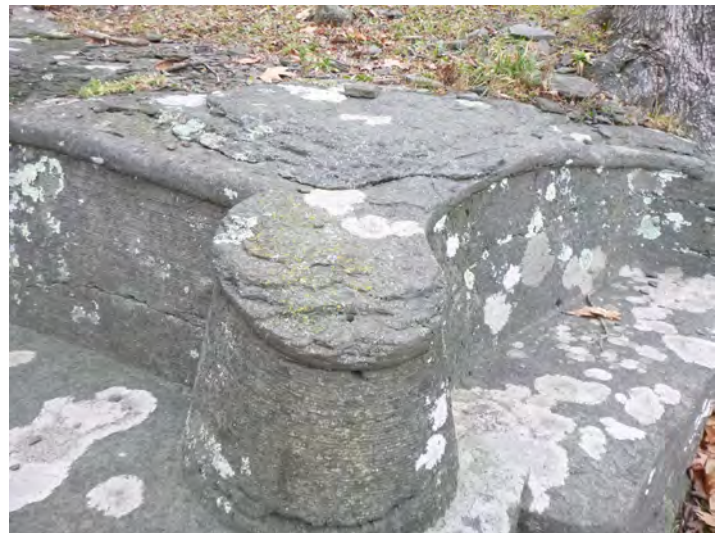
161-26 Stone\_Crack System units 2021-4

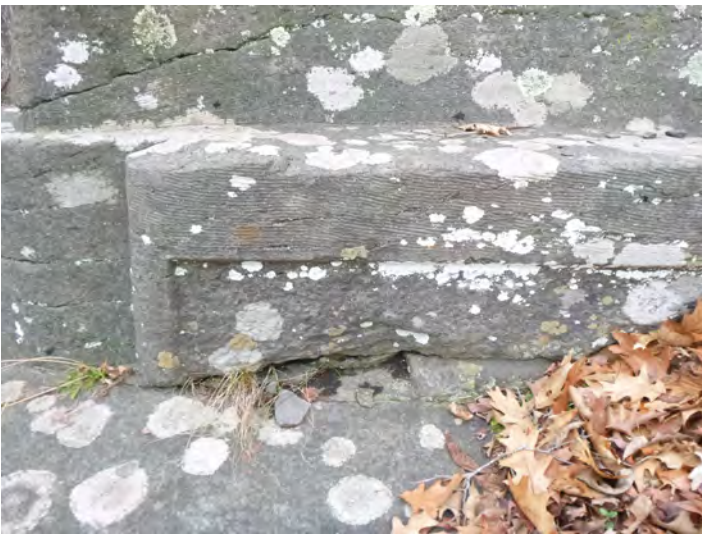
161-26 Stone\_SurfLoss Eroded 2021-1

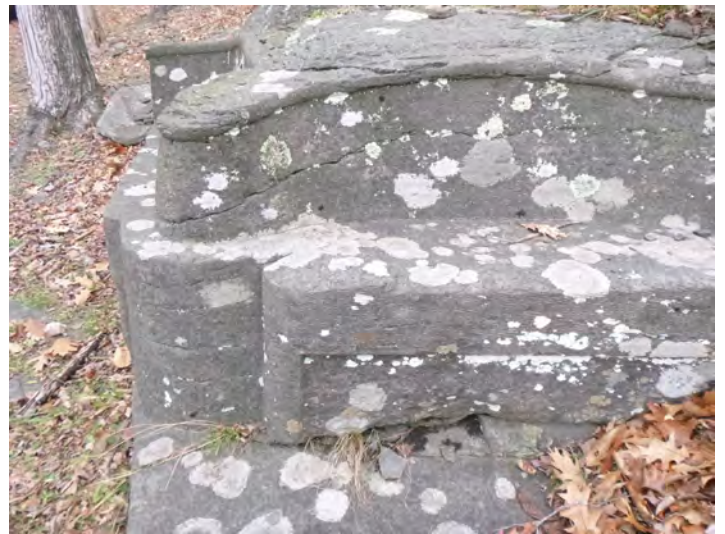
162-25 Stone\_Spall Missing 2021-1

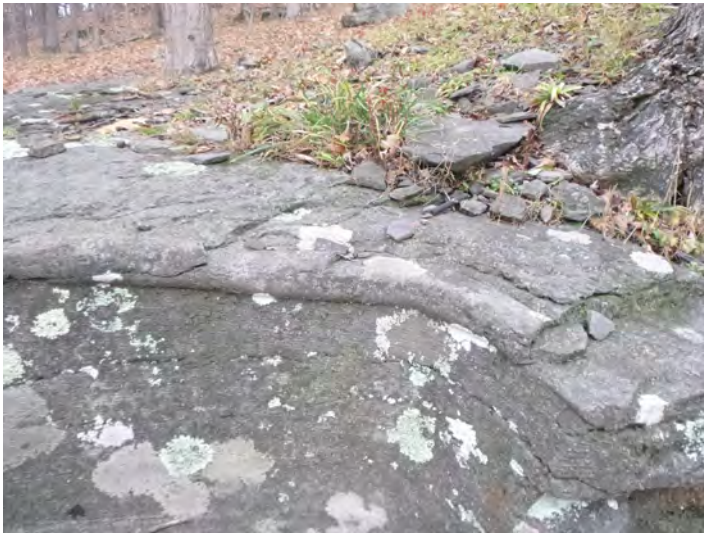
162-25 Stone\_Spall Missing 2021-2

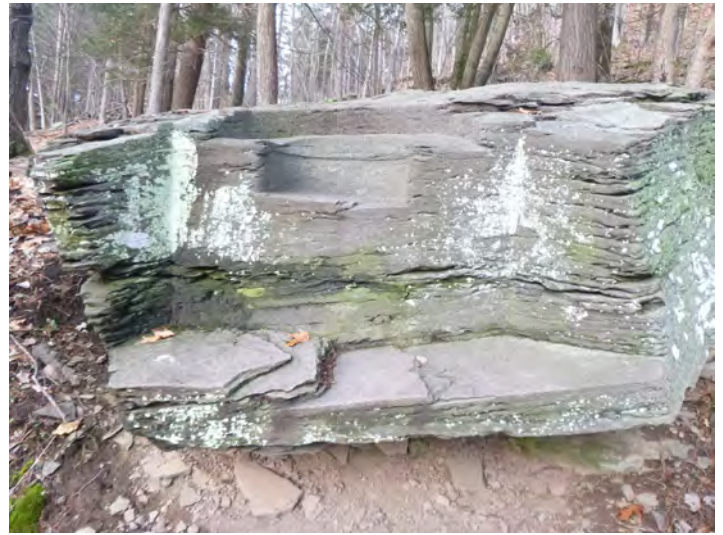
162-26 Stone\_Spall Missing 2021-1

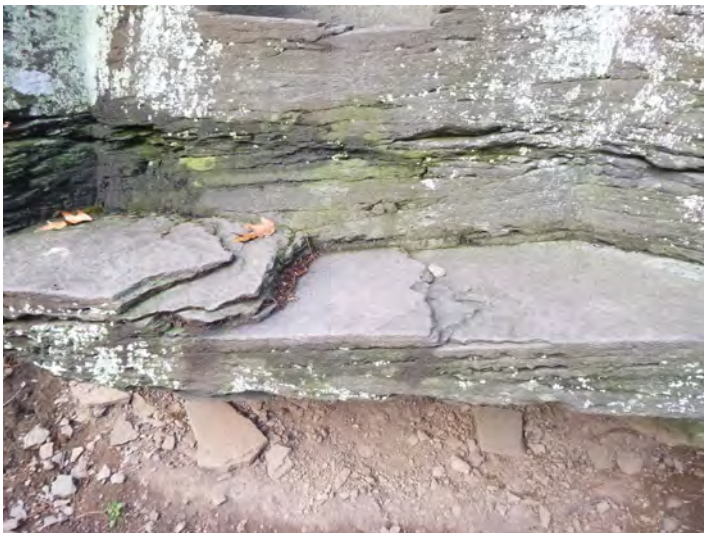
168-20 Stone\_SurfLoss Eroded 2021-1

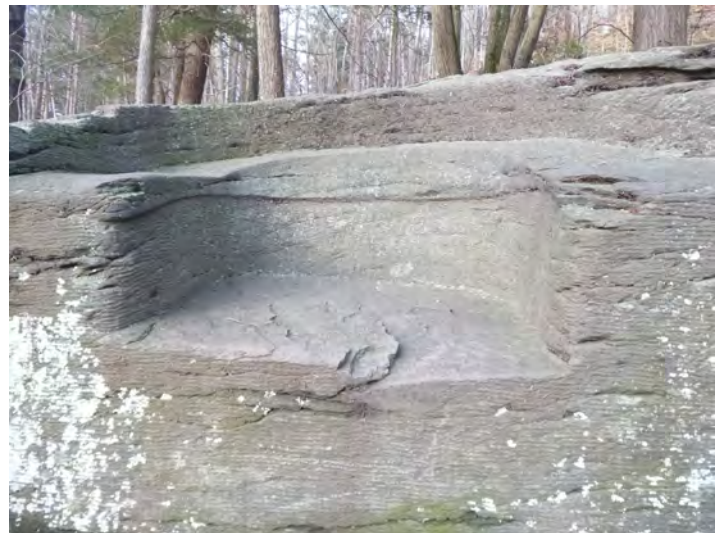
168-20 Stone\_SurfLoss Eroded 2021-2

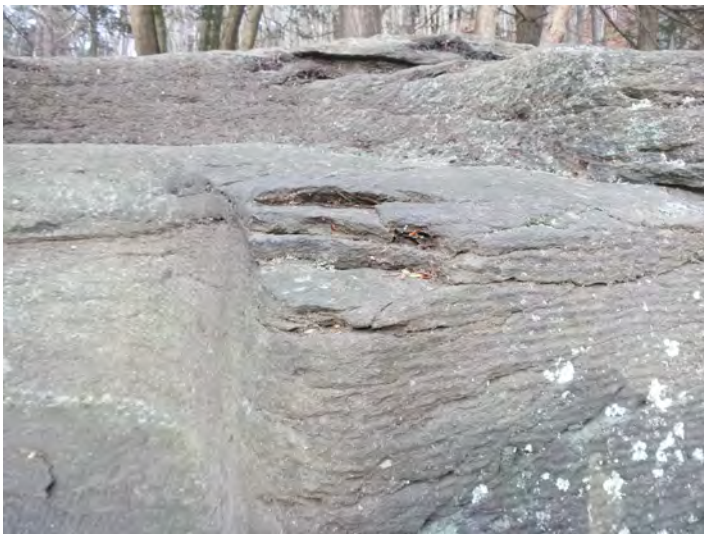
168-20 Stone\_SurfLoss Eroded 2021-3

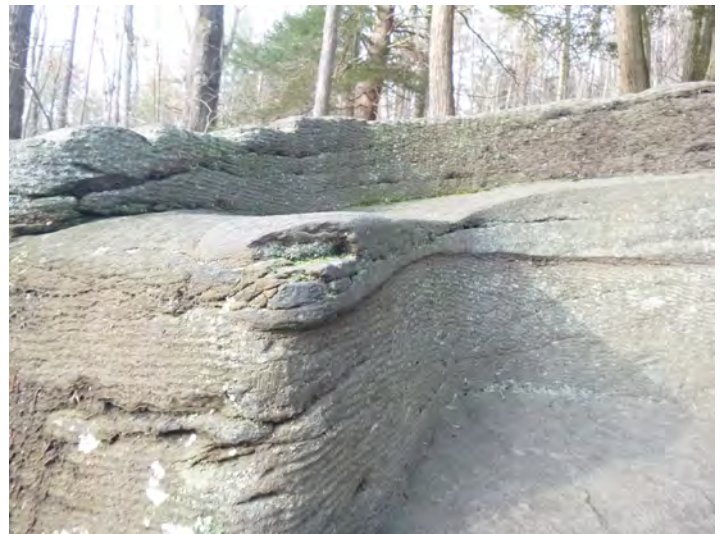
168-20 Stone\_SurfLoss Eroded 2021-4

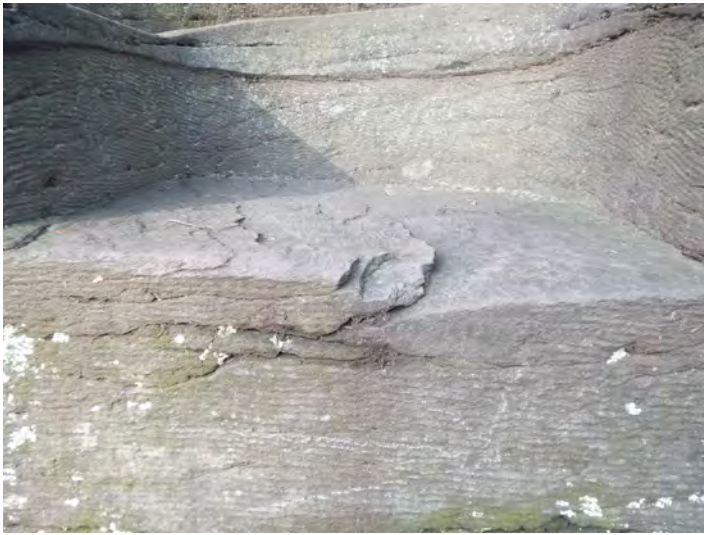
168-20 Stone\_SurfLoss Eroded 2021-5

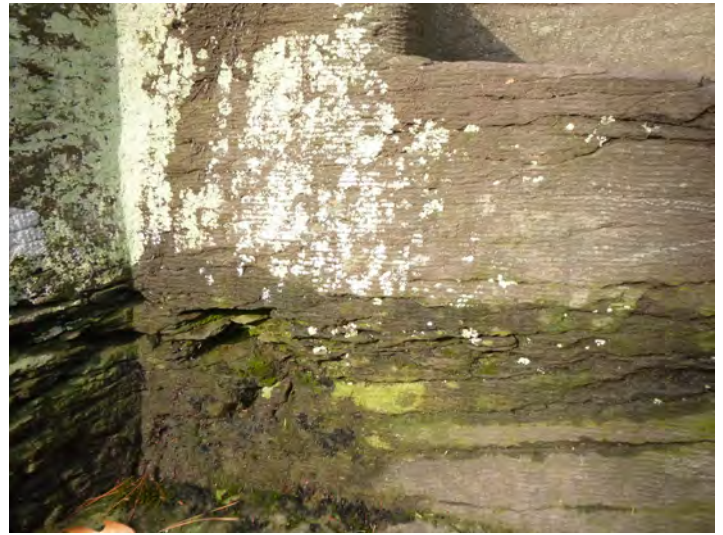
168-20 Stone\_SurfLoss Eroded 2021-6

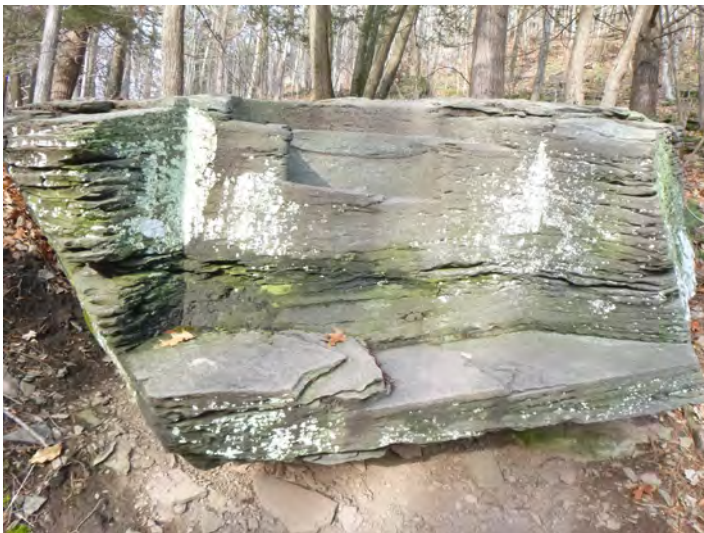
168-20 Stone\_SurfLoss Eroded 2021-7

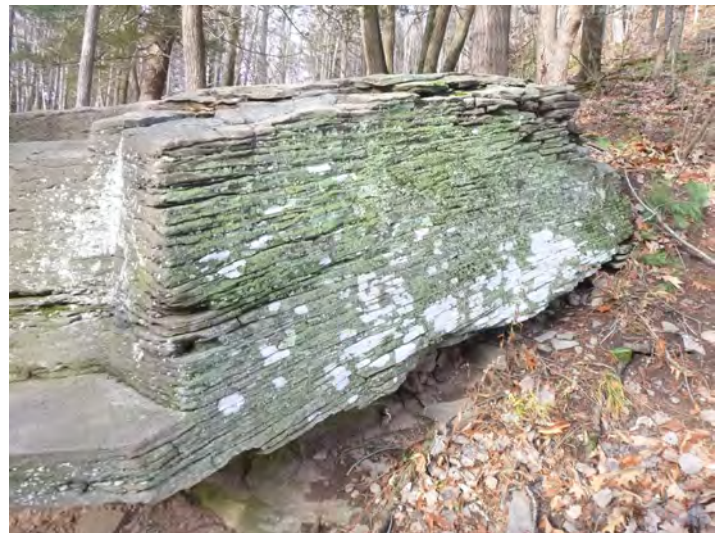
168-20 Stone\_Unsecured LooseBeddingPlane 2021-1

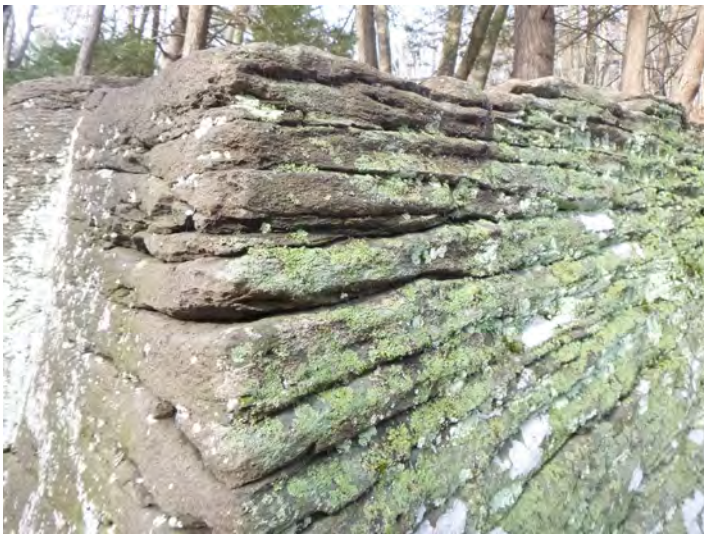
168-20 Stone\_Unsecured LooseBeddingPlane 2021-2

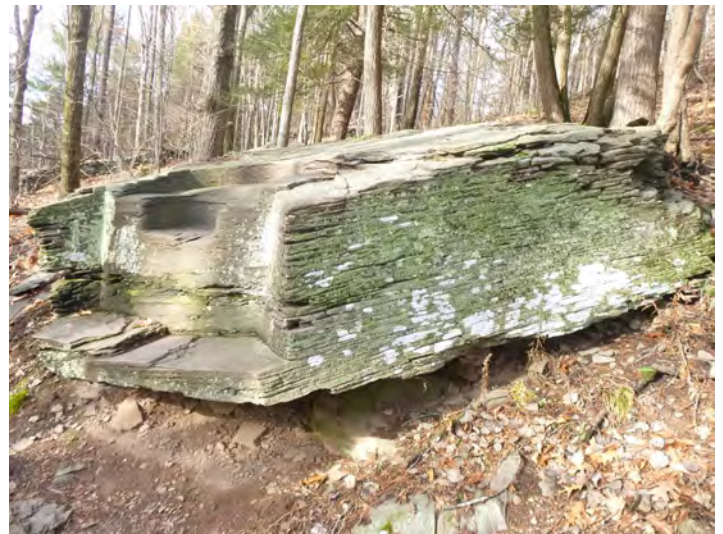
168-20 Stone\_Unsecured LooseBeddingPlane 2021-3

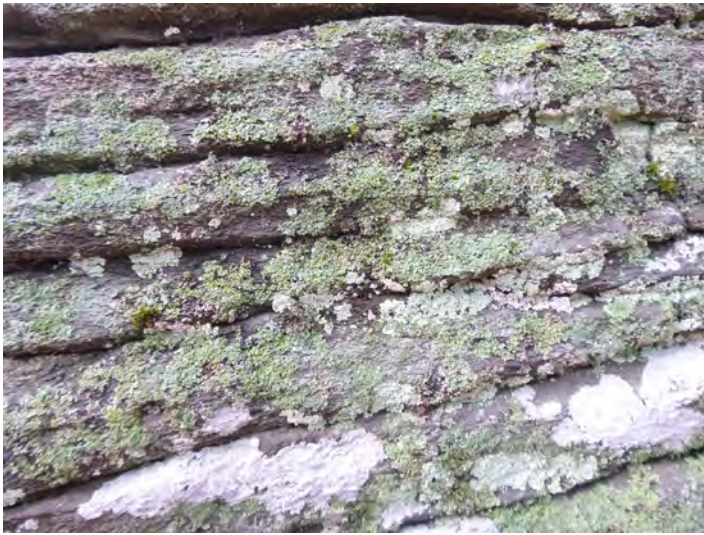
168-21 Stone\_SoilStain Biological 2021-1

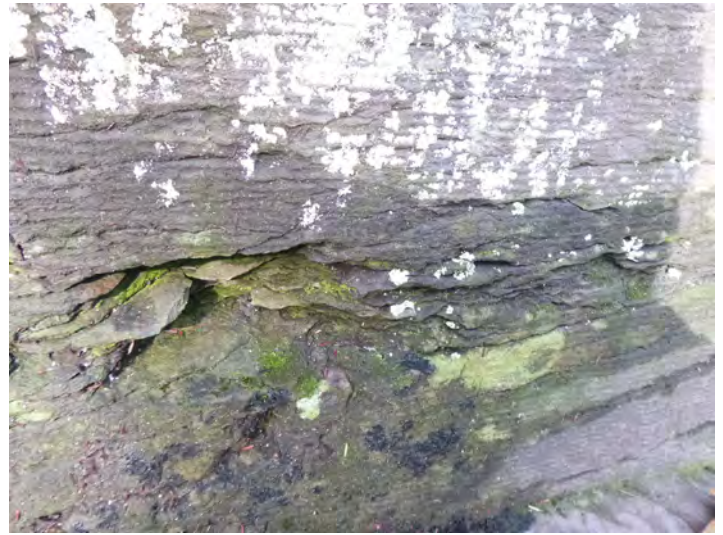
168-21 Stone\_SoilStain Biological 2021-2

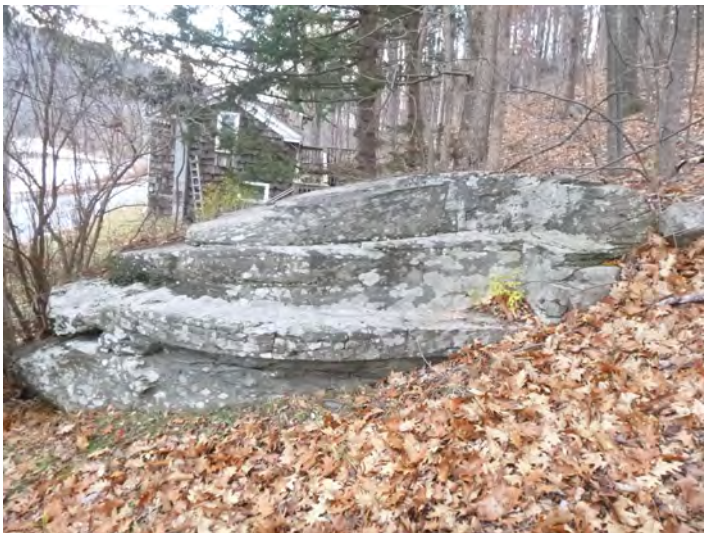
168-21 Stone\_SoilStain Biological 2021-3

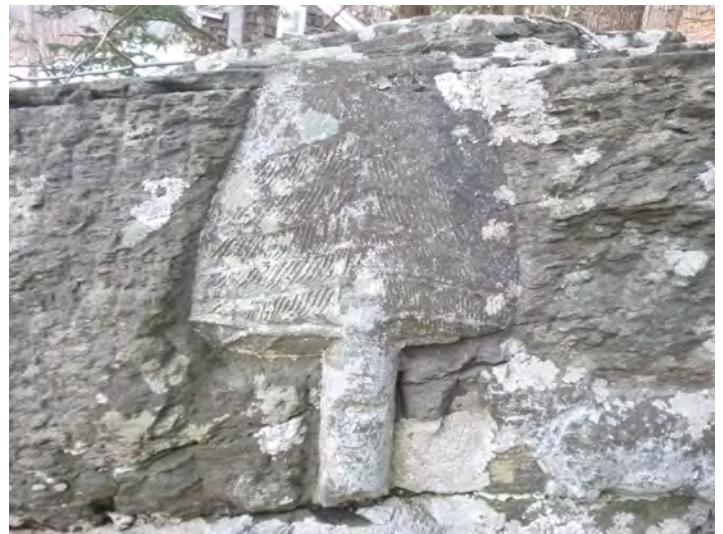
169-26 Stone\_Crack System units 2021-1

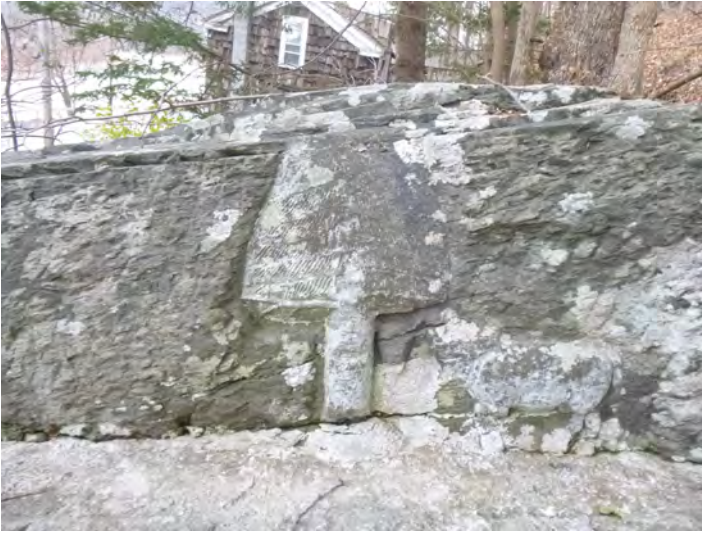
169-26 Stone\_SoilStain Biological 2021-1

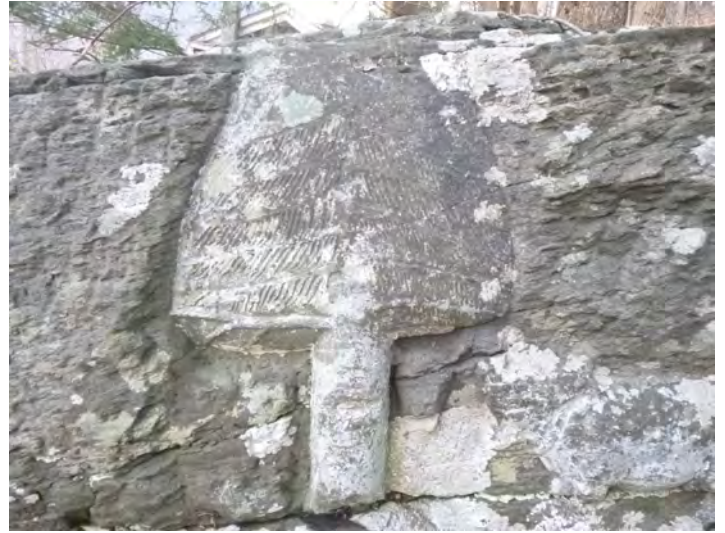
169-26 Stone\_Spall Missing 2021-1
